North West Main tower. Expansion Joints
Main-span

Pre - Post Inspection Information.

North West main Tower Expansion Joint.

North West Main Tower expansion joint . Removal and re-instatement of plate Main-span west No. 3.

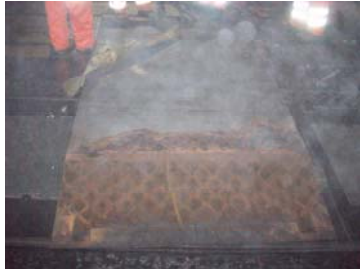
Tongue plate removal.

Tongue plate on MW3. lifted and laid down as specified as per Drawings. **Note. :** During lifting it was found that plate movement combined with the build up of corrosion scale, detritus on the edges of the plate created resistance. This was located in the north west corner of the plate. This was overcome by applying impact by means of a heavy hammer. This combined with the continual lifting force being applied by the crane was enough to free up and release the plate to allow removal .

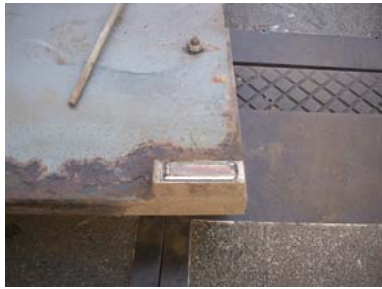
Packer plates welded to existing tongue plate bearing pads.

On completion of their inspection, it was agreed that plate MW3 could be reinstated. Whilst carrying out pre removal dimensional survey the mismatch recorded between the tongue plate and bitumen plate would require 5mm packer plates to be welded to the existing bearing pads. This was completed . Prior to the reinstatement of the tongue plate, all faces of the plate were cleaned by engineer using a grinder to remove all corrosive material to ensure no problems occurred with the refitting.

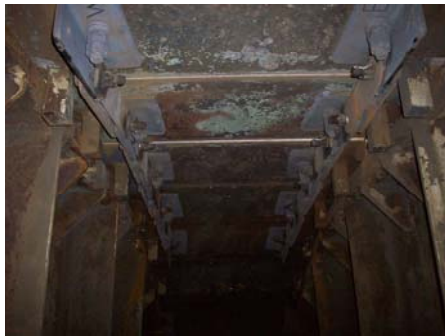
Following completion rocker, shuttle & tongue plates were reinstated without any problems. Emergency failsafe system connection plates and associated fixings attached to underside of sliding plate.

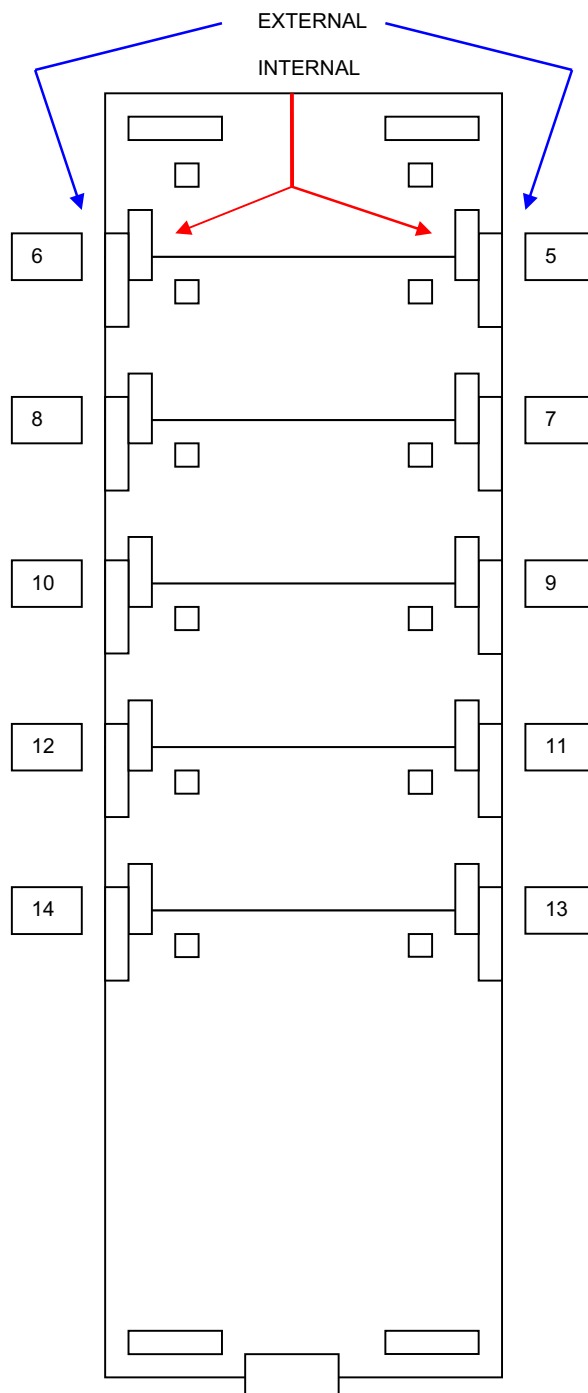
INSPECTION DEPARTMENT
Demag dimensional. . North west Mainspan plate. MW.3. . Pins & bushes. .
DATE. 2014.10.12.

PIN No.	EXTERNAL	INTERNAL
5	39mm	39mm
<u>Bush thickness</u>		
Top	4 mm	4 mm
Bottom	4 mm	4 mm
North	4 mm	4 mm
South	4mm	4 mm
6	39mm	39mm
<u>Bush thickness</u>		
Top	4 mm	3 mm
Bottom	4 mm	3 mm
North	4 mm	3 mm
South	4 mm	3 mm
7	39mm	39mm
<u>Bush thickness</u>		
Top	2 mm	3 mm
Bottom	2 mm	3 mm
North	2 mm	3 mm
South	2 mm	3 mm
8	39mm	39mm
<u>Bush thickness</u>		
Top	4 mm	3 mm
Bottom	3 mm	3 mm
North	4 mm	3 mm
South	3 mm	3 mm
9	39mm	39mm
<u>Bush thickness</u>		
Top	2 mm	2 mm
Bottom	2 mm	2 mm
North	2mm	1mm
South	1 mm	2 mm
10	39mm	39mm
<u>Bush thickness</u>		
Top	2 mm	2 mm
Bottom	0 mm	2 mm
North	2 mm	1 mm
South	1 mm	2 mm

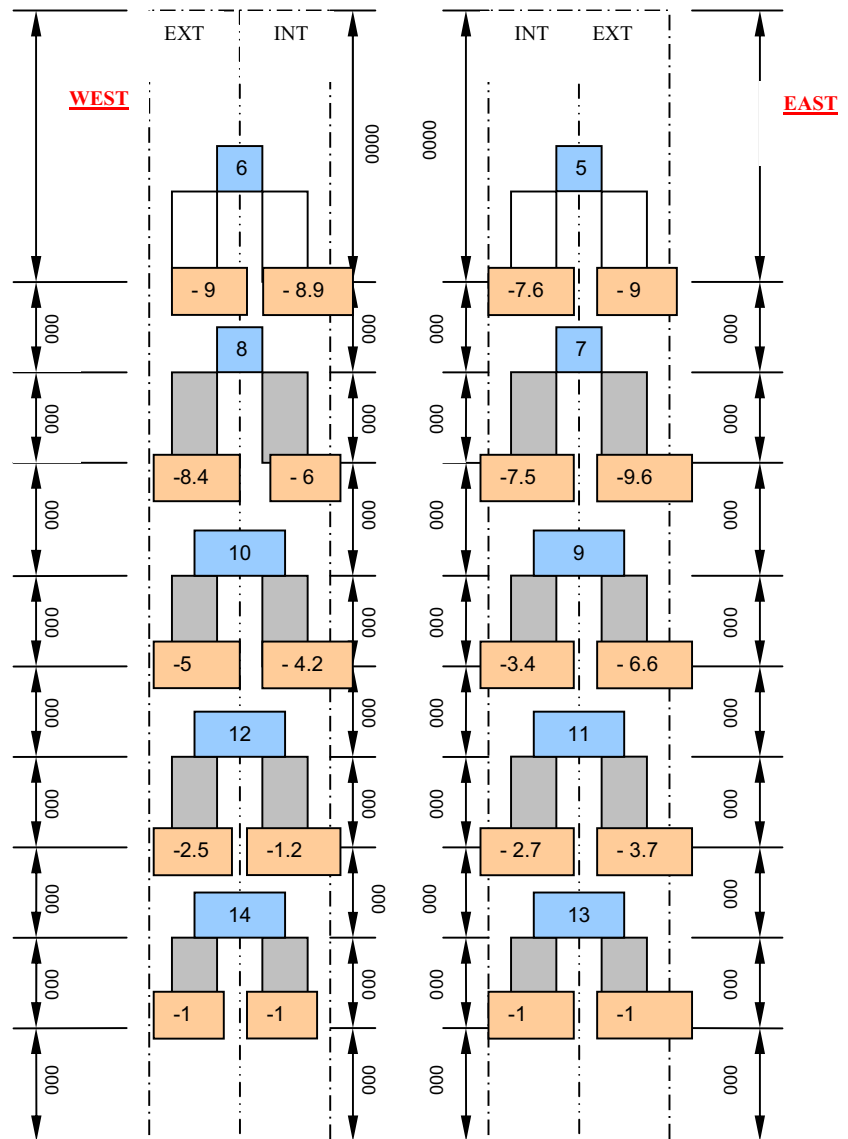
Radius girder wear down locations and Depression sizes are shown in mm.

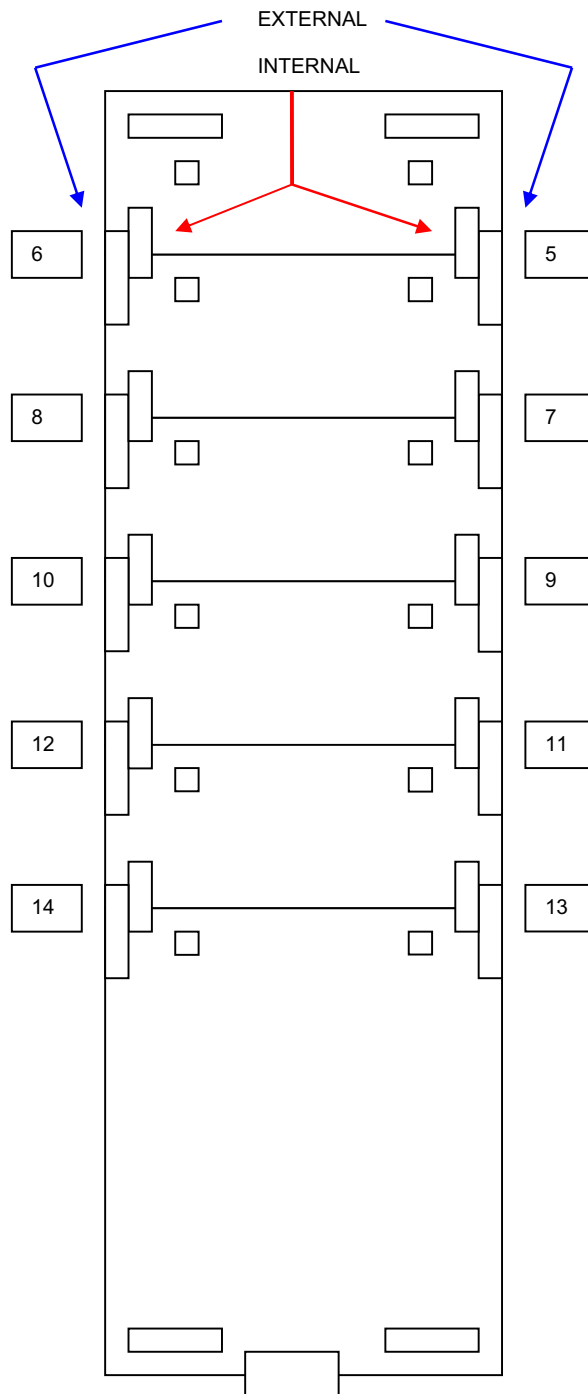
Demag dimensional. . North
west Mainspan plate. MW.3. .
Pins & bushes. .

PIN No.	EXTERNAL	INTERNAL
11	39 mm	39mm
<u>Bush thickness</u>		
Top	1 mm	2 mm
Bottom	2 mm	2 mm
North	2 mm	0 mm
South	0 mm	N/T
12	39 mm	39mm
<u>Bush thickness</u>		
Top	2 mm	0 mm
Bottom	0 mm	2 mm
North	0 mm	0 mm
South	0 mm	2 mm
13	39 mm	39mm
<u>Bush thickness</u>		
Top	0 mm	1 mm
Bottom	0 mm	1 mm
North	0 mm	0 mm
South	0 mm	1 mm
14	39mm	39mm
<u>Bush thickness</u>		
Top	0 mm	1 mm
Bottom	1 mm	1 mm
North	1 mm	0 mm
South	0 mm	1 mm

It should be recorded that no guarantee of complete 100% accuracy with regards to bush thicknesses can be given.

Some bush wear has receded back into the pin location making it difficult to obtain an exact measurement.

The pin internal bore in itself has areas of corrosion, detritus.
