A90 Forth Road Bridge Special Inspection Report

North Main Tower Expansion Joint
Removal & Reinstatement of Side-Span Plate
SW No.3
October 2015

SPECIAL INSPECTION REPORT

October 2015

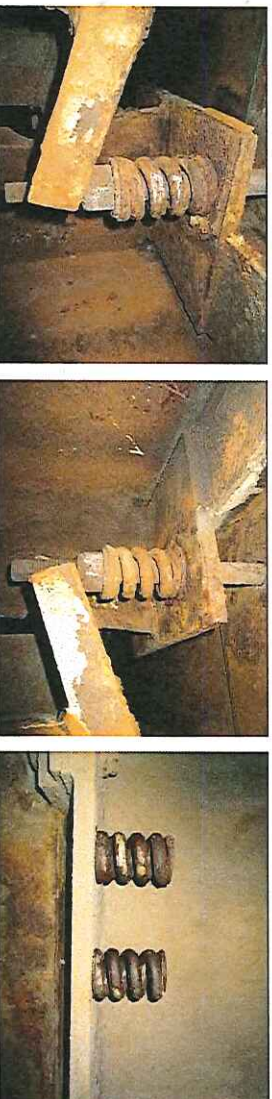
Springs: Tongue plates springs both east & west were intact and secure. General breakdown of protective paint coating on the springs was evident. The continual compression & de-compression of plate movement from vehicle axial load transferal induces break-down. This combined with the location and exposure to the elements creates an environment which exposes the springs and general corrosion is inevitable - this was evident on both springs at the time of inspection. Spring dimensions were recorded prior to removal - spring sizes on both East & West springs were recorded at 72mm. By recording this information this ensure's that new springs can be compressed to this size on reinstatement of the tongue plate. Both blocks located on the east & west side of the plate remain intact & secure.

General condition of springs during pre-inspection

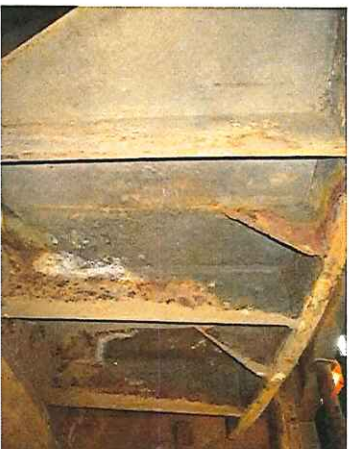
The cell condition was to be as expected, although areas of heavy corrosion were evident on the cell steelwork & associated fixings. The majority of the discolouration / staining on the cell steelwork is created by constant ingress of water distributed from the carriageway and through the expansion joint plates. In general the cell steelwork remains in a satisfactory condition.

Heavy corrosion to cell steelwork

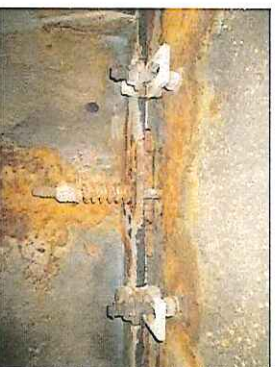
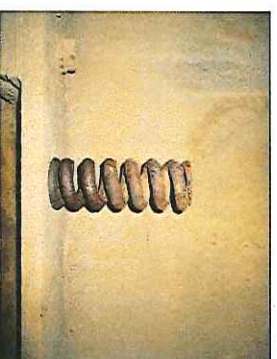
Rocker Spring: Rocker plate spring located centrally in the plate were intact and secure. General breakdown of the protective paint coating on the spring was evident. The continual compression & de-compression of plate movement from vehicle axial load transferral induces break-down. This combined with its location and exposure to the elements creates an environment which exposes the spring and general corrosion is inevitable. This was evident on the rocker spring at the time of inspection. Spring dimension's were recorded prior to removal, spring size recorded at 140mm. By recording this information this can ensure that new spring will be compressed to this size on reinstatement of the rocker plate.

Condition of Rocker Plate and Springs

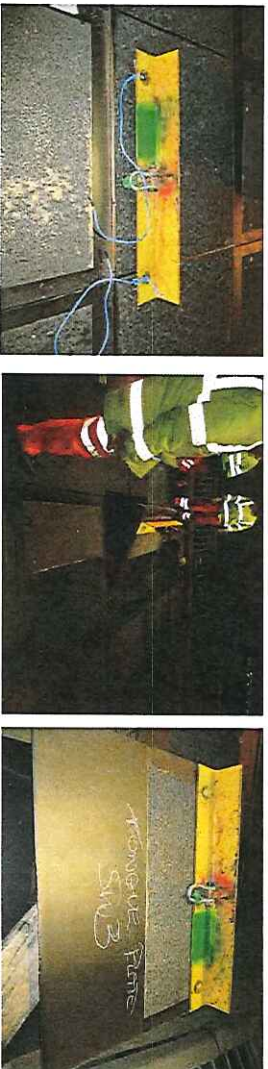
Fixing of lifting eye beam for removal of slide train

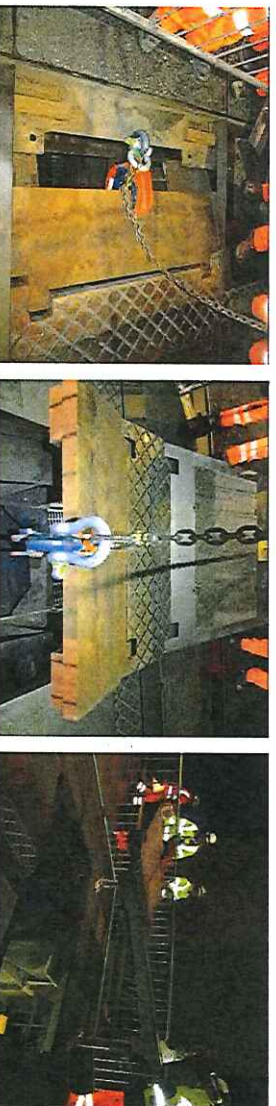
Removal of slide train

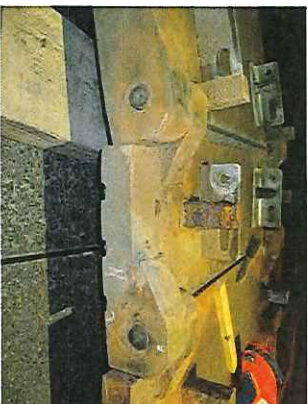
Pins: The sliding plate section pins (as in previous inspections on several plates) were found to be worn and out of shape. All remain in-situ, intact and secure.

General Condition of Slide Train Pins and Bushes

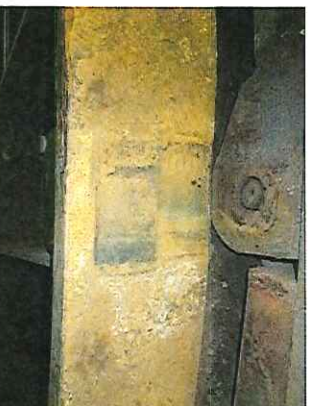
Bushes: All bushes were visually inspected and dimensions recorded. Bush thickness were measured in four locations on both internal & external faces. Wear-down was evident on all bushes. Refer to inspection record sheets within Appendix B for more information.

Example of Wear to Radius Arm from Bushes

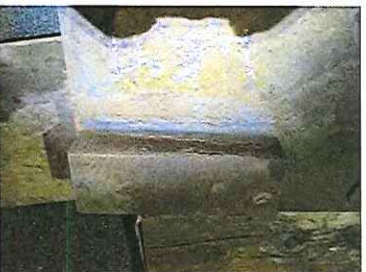
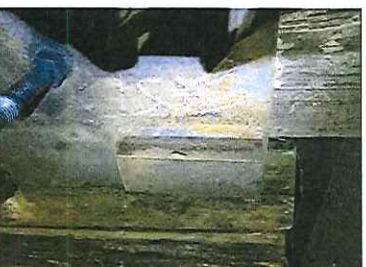
Rocker plate end bearing blocks: Both blocks located on the east & west side of the plate remain in a satisfactory condition. All welds on the rocker plate end bearing support blocks were visually inspected, both were found to be in a satisfactory condition. It was decided that no further method of inspection would be necessary. A slight mismatch of levels between the rocker plate end and the deck panel end was recorded. Refer to inspection record sheets within Appendix B for more information.

Rocker Plate End Bearing Blocks (East and West)

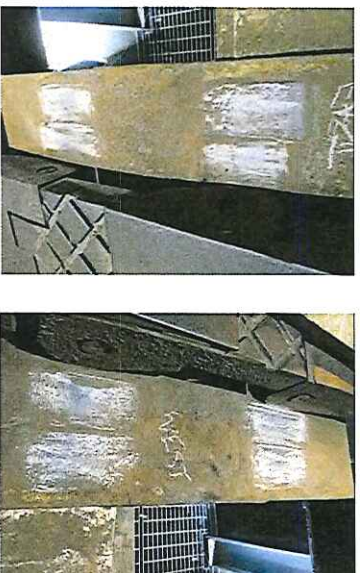
Radius arm girder: A visual inspection of the radius arm girder was carried out to record the depth of wear down through the constant movement of the sliding plate sections. Refer to inspection record

sheets within Appendix B for more information. The structural integrity of both E & W radius arms remain in a satisfactory condition.

Radius Arm Girders

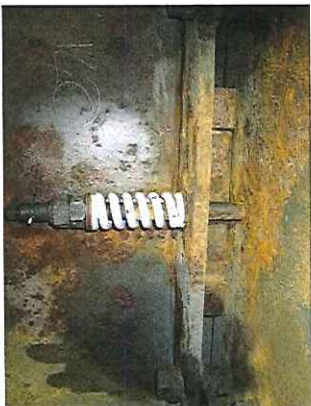
New spring fitted to rocker plate

Rocker plate: New spring fitted. Tensioned to required pre-removal length of 140mm. Fail-safe bolts fitted. Failsafe train plates fitted & tightened. All satisfactory

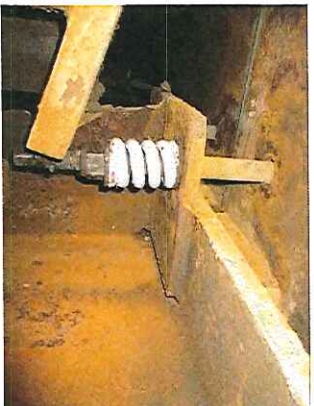
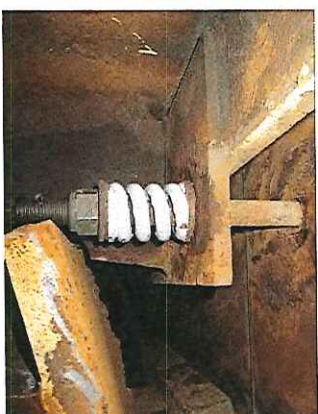
New springs fitted to tongue plate

Tongue plate: New springs were fitted on both East & West. Tensioned to required pre-removal length of 72mm. Fail-safe bolts fitted. All satisfactory.

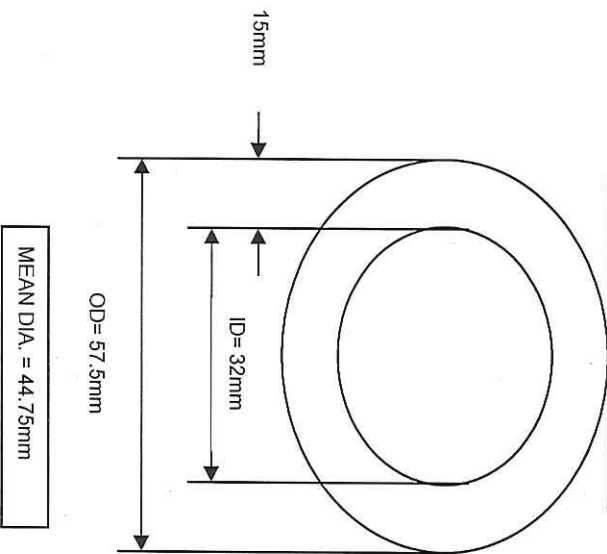
EXISTING SPRING (E)

MEAN D/A. = 44.75mm

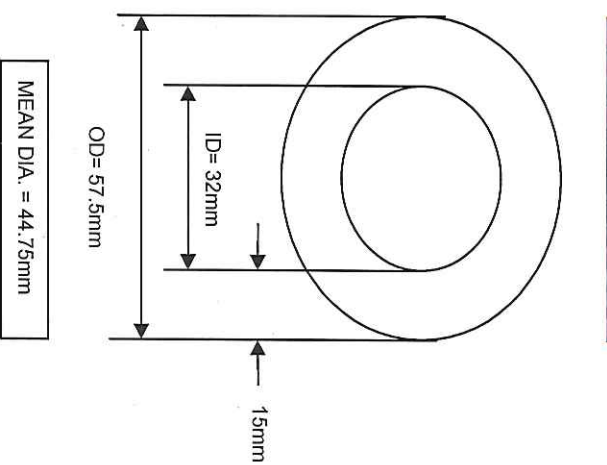
Existing spring (W)

MEAN D/A. = 44.75mm
