INSPECTION DEPARTMENT
-----------------------

North west main tower expansion joint . rocker plate location bolts.
--

DATE. 10/05/11
----------------

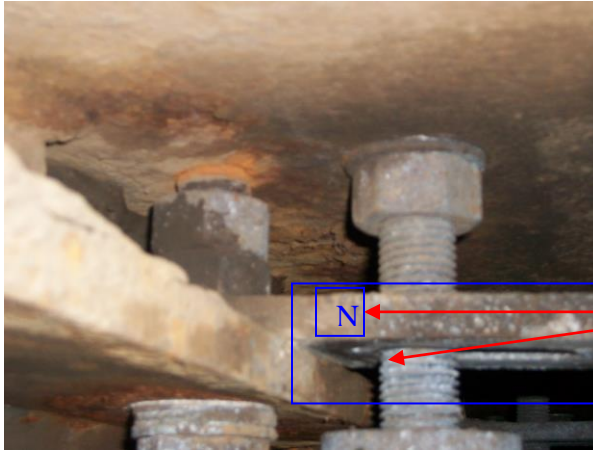
Rocker plate movement location bolts at their furthest point northwards as indicated on pictures.

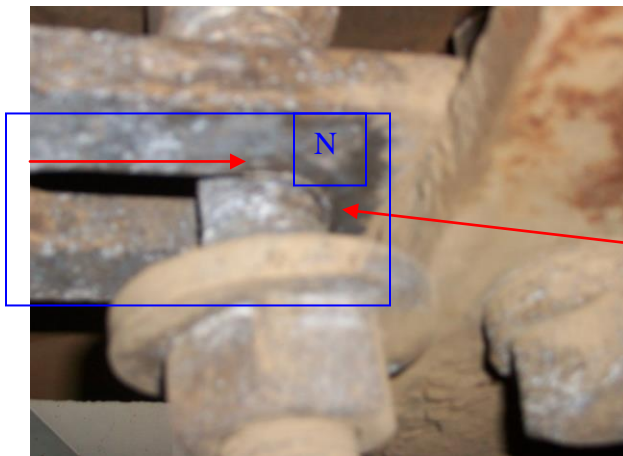
View from underside. This is probably down to vertical misalignment from topside on installation.
