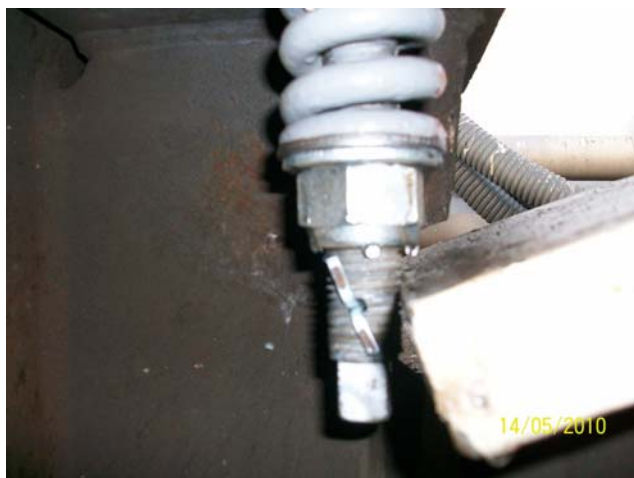
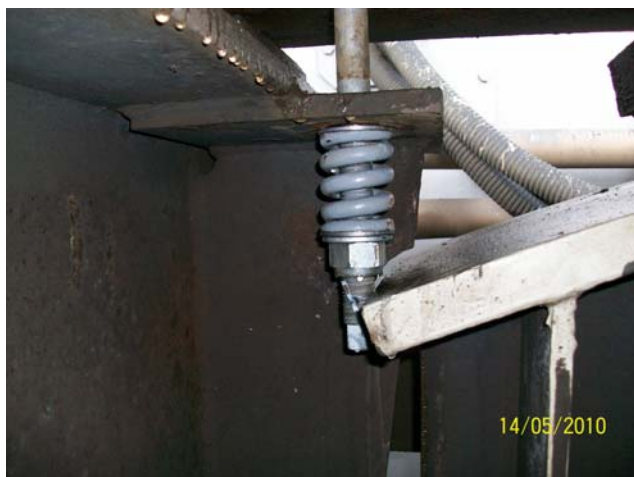
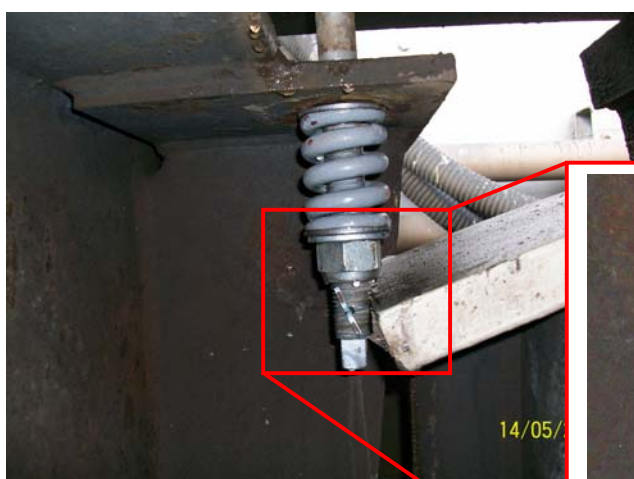
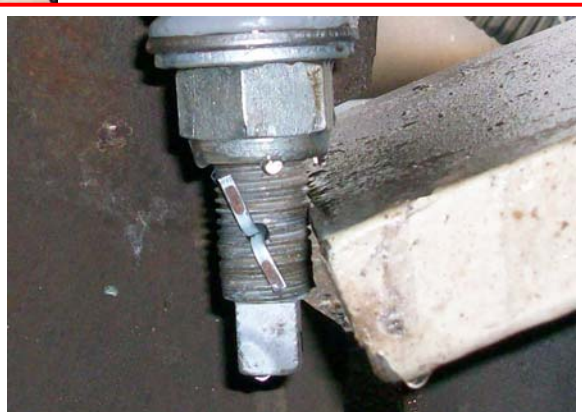
ON INSTALLATION OF THE SIDE SPAN TONGUE SPRING IT WAS DISCOVERED THAT THE FIXINGS CANNOT BE INSTALLED AS PER DRAWING, DUE TO A CLASH WITH THE RADIUS GIRDERS. THIS IS ILLUSTRATED IN THE PHOTOS.

IF SECOND NUT IS TO BE INSTALLED TO DRAWING MODIFICATION TO RADIUS GIRDER WILL BE REQUIRED.

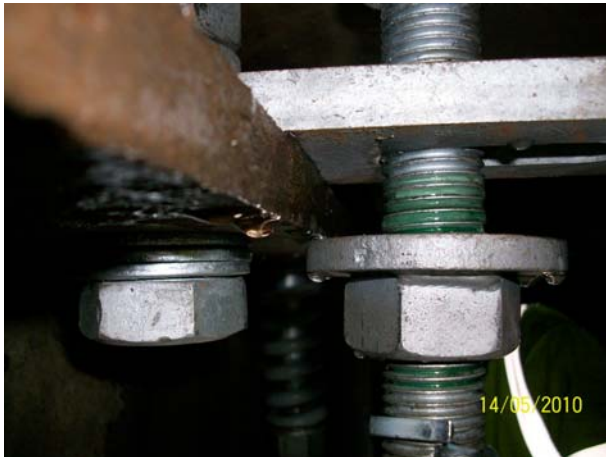
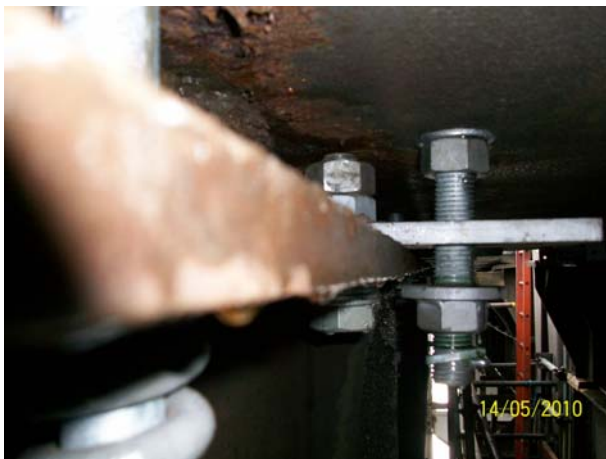
THE SIDE SPAN ROCKER LINK
PLATE TO SUPPORT BEAM IS NOT
FITTED TO DRAWING.
LINK PLATES HAVE BEEN REEMED
OUT TO ALLOW FOR ALIGNMENT
WITH ROCKER PLATE HOLE.
ALSO THE SPECIFIED 15mm
CLEARANCE BETWEEN LINK PLATE
AND WASHER IS NOW 25mm DUE
TO CLASH WITH BEAM FLANGE.

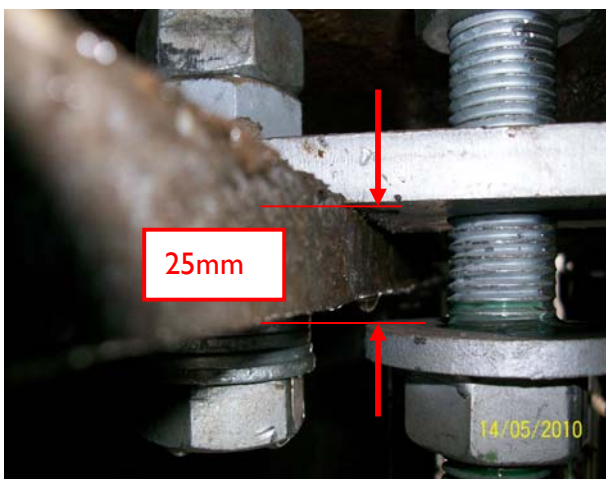
SEE BOTTOM PHOTOGRAPH.
