NORTH AND SOUTH VIADUCT ACCESS PLATFORMS **INSPECTION REPORT**

On Monday 12th January and Tuesday 13th January 2009 the underside inspections of the north and south viaduct access platforms were carried out with the use of a 44 tonne mewp.

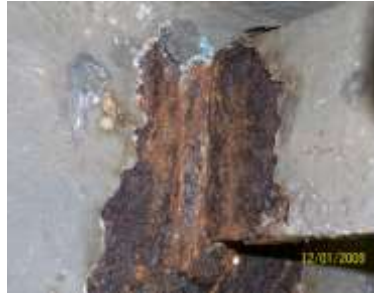
P2 UNCLEANED WELD

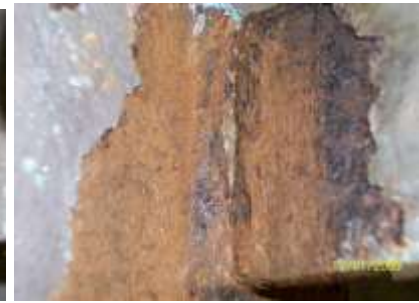
P3 WELD WIRE BRUSHED

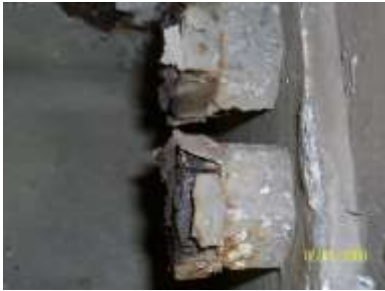
As the photographs show there is a great deal of blooming of nuts, as shown in photograph 4. But when cleaned as in photograph 5 the corrosion is not as severe as first appears.

P4 UNCLEANED

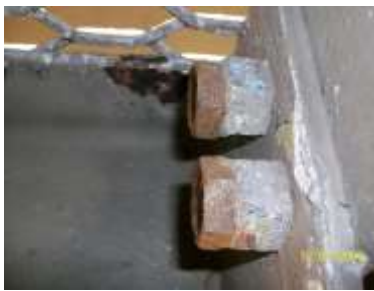
P5 CLEANED

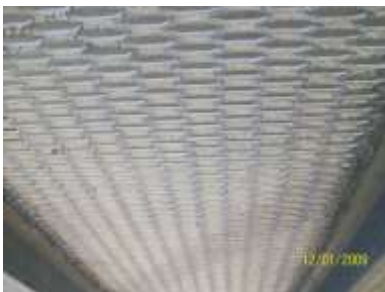
P7 TYPICAL EASTSIDE EXPAMET

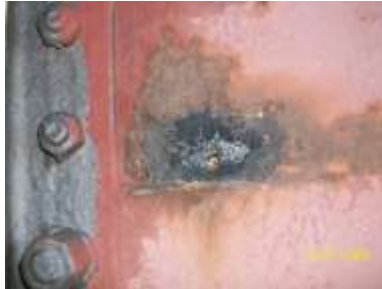
In P46 this photograph shows where the kick plate has corroded through, this is an isolated defect.
