Location PP. 24 S/W North west side Span. .
Bolt change report.

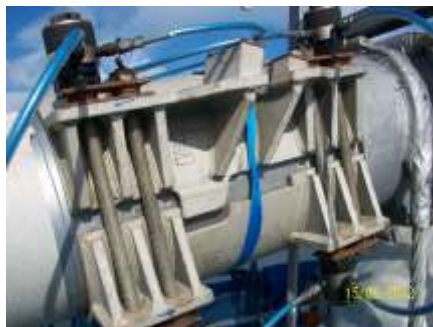
09.10. am. PS. 2 tensioners fitted and hydraulic circuit completed.

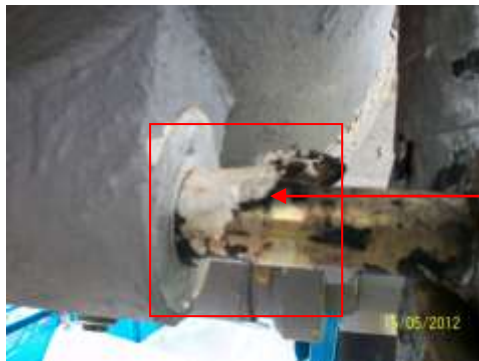
On removal of bolt, material what seemed like paper located around bolt.

Bolt "D" being removed.

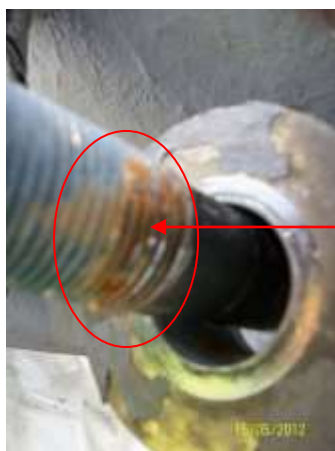
It should also be recorded that during bolt removal water found to be evident in bolt location sleeve, and that discolouration / slight corrosion was evident on threads of old bolt.

Discolouration / slight corrosion was evident on th threads of old bolt.

11.35 am.. New Bolt fitted.

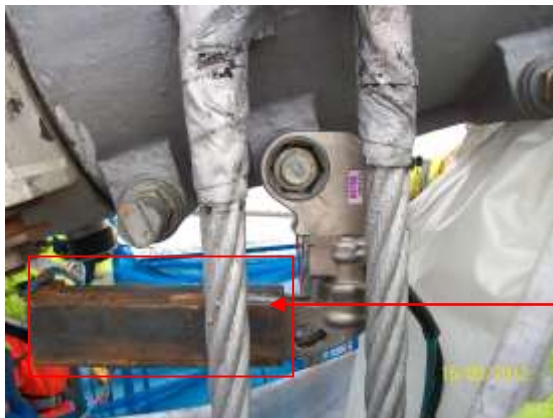
11.55. am. Extension sleeve fitted to RSL.6 Torque tool reaction foot had to be removed by engineer I. Alexander. In the workshop. Unable to locate on new bolt live side with sleeve attached.

Extension sleeve fitted to RSL.6
