Location PP. 54 North East Main Span. .
Bolt change report.

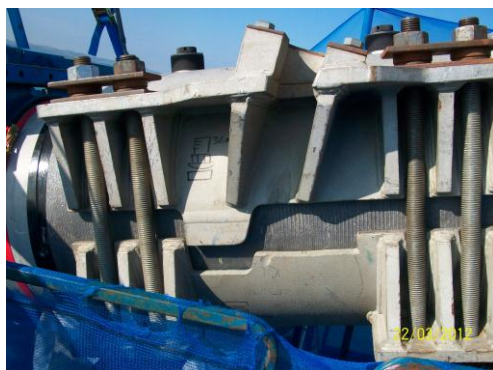
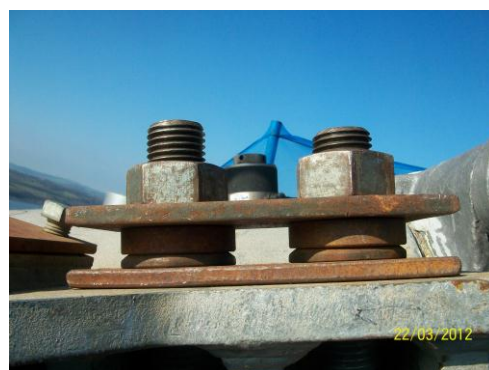
At approx 15.50 PM lower half of temporary cable band was transported to location by cradle, and again This was secured in position by the use of ratchet straps and chain pulls until lower half was positioned. All 8 M36 bolts located in position and secured. All plates and washers positioned as per (Aecom drawings) and tightened by spanner. **(All M36 bolts were give as specified thread extensions on the tensioned end of a minimum of 1.5 times thread diameter. ie M36 = 55mm . Dead end to have minimum of 2 in No threads showing below nut. (As per method statement.)**

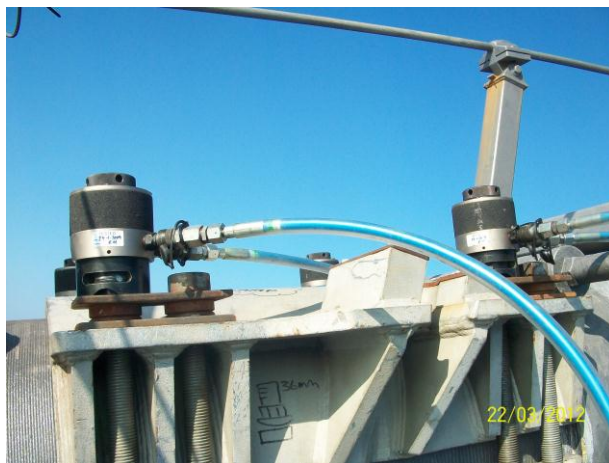
10.30 AM. PS. 2 tensioners fitted and hydraulic circuit completed.

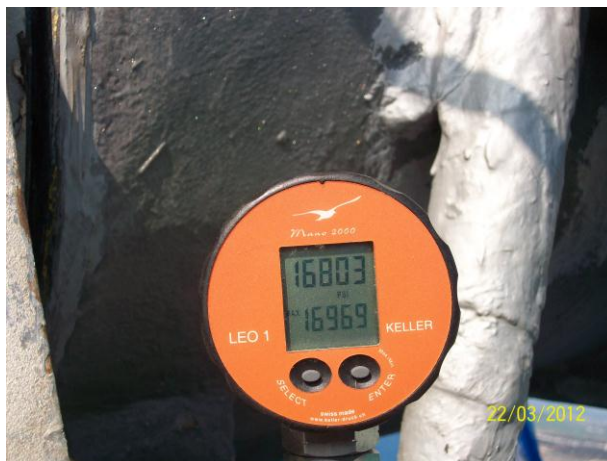
10.35 AM. Circuit pressurised and taken up in increments as requested with continual monitoring observations being carried out on clamp and PS 2 tensioners until required pressure of 16610 psi @ 350 kn (1130 bar) was achieved.

Pressure reached 16969

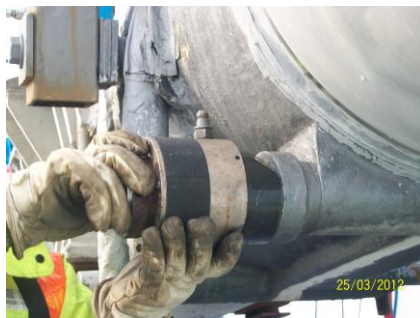
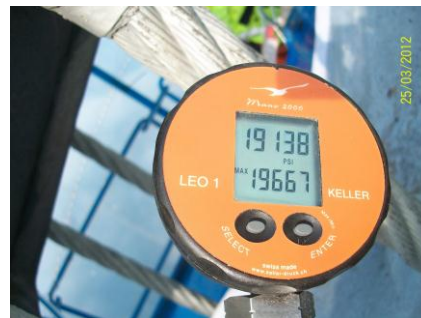
13.40 PM. Operations to remove defective bolt “D” began. PS 4 tensioner applied to dead side , required pressure in old bolt could not be achieved to release nut. Alternative method applied . The RSL torque wrench would be used . This required a reaction point for the foot of the tool to be able to apply enough torque for the nut to release. Defective nut would still not release.

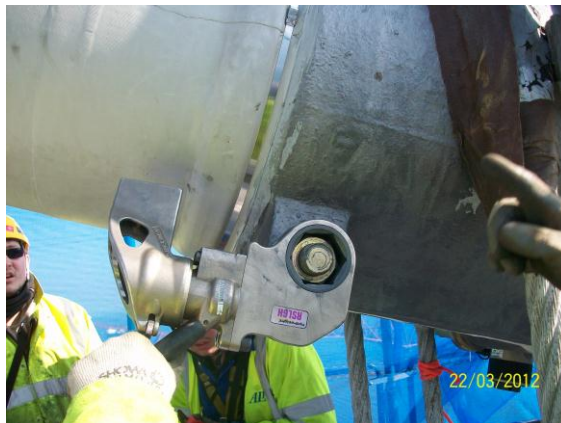
13.45 pm. RSL 6 offered up to defective nut to see what method could be used to achieve a suitable reaction point. (attention was taken to ensure that no damage would occur to the main cable wrapping when pressure was applied.)

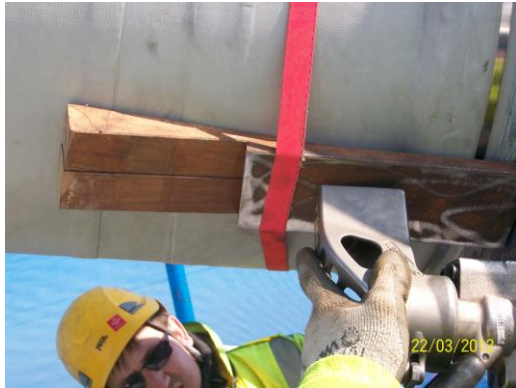
13.50 PM. Method adopted, two hardwood wedges applied to main cable for protection of wrapping . 20 mm steel plate attached and held in position by ratchet strap to give suitable reaction point for RSL 6. This method was un successful , nut would not release.

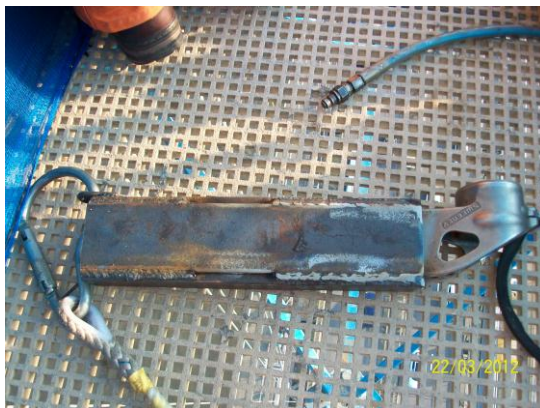
14.30 PM. Engineer returned with fabricated extension sleeve.

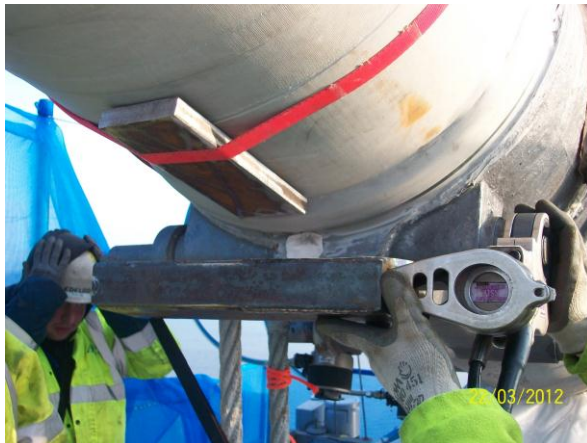
14.35 PM. Fabricated extension sleeve designed to be used horizontally with required purchase to be gained against the underside of the main cable. Reaction point to be gained from metal plate . No success using this method.

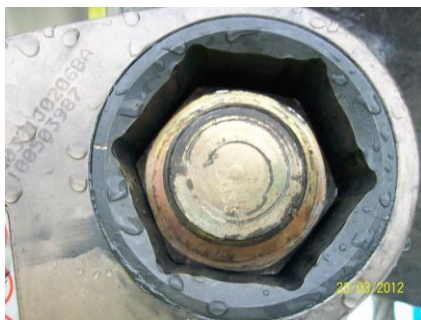
Prior to leaving platform photographs & dimensions were taken on the gaps between the nut size against the cassette contained in the RSL 6 as it was found that the required movement was too much before a reaction point was reached to allow the tool to bite. Discussions between Maintenance manager took place that evening to design and fabricate this insert which would be used to counteract excess movement .

Dimension – nut – 65mm.

Dimension – RSL 6 cassette. – 70mm.

Dimension – nut – 55mm.

Dimension – RSL 6 cassette. – 60mm.

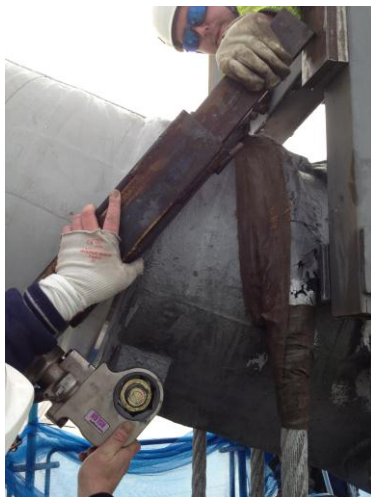
09.00 AM. Work began to try and release Bolt “D”. With the increase in pressure achieved in the hydraulic pump and the repositioning of the RSL. 6. extension sleeve attached vertically with the reaction point being against two steel packer plates attached and secured by means of a ratchet to the north face of the west hand-strand. This adopted method prove to be a success .The nut was released methodically , using turns of $\frac{1}{4}$ at a time which allowed the stroke of the hydraulic pump and RSL. 6 to carry out its function efficiently.

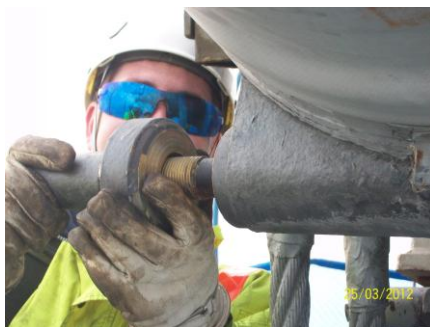
09.15 AM. Bolt “ D” released . Slight coating of moisture was observed on bolt sleeve.

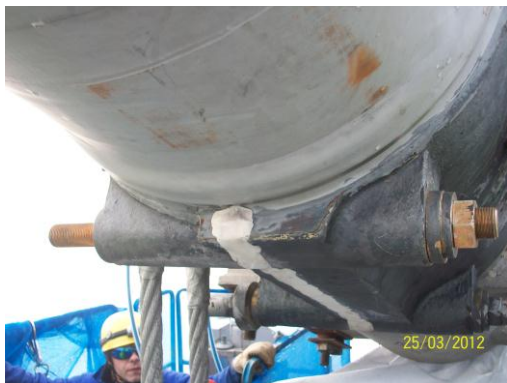
09.25 AM. Replacement bolt “D” inserted . No problems encountered. Care taken to ensure positioning of washers and cleanliness of mating face on cable band prior to re- tensioning of new bolt.

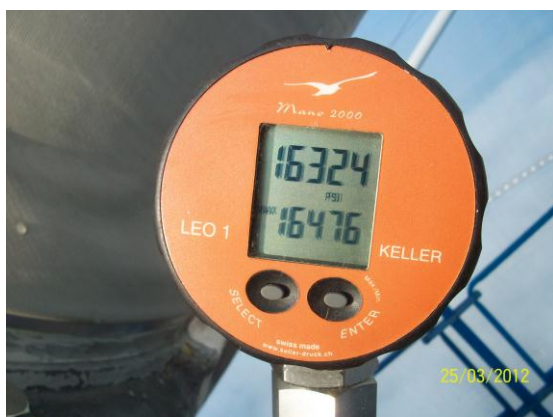
10.00 AM. Ps 4 applied to re-tension new bolt, pressure increments applied up to 16500 psi using air pump located on the footpath, this pressure was not enough to raise the tensioner to the acceptable required load as specified.

10.05 am. Reverted to hand pump to reached the specified pressure of between 700 kn @ 18 488 psi and 750 kn @ 19 578 psi.

Pressure taken to 19667 psi. this operation was completed three times to ensure that required load had been reached. All readings taken were over 19000 Psi.

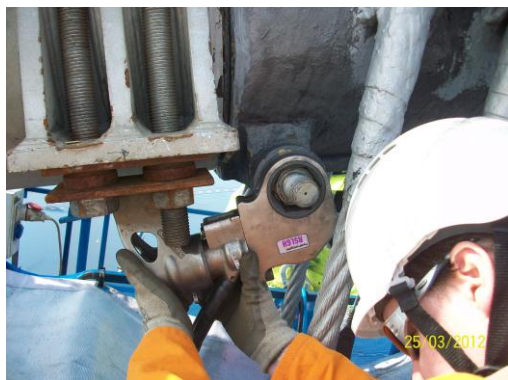
13.50. PM. Began to release Bolt "B" ¼ of a turn at a time.

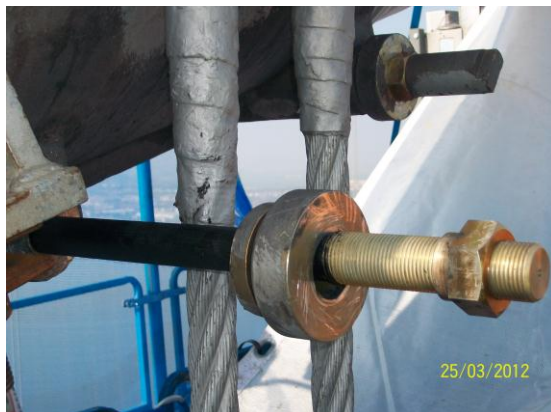
14.10 pm. New bolt entered.

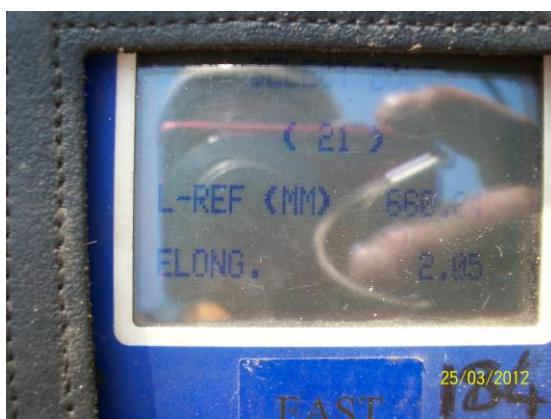
14.30. PM. Bolt torqued up using the RSL. 6. New bolt readings were taken and recorded on Bolt scan EMS., machine 184 group 1 under bolt No 21. New bolt " L "referenced AT 660.084.
