An exploratory exercise was undertaken during a nightshift road repair at panel point 00 N.W. on the side tower side.

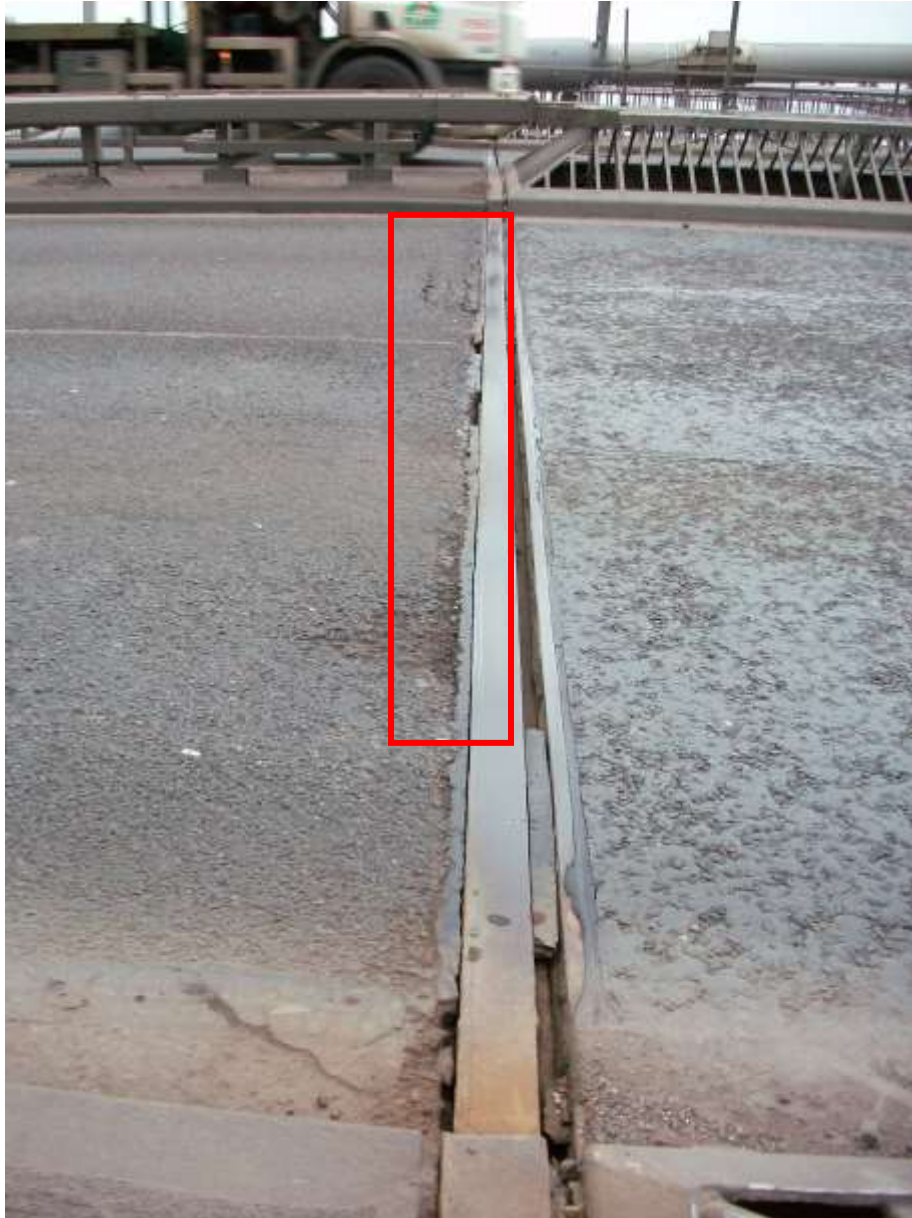
In carrying out these repairs, an investigation into discovering what the anchor detail is in situ. This double angle fabrication is suffering from a lot of movement, which indicates that the anchor detail has failed.

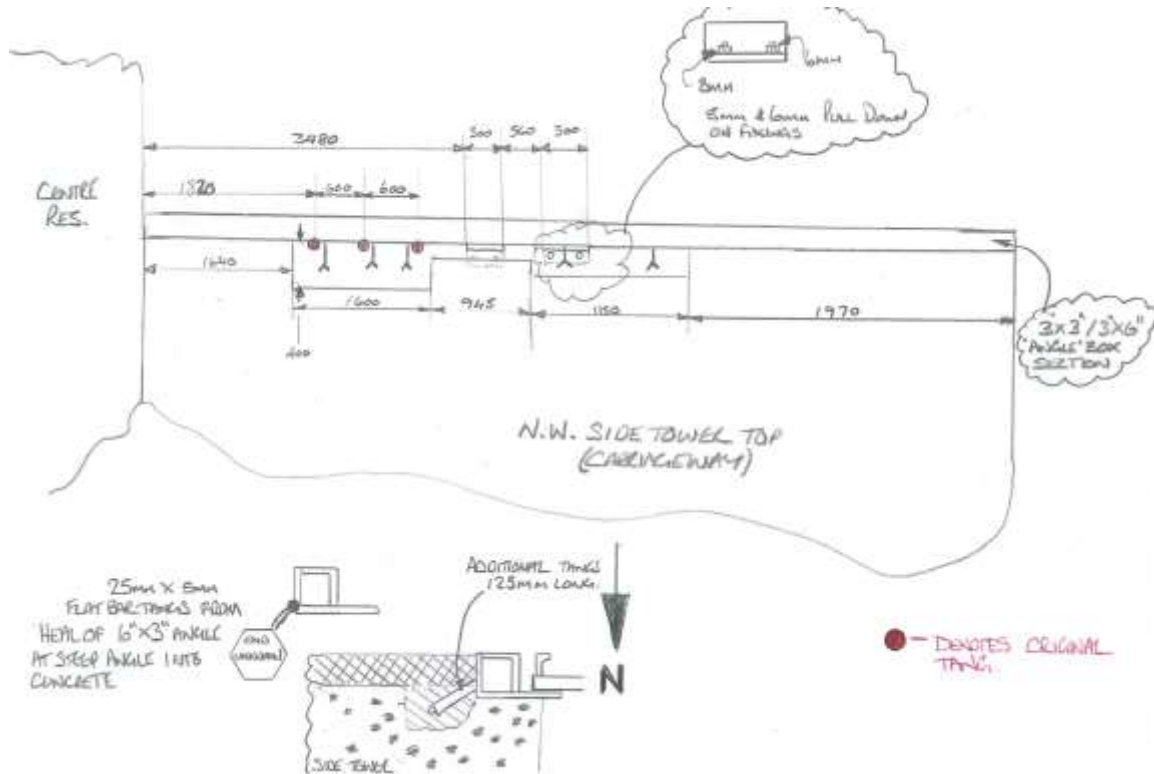
Main sketch on plan view

Three original tangs were exposed (marked with red dot) under the more serious surface depression. These tangs have a spacing of 600mm between them, suggesting there could be tangs at this spacing over the entire length, but this has not been confirmed.

During the surface removal two other sections of angle from a previous repair were discovered, one of which was fully exposed, revealing that the fixings were loose. As indicated the sketch there was 6mm – 8mm pull-down on these nuts.

Five additional tangs were added (see detail above), the three exposed original tangs were re-welded. It must be noted that the angle is suffering from corrosion/lamination which may result in future weld failure for all the tang welds old and new.

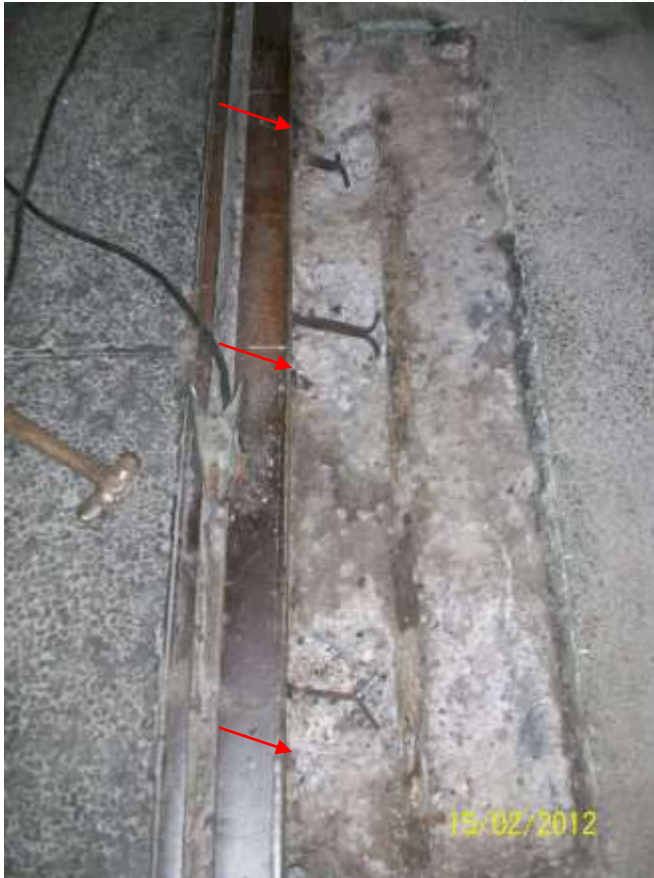
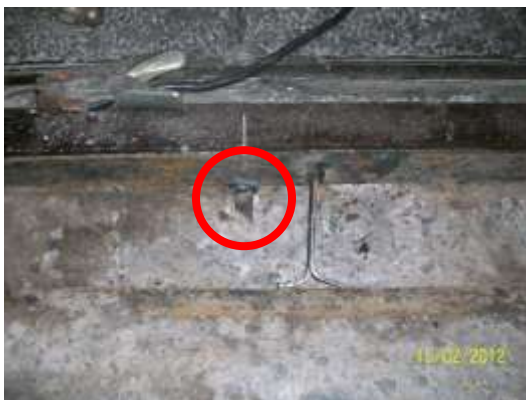
Existing Tangs, re-welded
