An urgent repair was undertaken on the southbound carriageway during a nightshift on the 17th of July, 2012; at Panel Point 00 N.E. at the side tower.

This temporary repair was carried out with the same detail as P.P. 00 N.W. on the 14th of February, 2012. In carrying out these repairs, it was found that the existing anchors had failed.

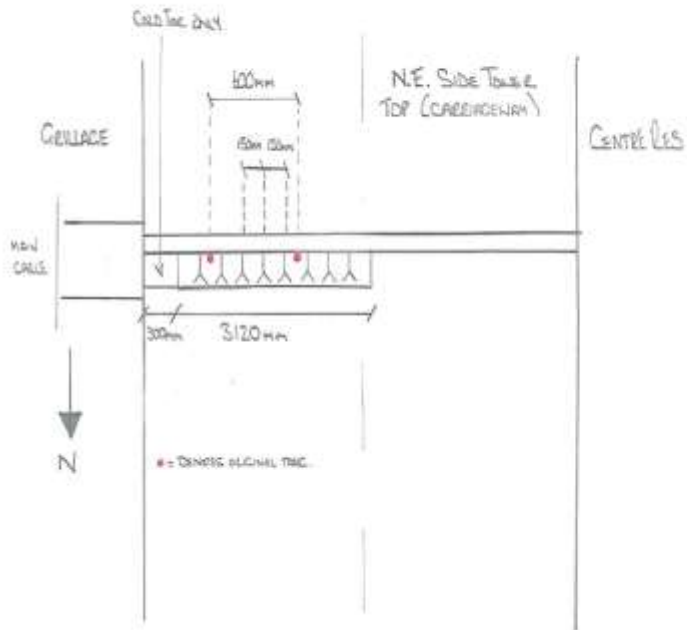
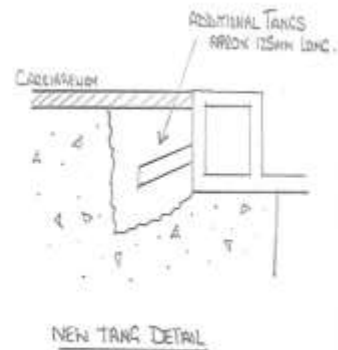
Main sketch on plan view

Two original tangs were exposed (marked with red dot). These tangs had split and an air gap of approximately 30mm was present. They are also showing signs of corrosion. These tangs have a spacing of 600mm between them, possibly confirming that there could be tangs at this spacing over the entire length, as with the N.W. Eight additional tangs were added (see detail above) with a spacing of approximately 150mm.

The new tangs were welded into position and the area was cleared of dust and debris. Rapid set concrete was mixed and poured in to a depth of approximately 25-35mm completely covering the new tangs. The concrete was allowed to cure for 1hr – 1.5hrs. The concrete was overlaid with a road surface filler and compacted before a hot applied sealant was used on the joints.

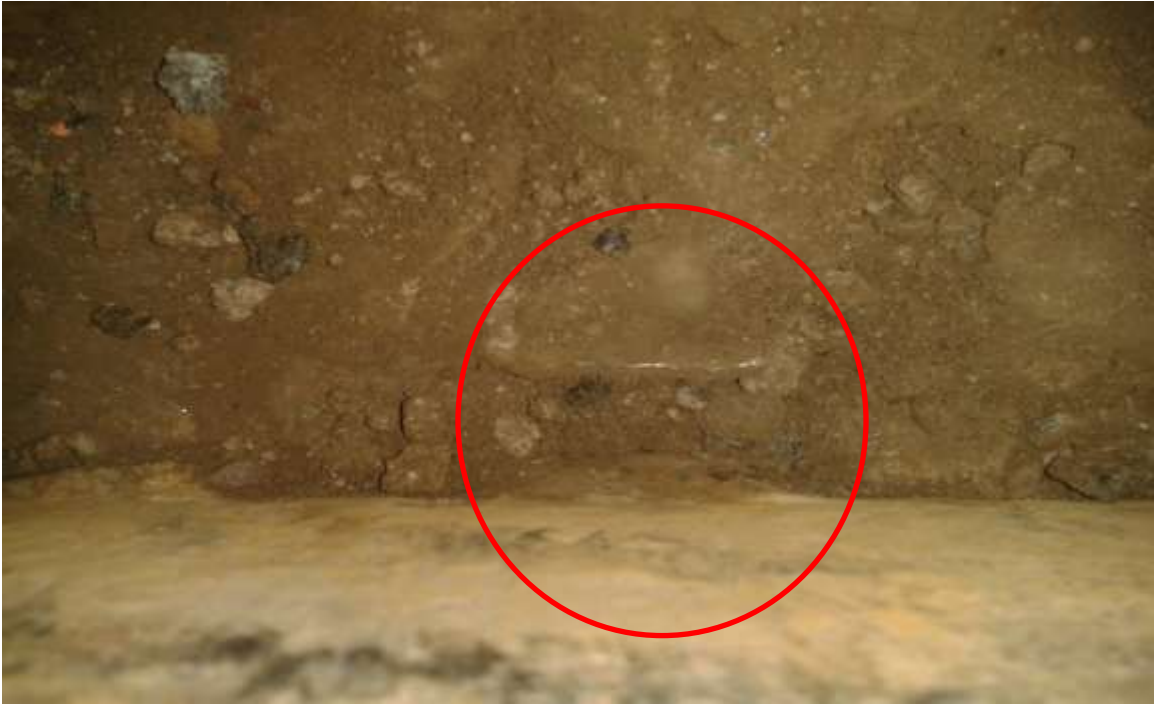
Original Tang.

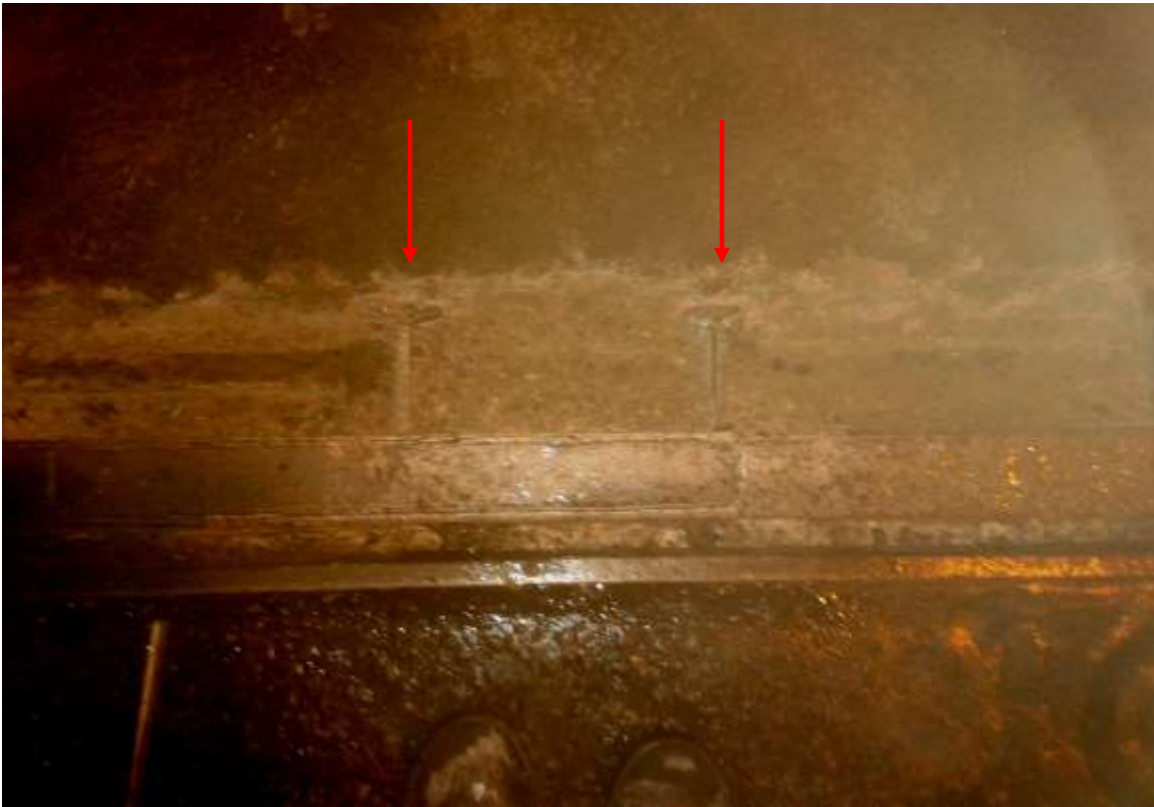
New Tangs welded into place.

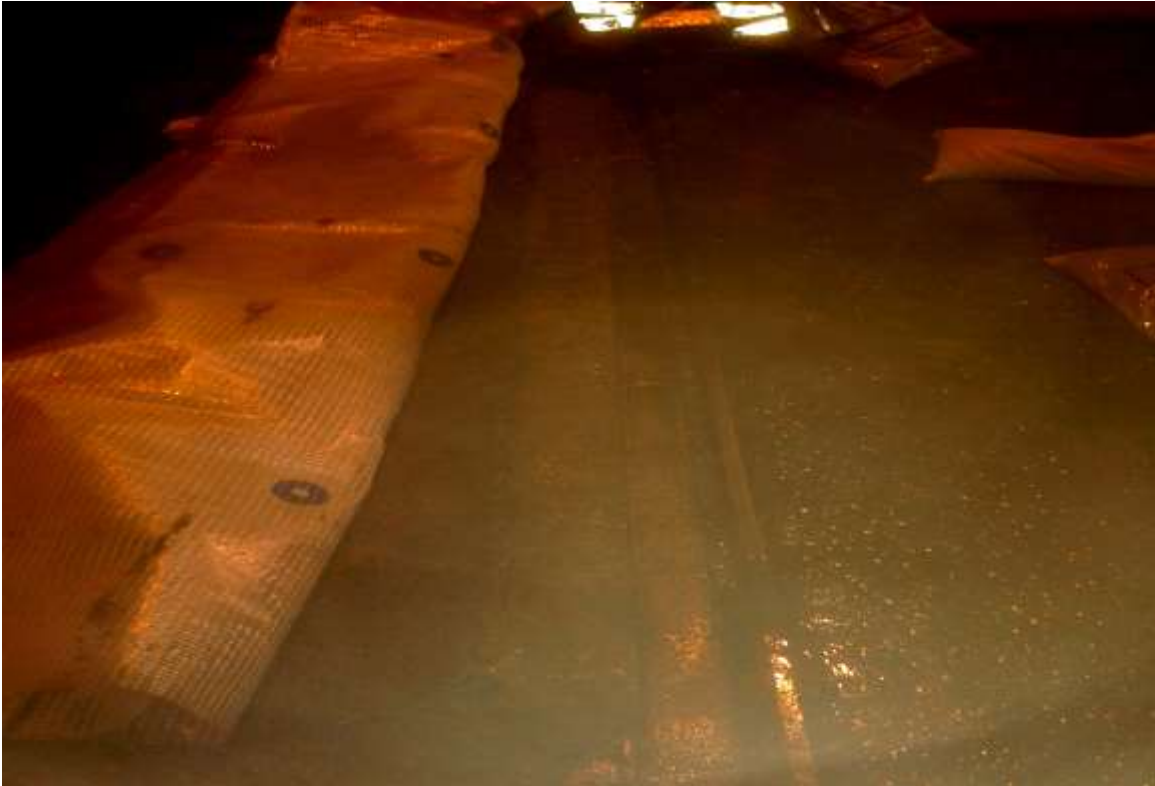
Concrete in situ.

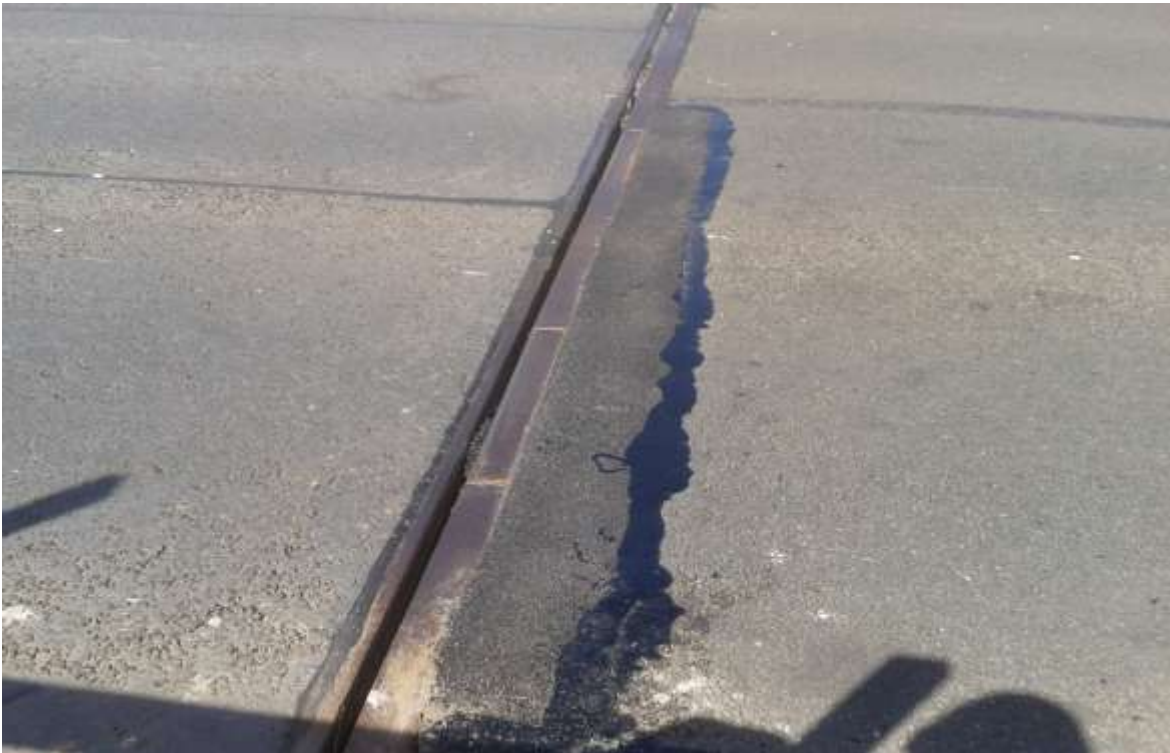
Finished Surface.
