P.P. 99 N.E.

**14/10/2009**

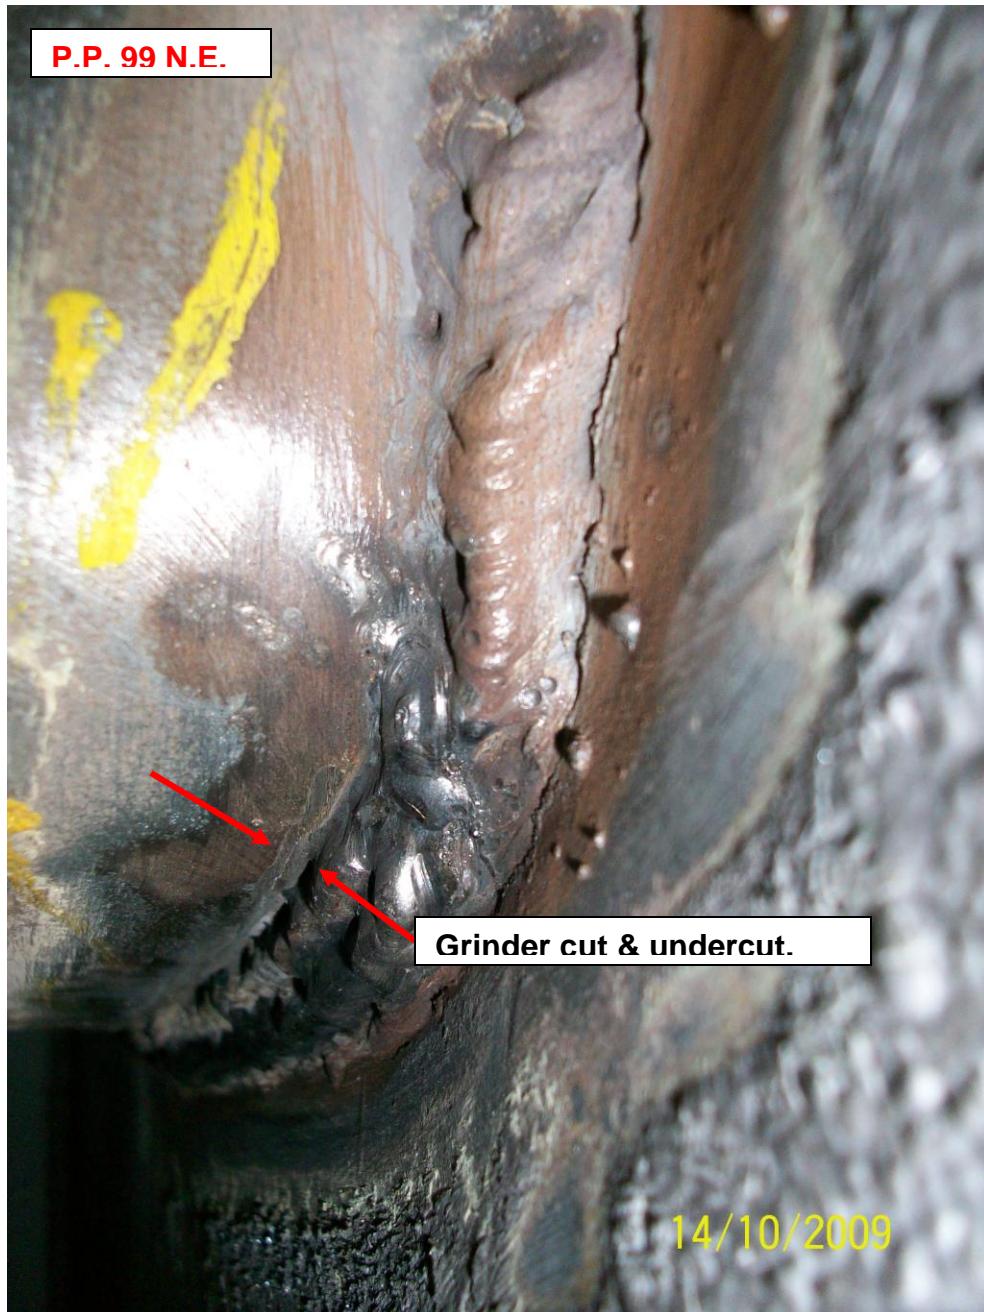
**Trough soffit ground out, not filled with weld. Some of the depth maybe due to undercut.**

**Depth = 2.5 – 3mm**
