INSPECTION DEPARTMENT
Post Inspection information of plates ME 3 & SE 3.
DATE. 12/10/11.

Following the successful removal and reinstatement of the South East main tower expansion joint plates ME 3 & SE 3 on a planned programme of works carried out on Saturday the 8th of October 2011, a visual inspection was carried out and photographs recorded specifically to indicate that the operation reinstatement had been carried out successfully and that both plates were functioning as per pre- removal. This inspection was carried out in conjunction with requested scheduled monthly inspections. Recorded individual photographs show the condition of all components of the secondary failsafe systems and their associated fixings.

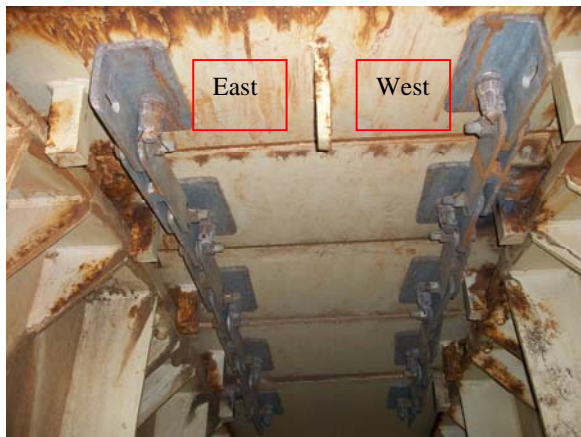
Expansion plate ME3.
Failsafe system as Inspection 11/10/11.

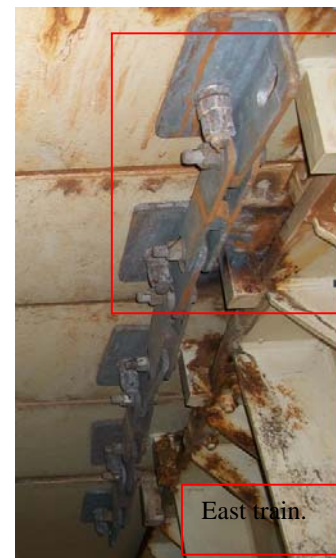
Fail-safe highlighted section
showing connection plate &
fixings. On East train.

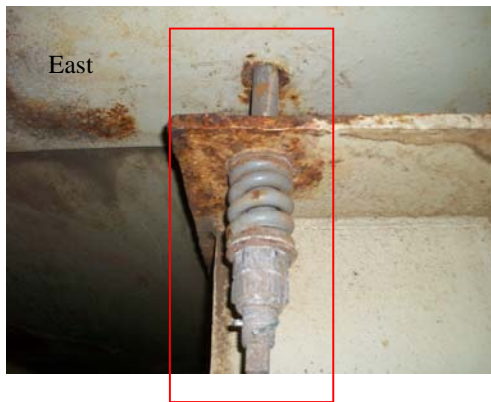
ME3 E East Tongue plate spring, remains under tension no movement evident – post inspection.

Current status as photographs show slight corrosion in areas on tongue pin, slight paint breakdown to protective paint coating, creating areas of slight corrosion on spring. Spring washers in position top & bottom. Primary & secondary locking nut in location and secure, spring clip intact and secure. Corrosion evident on associated steelwork.

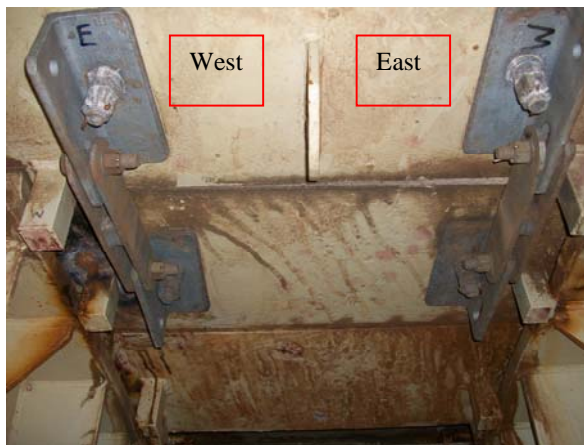
Expansion plate SE3.
Failsafe system as Inspection 11/10/11.

Information: As photographs show failsafe system plates and location markings are **contradictory to one another**, please ignore plate markings. Marked up incorrectly on installation.

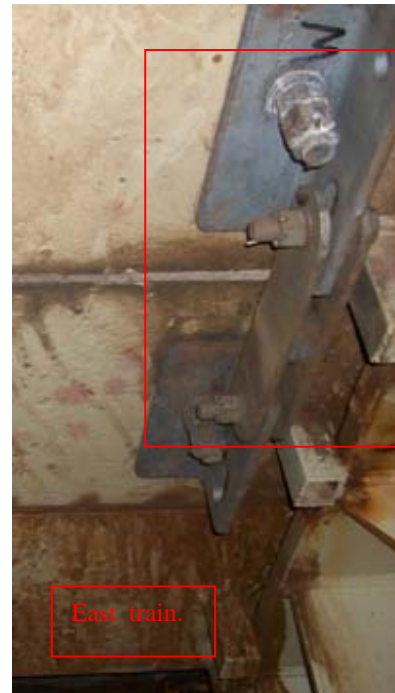
Fail-safe highlighted section
showing connection plate &
fixings. On East train.

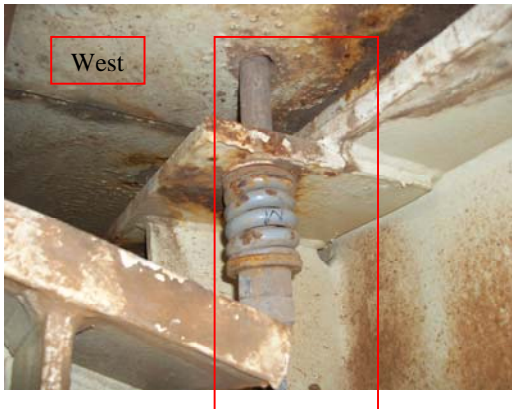
SE3 West Tongue plate spring, remains under tension no movement evident – post inspection.

Current status as photographs shows slight corrosion in areas on tongue pin, slight paint breakdown to protective paint coating, creating areas of slight corrosion on spring. Spring washers in position top & bottom, primary & secondary locking nut in location and secure, spring clip intact and secure. Corrosion evident on associated steelwork.
