INSPECTION DEPARTMENT
Post Inspection information of plates ME 3 & SE 3.
DATE. 12/10/11.

Following the successful removal and reinstatement of the South East main tower expansion joint plates ME 3 & SE 3 on a planned programme of works carried out on Saturday the 8th of October 2011, a visual inspection was carried out and photographs recorded specifically to indicate that the operation reinstatement had been carried out successfully and that both plates were functioning as per pre- removal. This inspection was carried out in conjunction with requested scheduled monthly inspections. Recorded individual photographs show the condition of all components of the secondary failsafe systems and their associated fixings.

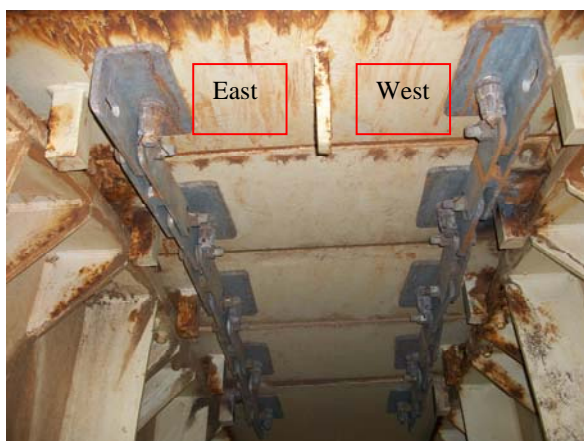
Expansion plate ME3.
Failsafe system as Inspection 11/10/11.

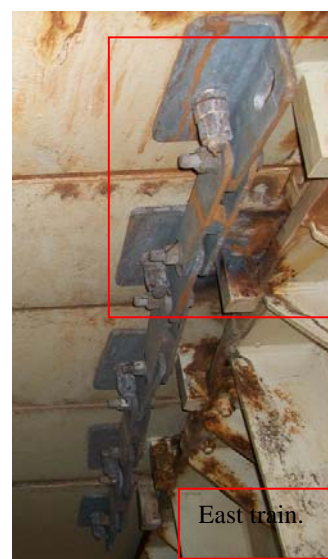
Fail-safe highlighted section
showing connection plate &
fixings. On East train.

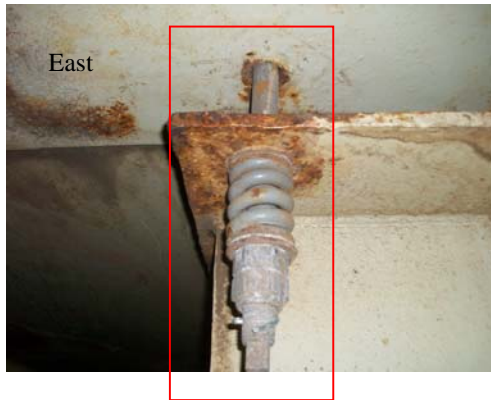
ME3 E East Tongue plate spring, remains under tension no movement evident – post inspection.

Current status as photographs show slight corrosion in areas on tongue pin, slight paint breakdown to protective paint coating, creating areas of slight corrosion on spring. Spring washers in position top & bottom. Primary & secondary locking nut in location and secure, spring clip intact and secure. Corrosion evident on associated steelwork.

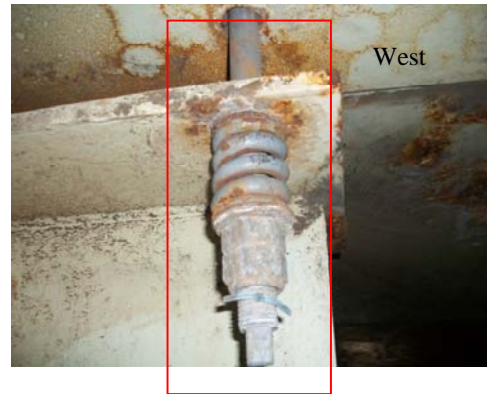
ME3 West Tongue plate spring, remains under tension no movement evident – post inspection.

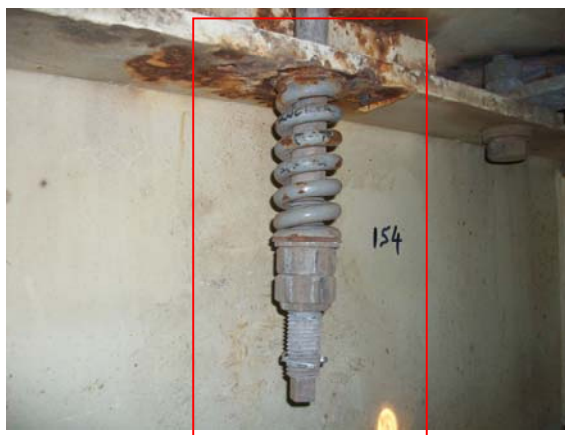
Rocker plate spring ME 3, remains under tension no movement evident – post inspection.

Current status as photographs show slight corrosion in areas on tongue pin, slight paint breakdown to protective paint coating creating areas of slight corrosion on spring. Spring washers in position top & bottom, primary & secondary locking nut in location and secure, spring clip intact and secure.

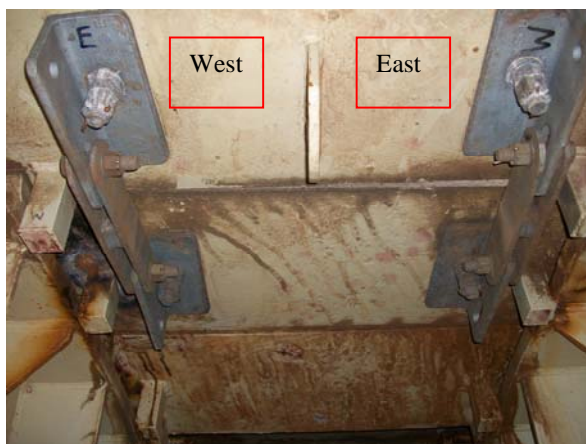
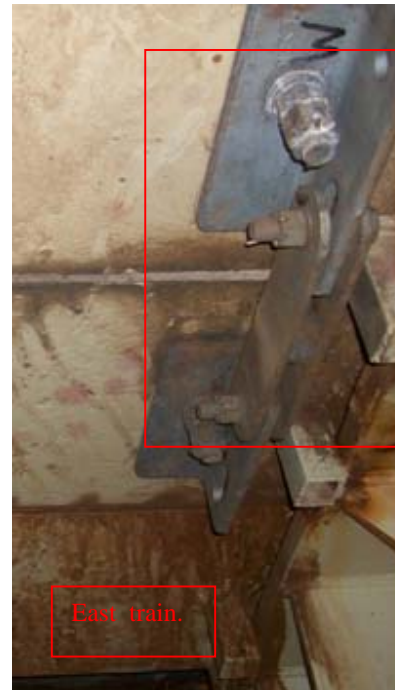
Expansion plate SE3.
Failsafe system as Inspection 11/10/11.

Fail-safe highlighted section
showing connection plate &
fixings. On East train.

Information: As photographs show failsafe system plates and location markings are **contradictory to one another**, please ignore plate markings. Marked up incorrectly on installation.

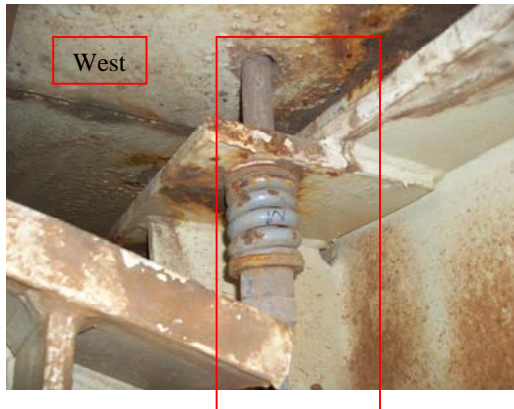
SE3 West Tongue plate spring, remains under tension no movement evident – post inspection.

Current status as photographs shows slight corrosion in areas on tongue pin, slight paint breakdown to protective paint coating, creating areas of slight corrosion on spring. Spring washers in position top & bottom, primary & secondary locking nut in location and secure, spring clip intact and secure. Corrosion evident on associated steelwork.

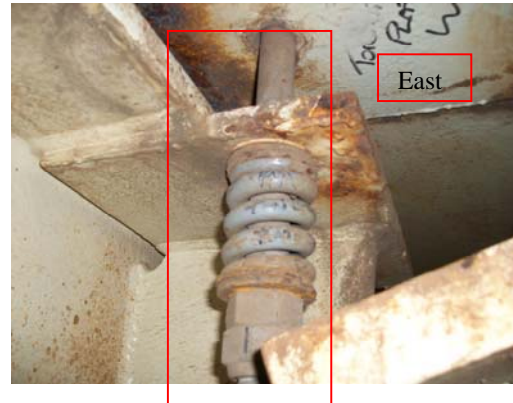
SE3 East Tongue plate spring, remains under tension no movement evident – post inspection.

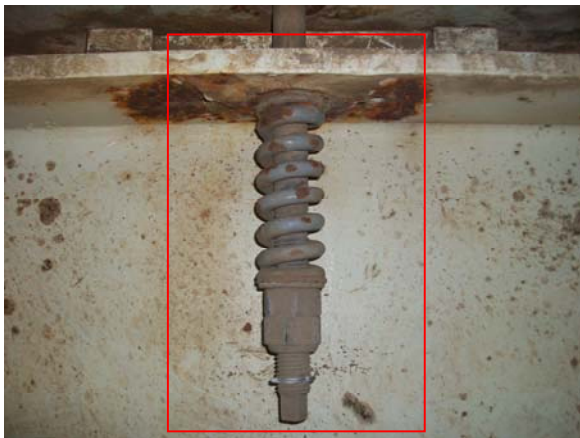
Rocker plate spring SE 3, remains under tension no movement evident – post inspection.

Current status as photographs show slight corrosion in areas on tongue pin, slight paint breakdown to protective paint coating creating areas of slight corrosion on spring. Spring washers in position top & bottom, primary & secondary locking nut in location and secure, spring clip intact and secure.
