**ATKINS LTD**  
**FORTH ROAD BRIDGE**  
**SURVEY OF COATING CONDITION**  
**ACCESS REPLACEMENT STEELWORK**  
**ON SECTIONS S1 TO S9**

The site survey was carried out on 20<sup>th</sup> July 2010 and it was required to assess the condition of the existing coatings, which had been subject to mechanical damage and areas had been heat affected where steel brackets had needed to be cut away for replacement fittings.

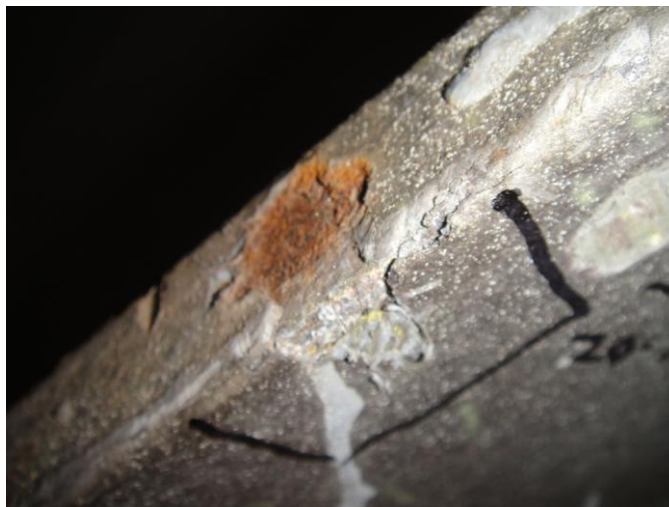
**Figure 1**

A typical example of a test and sampling area adjacent to an edge with mechanical damage can be seen in [Figure 1](#) and in close up on the underside in [Figure 2](#)

At this location it was noted that the access scaffold clips had been fixed with tightening bolts, direct to the coated steel and without any spreader plate to prevent damage. The scaffold clips were also positioned so that only one end of the clip was located on the edge of the steel and the remainder of the clip was separated progressively away from the contact point.

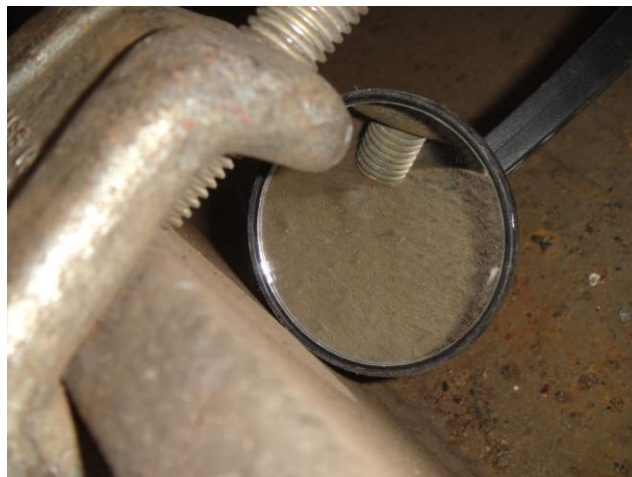
**Figure 3**

A typical view of a fixing bolt can be seen in **Figure 3**. a misaligned clip in **Figure 4** and confirmation of the depth of spacing using a steel ruler can be seen in **Figures 5**.

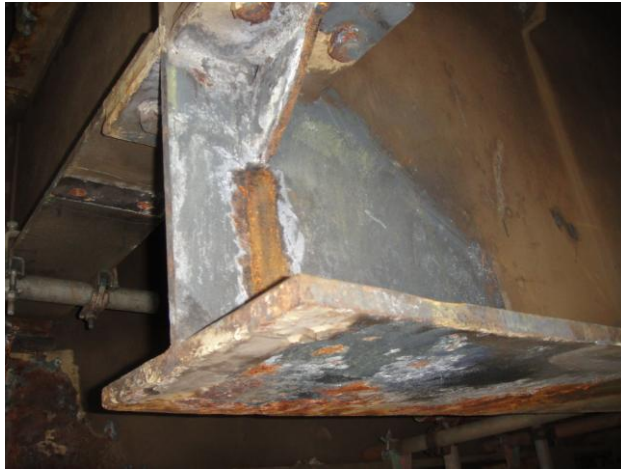
*Figure 6*

On section S2 there was a heat affected area, where a bracket had been removed by cutting, see [Figure 6](#), and testing of the surrounding heat affected paint showed that the spread of thermal degradation from the source of the heat appeared to average about 4 cms away from the burnt and cut steel.

This was more significant on the underside of the flange where clearly heat transfer had been greatest, but this was confused by the fact that the paintwork in this area had rusted back to bare steel and the coating had generally lost its protective properties.

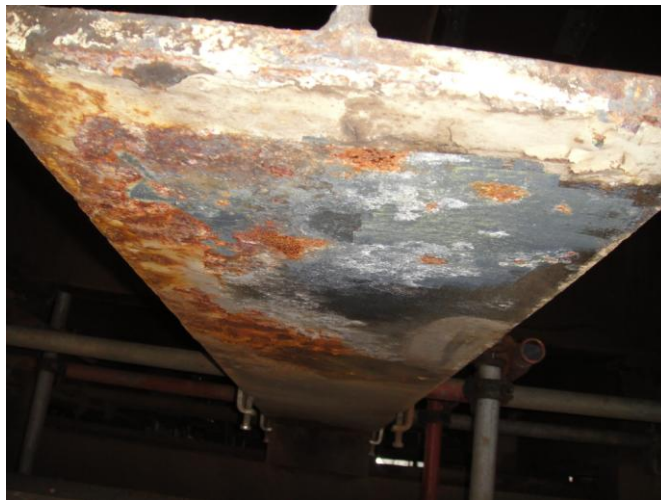
*Figure 7*

This coating would need to be removed 100% back to bare metal to prevent any further pitting of the steel, a close up of the underside of the flange in question, can be seen in [Figure 7](#).

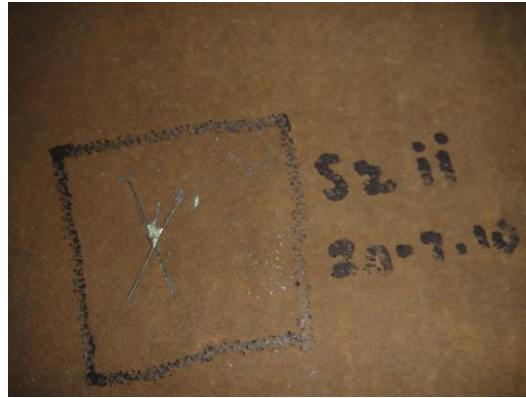
**Figure 8**

On the web of the beam at the same location, a series of adhesion tests and sampling were carried out progressively away from the flame cut edge and this confirmed that again the extent of spread on the web was approximately 5 cms.

One of the adhesion test areas and the sampling of the coating can be seen in [Figure 8](#) and it was clear that again all of this paint had thermally degraded to a point where it would all need to be removed before a sound bevelled edge could be achieved.

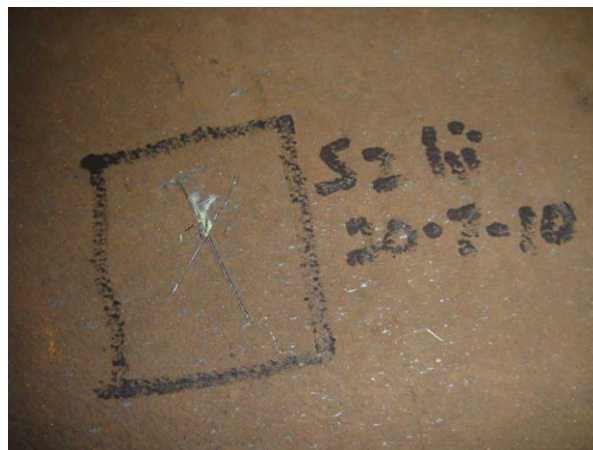
**Figure 9**

Even the most distant St Andrews cross cut test showed degradation of the intermediate layers over the zinc metal spray, illustrating the atmospheric degradation of the aged coating, see [Figure 9](#) and in close up [Figure 10](#).

On section S6 on the north side there was sound paint on the web of the beam, very similar to the coating on S2, see [Figure 9](#), but on the flange the coating was breaking down as well as the zinc metal spray at the edges and on the soffit, see [Figure 10](#) and [Figure 11](#). It can also be seen in close up in [Figure 12](#), where corrosion of the substrate was occurring beneath the degraded paint and metal spray layers.

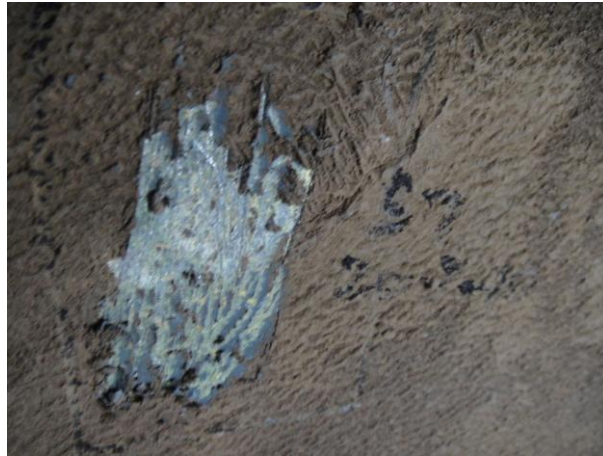
In section S7, the zinc breakdown and associated substrate rusting can be seen in **Figure 13** and this breakdown was repeated on sections S8 and S9, see **Figure 14**.
