North West Main Tower expansion joint . Removal and re-instatement of plate Main-span west No. 3.

On Sunday the 12<sup>th</sup> of October 2014, a programme of works operational procedure was carried out, the objective, to inspect and report the current status of the North main tower expansion joint plate MW 3. and to carry out any requested repairs or remedial works if required before being reinstated back into position.

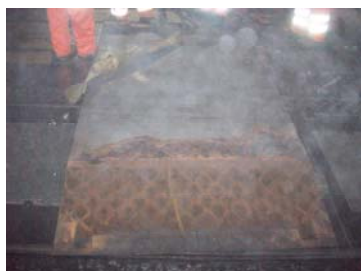
Tongue plate on MW3. lifted and laid down as specified as per Drawings. **Note. :** During lifting it was found that plate movement combined with the build up of corrosion scale, detritus on the edges of the plate created resistance. This was located in the north west corner of the plate. This was overcome by applying impact by means of a heavy hammer. This combined with the continual lifting force being applied by the crane was enough to free up and release the plate to allow removal .

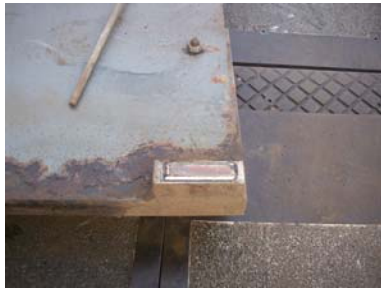
On completion of their inspection, it was agreed that plate MW3 could be reinstated. Whilst carrying out pre removal dimensional survey the mismatch recorded between the tongue plate and bitumen plate would require 5mm packer plates to be welded to the existing bearing pads. This was completed . Prior to the reinstatement of the tongue plate, all faces of the plate were cleaned by engineer using a grinder to remove all corrosive material to ensure no problems occurred with the refitting.

Packer plates welded to existing tongue plate bearing pads.

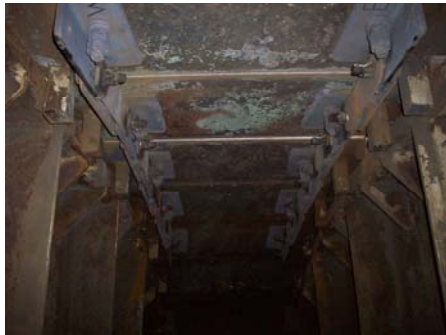
Following completion rocker, shuttle & tongue plates were reinstated without any problems. Emergency failsafe system connection plates and associated fixings attached to underside of sliding plate.
