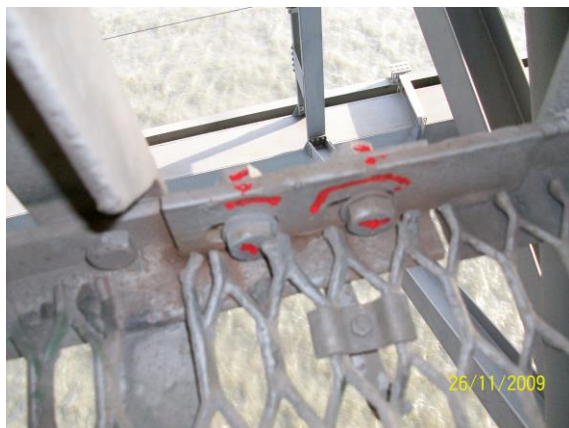
P.P. 94 S.E.

WALKWAY SPLICE BOLTS.
2 BOLTS LOOSE EAST SIDE OF
WALKWAY.

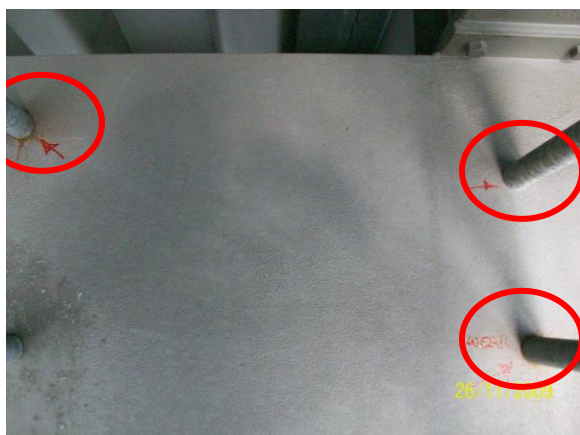
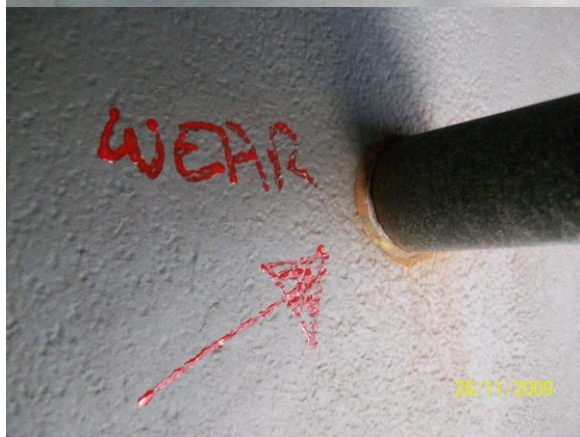
P.P. 84 S.E.

REDUNDANT TUBE AND
FITTING: REQUIRES REMOVAL.
NOW CAUSING WEAR AT THE
THREE POINTS INDICATED.

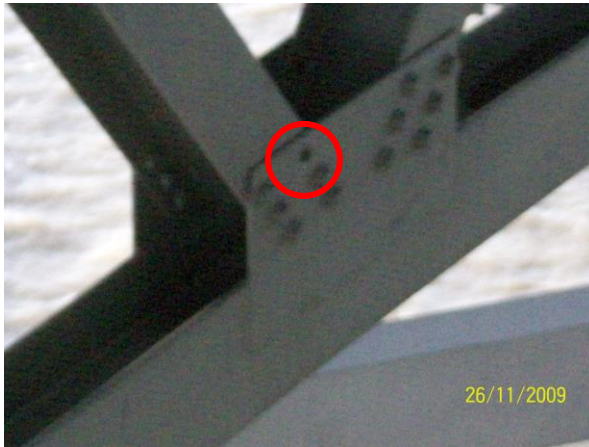
P.P. 79 S.E.

BOLT SHEARED ON BEAM 4,
NORTH FACE BOTTOM CLUSTER.

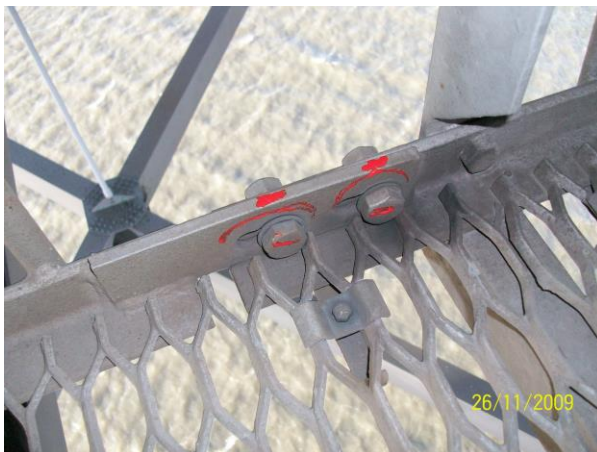
P.P. 74 S.E.

WALKWAY SPLICE BOLTS.
2 BOLTS LOOSE WEST SIDE OF
WALKWAY.

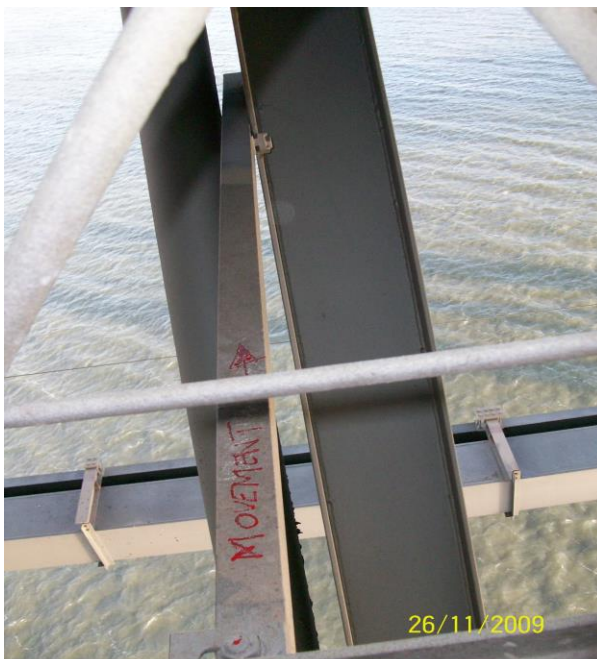
P.P. 64 S.E.

UNDER ANGLE WALKWAY
SUPPORT HAS LOOSE
LINDAPTOR ON EAST SIDE
CAUSING MOVEMENT.

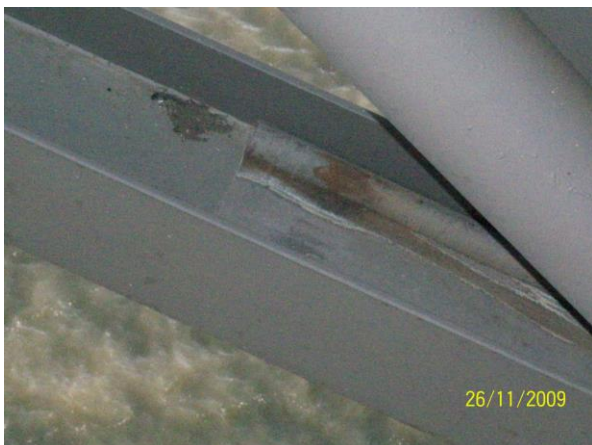
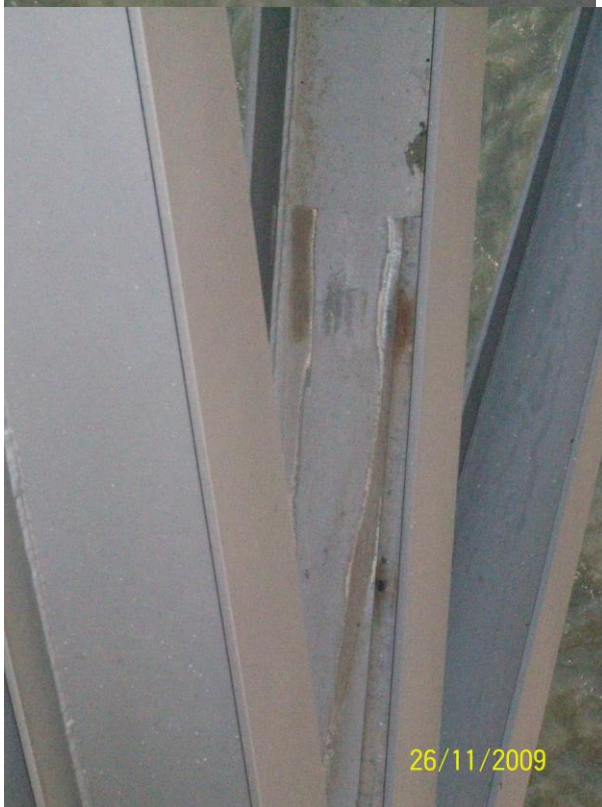
P.P. 60 S.E.

BEAM 7 HAS A SCAFFOLD TUBE
APPROXIMATELY 1 METRE IN
LENGTH.

THIS IS CAUSING WEAR TO WEB.

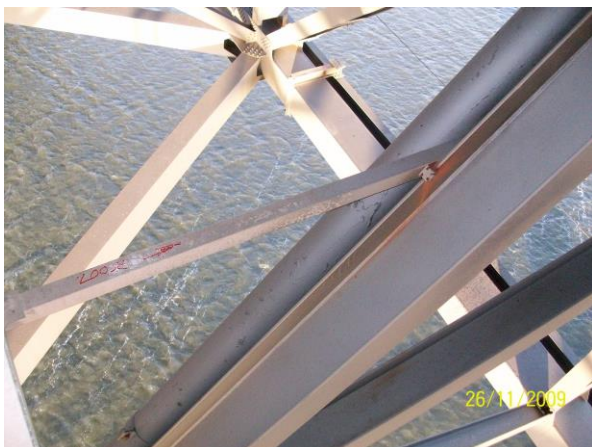
P.P. 54 S.E.

UNDER ANGLE WALKWAY
SUPPORT HAS LOOSE
LINDAPTORS ON EAST & WEST
SIDES CAUSING MOVEMENT

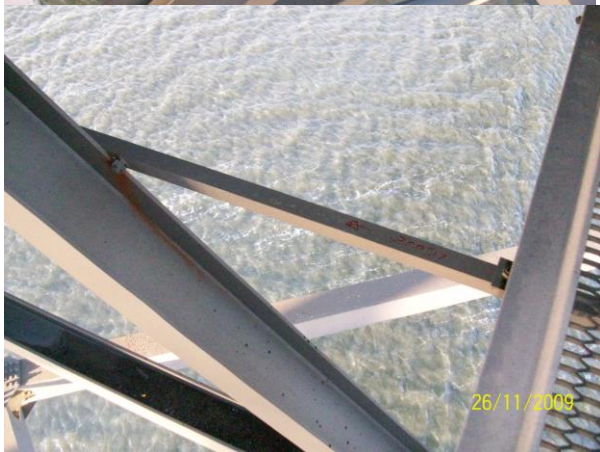
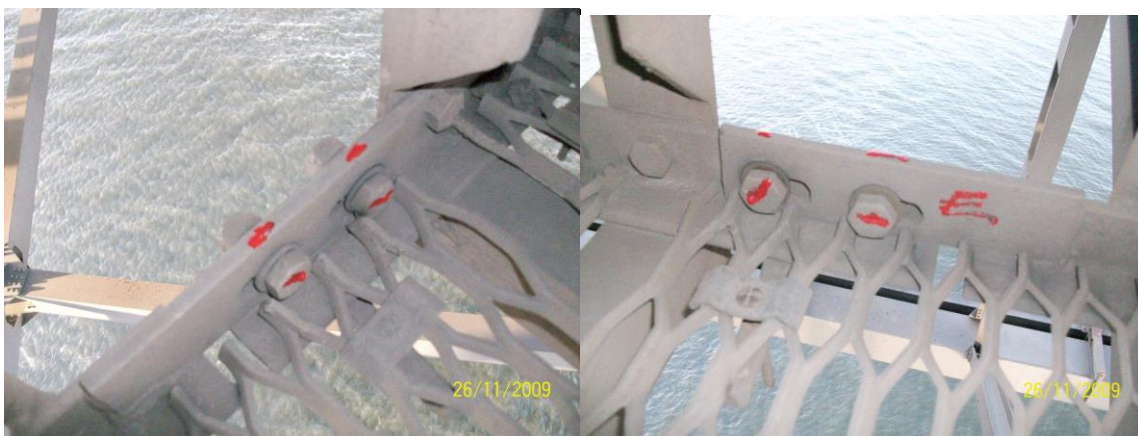
P.P. 52 S.E.

WALKWAY SPLICE BOLTS LOOSE – 2 EAST & 2 WEST.
