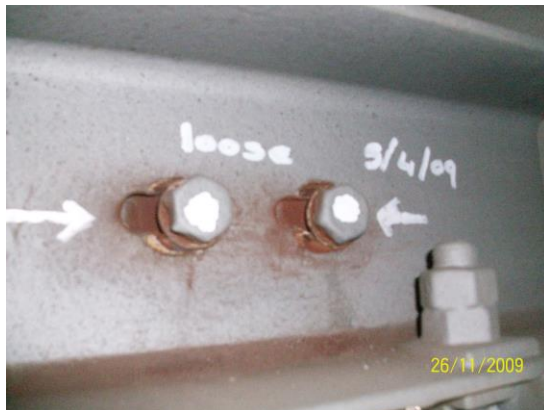
P.P. 97S.E.

WALKWAY SUPPORT, 2 BOLTS
LOOSE. PREVIOUSLY RECORDED
04/09, STILL OUTSTANDING.

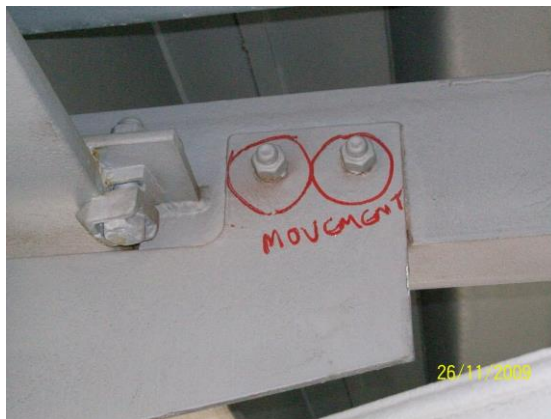
P.P. 97S.E.

2ND SUPPORT SOUTH OF PANEL
POINT. SIGNS OF MOVEMENT
VISIBLE, INDICATING BOLTS ARE
BECOMING LOOSE.

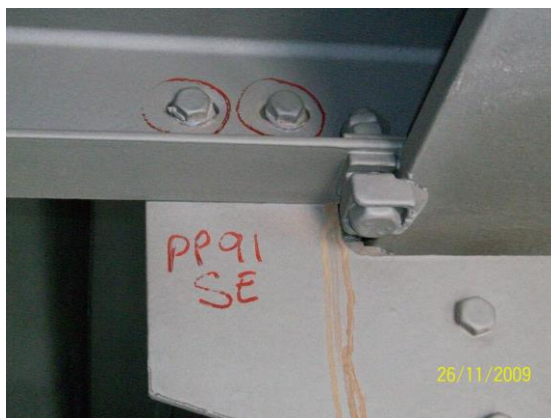
P.P. 91S.E.

SUPPORT SOUTH OF PANEL POINT.
SIGNS OF MOVEMENT VISIBLE,
INDICATING BOLTS ARE BECOMING
LOOSE.

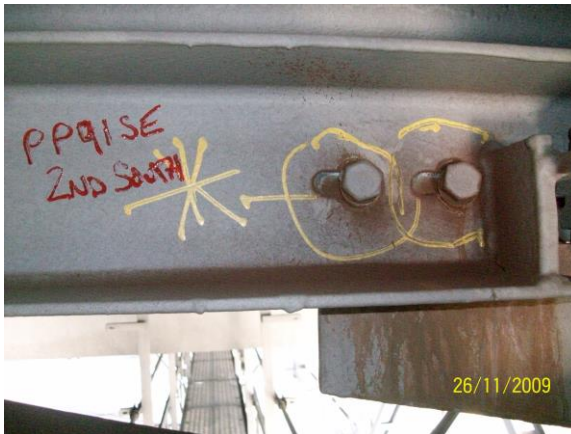
P.P. 91S.E.

2nd SUPPORT SOUTH OF PANEL
POINT. SIGNS OF MOVEMENT
VISIBLE, INDICATING BOLTS ARE
BECOMING LOOSE.

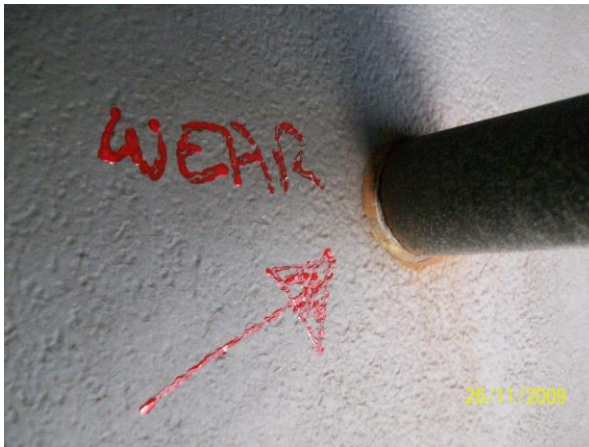
P.P. 84S.E.

WEAR VISIBLE FROM POSSIBLY 3
OUT 4 TUBES RUBBING ON
X-GIRDER.

**TUBE & FITTING WILL REQUIRE
REMOVING TO ENABLE ANY
REPAIR.**

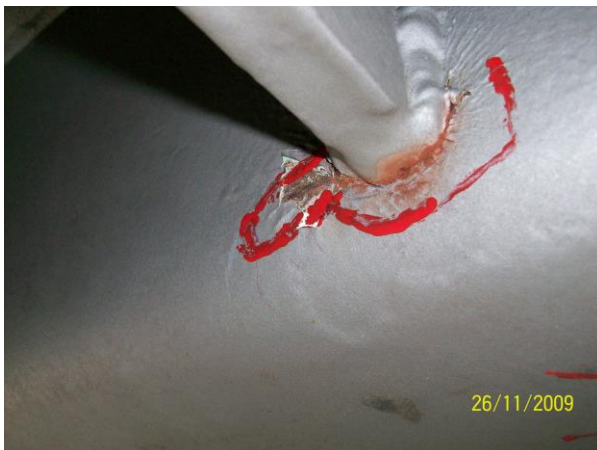
P.P. 80S.E.

STIFFENER BETWEEN STRINGER
No.1 AND TROUGH No.1 HAS
CRACKED AROUND NOSE AND IS
LEADING INTO TROUGH APPROX.
25mm.

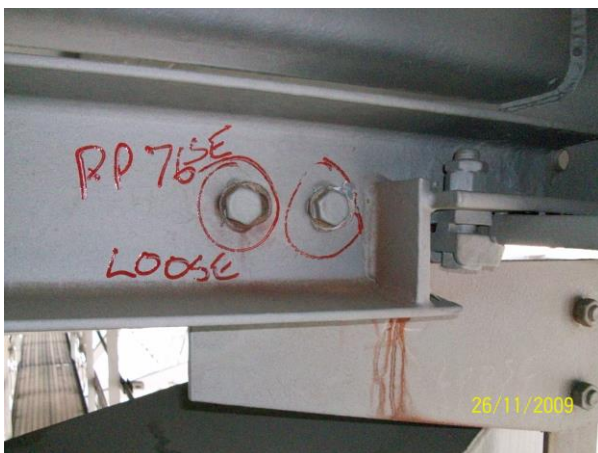
P.P. 76 S.E.

2nd SUPPORT SOUTH OF PANEL
POINT, HAS 2 LOOSE BOLTS.

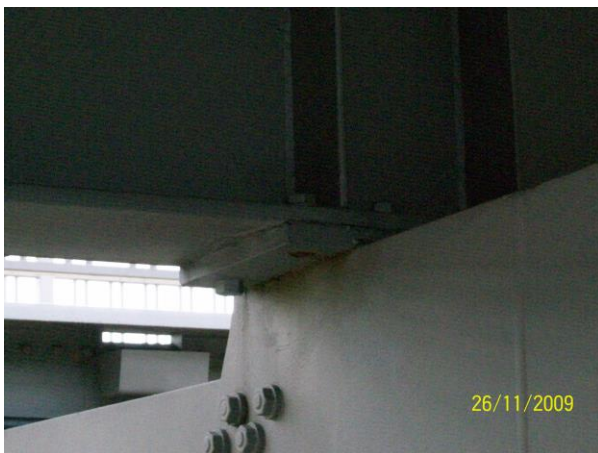
P.P. 83 S.E.

STRINGER No. 1 BEARING PLATE HAS
SHEARED BOLT (NORTH INNER).
REQUIRES REPLACING.

ACCESS REQUIRED.

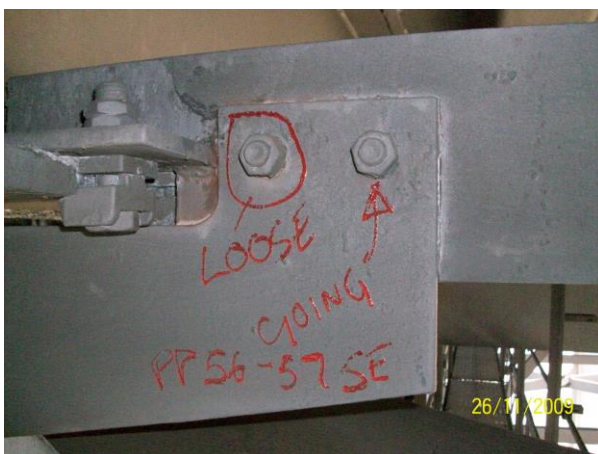
P.P. 56-57 S.E.

WALKWAY SUPPORT, ONE BOLT
LOOSE SECOND BOLT SHOWS
SIGNS OF MOVEMENT.

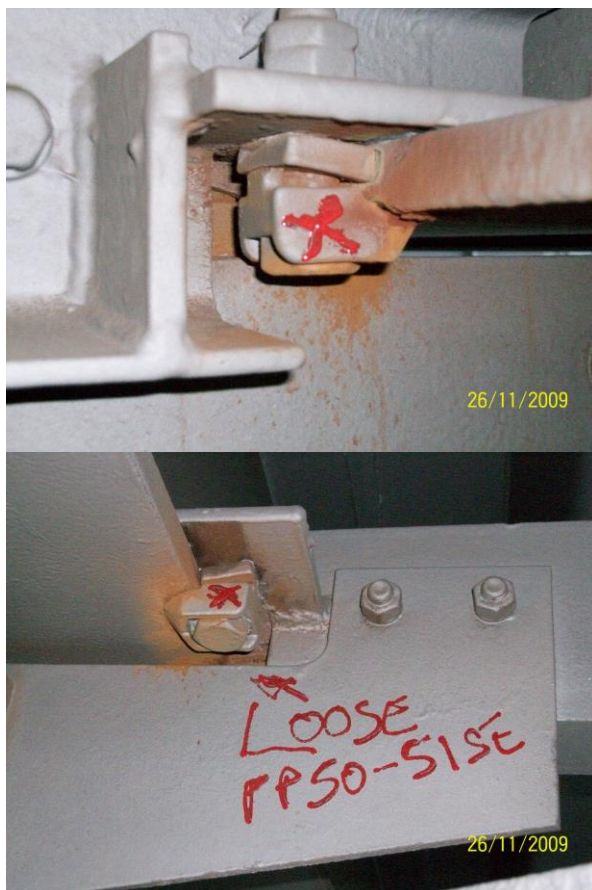
P.P. 50-51 S.E.

WALKWAY SUPPORT, LINDAPTORS
NORTH AND SOUTH SIDES OF
SUPPORT LOOSE.
