Photographs taken of defective service duct supports/stiffeners.  
Between PP68.5 & PP 71.5 ( east )

INSPECTION DEPARTMENT
Mainspan upper front Pl. ( East side ) inner balustrade service ducts
DATE. 13/06/10

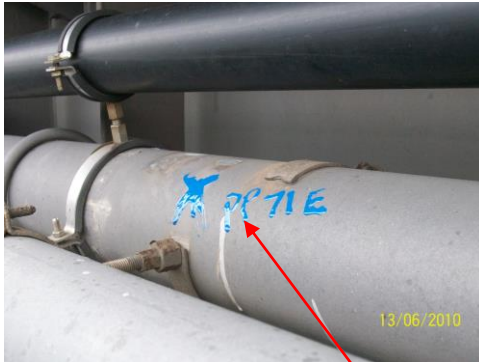
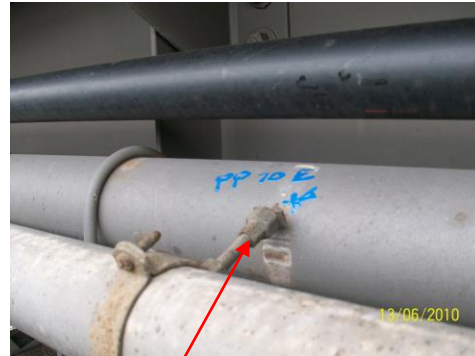
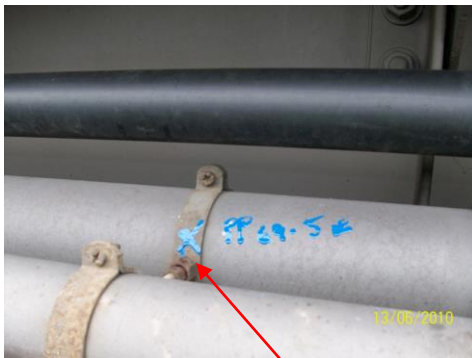
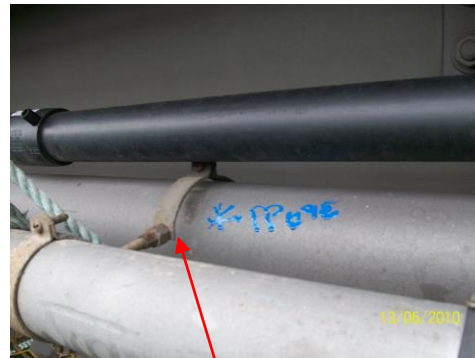
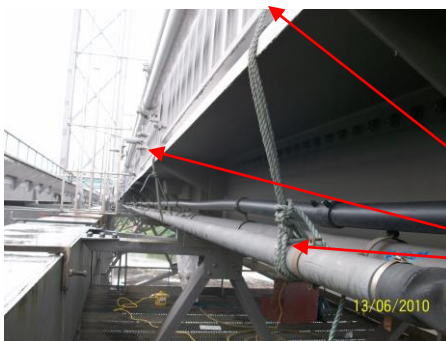
Section of service ducting being supported at 2 locations with rope over a distance of approx 6 mtrs. All holding / support brackets either missing or broken. Between PP69 & 71 east

There are approximately 8- 10 brackets that require to be replaced throughout this section.
