INSPECTION DEPARTMENT
SOUTH EAST BOX GIRDER.
DATE. 03/10/12.

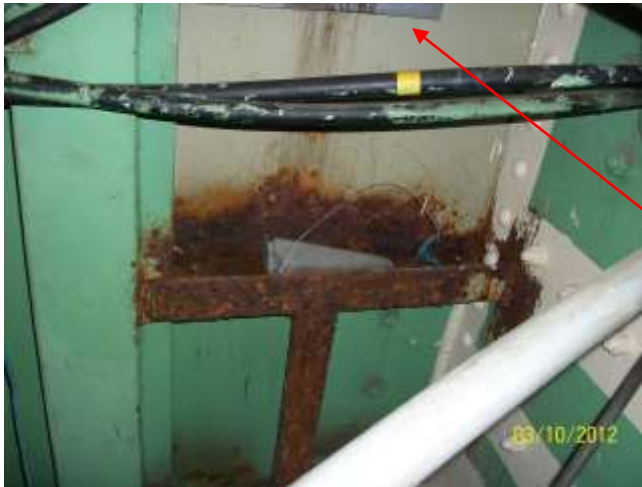
Egress for cables . water coming through cored holes in north east face. (first reported 2004. requires to be sealed and corrosion cleaned up.

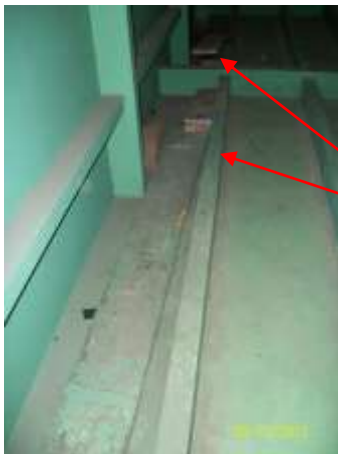
Located on the floor of section box 26 x on the east side of the box girder between outrigger beams 104/105 baton offcuts.

Following completion of electrical programme of works box girders will be cleaned and all surplus materials and debris removed by general operatives.

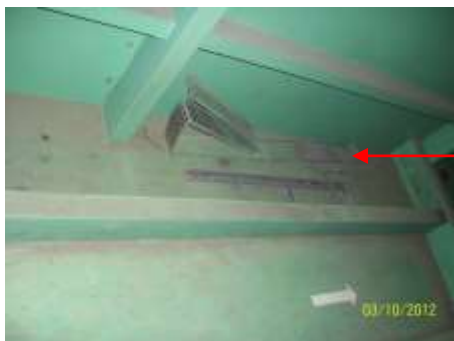
Located on the floor of section box 27 x on the east side of the box girder between outrigger beams 110/111 cable tray / unistrut.

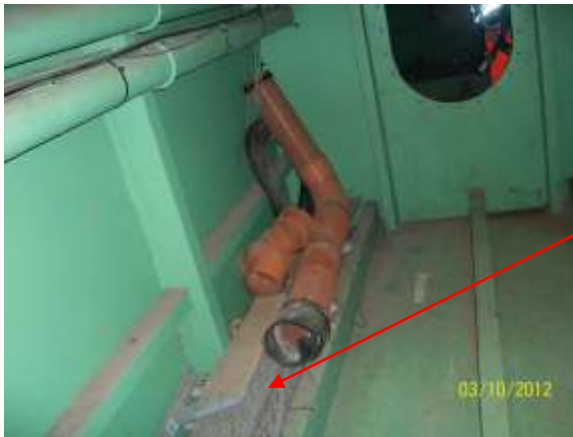
Located on the floor of section box 31x on the east side of the box girder between outrigger beams 110/111 cable tray / unistrut etc. (downpipe sections will be removed by balfour beatty)

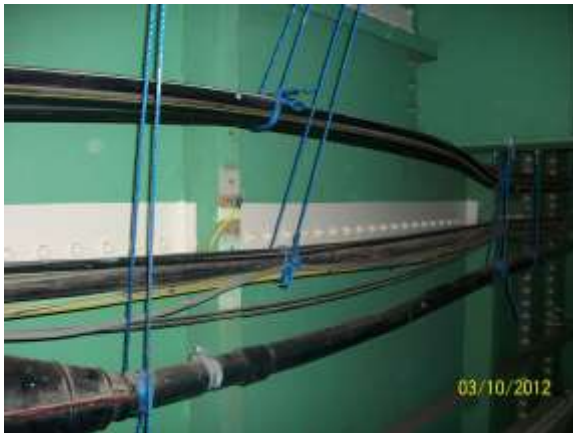
Located in section box 31x between outrigger beams 125/126 ducts/ cables supported by ropes.

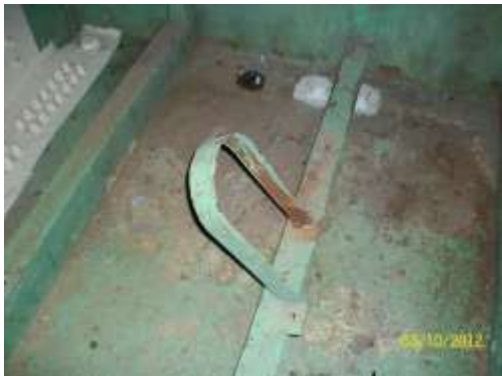
Located on the floor in section box 31x between outrigger beams 126/127 there is the original holding bracket for drain. (this will be removed by Balfour Beatty)

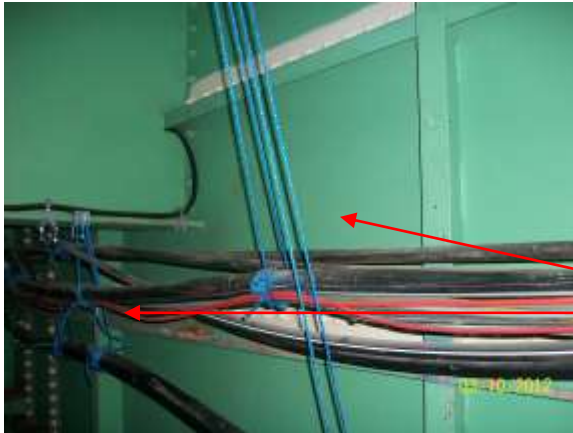
Located in section box 32x between outrigger beams 128/130 ducts/ cables supported by ropes.

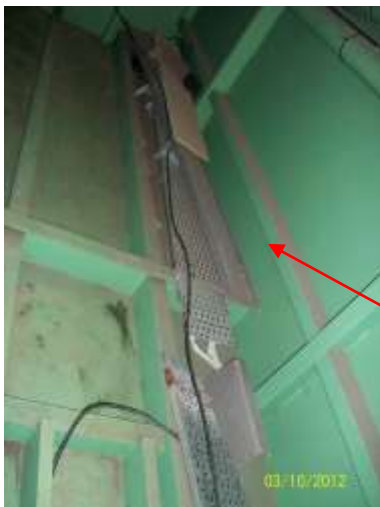
Located in section box 32x between outrigger beams 130 /132 cable tray / wires lying on floor.

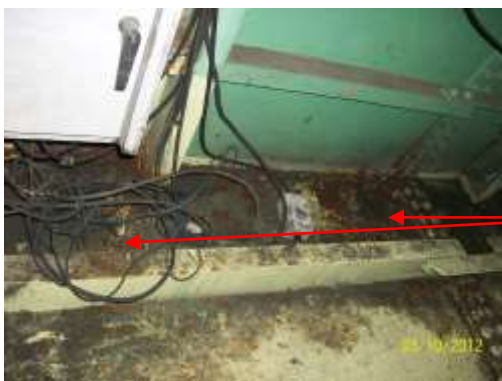
Floor section on the east side of section box 42x between outrigger beams 172/173 requires to be cleaned , also cables require to be tidied up.

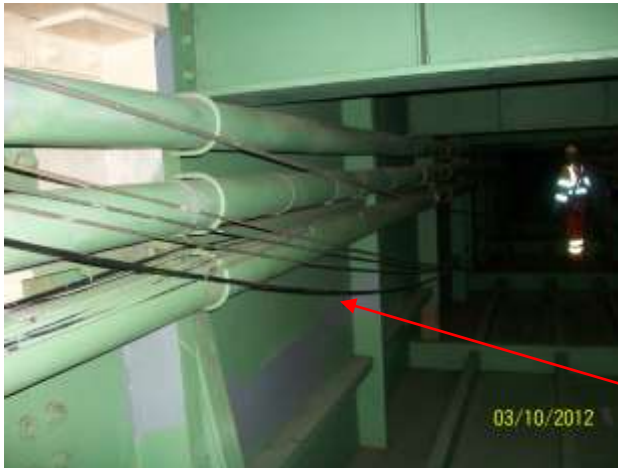
Cables located on the east face of box girder from section box 44x through box girder to section box 52x. require to be secured. Cables hanging down.

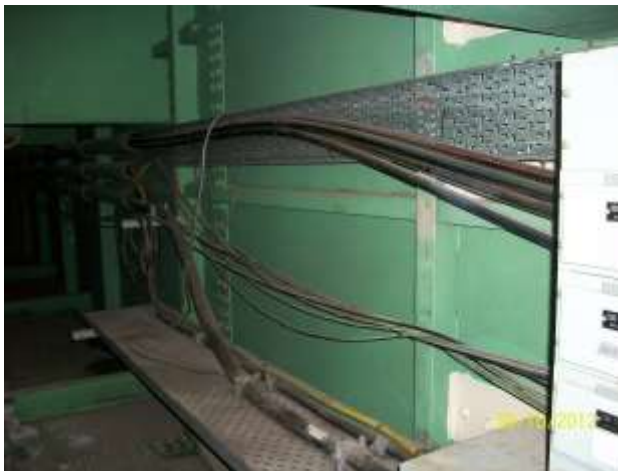
Cables located on the east face at section box 53 x between outriggers 219/222 require to be supported tidied up.

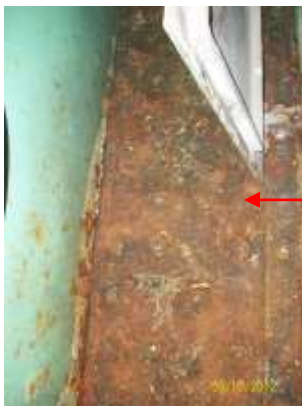
Floor section located in box 53x between outriggers 221/222 requires to be cleaned up staining /corrosion evident.
