South East Main Tower expansion joint . Removal and re-instatement of plates Main-span east 3. & Side-span east 3.

On Saturday of 8<sup>th</sup> October 2011, a programme of works operational procedure was carried out, the objective to carry out an inspection of the current condition of the South main tower expansion joint plates ME3. & SE3. and to carry out any associated repairs and remedial works if required before plates were reinstated back into position.

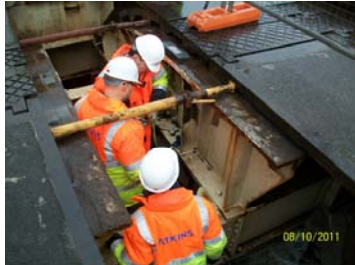
**It should be recorded that during this period consultants from Atkins accompanied by bridge managers were in attendance to observe and photograph current status of plates.**

On completion of their visit , it was agreed that plates on ME 3. could be reinstated following the addition 10 mm packer plates under the Tongue plate to remove the mis-match between tongue plate end and bitumen plate
