INSPECTION DEPARTMENT
South side tower (top) inspection of all elements accessible.
DATE. 05/04/11.

As requested a visual / principal was conducted of all accessible elements on the South side tower top both East and West , following are photographic and written information with regards to current status related to

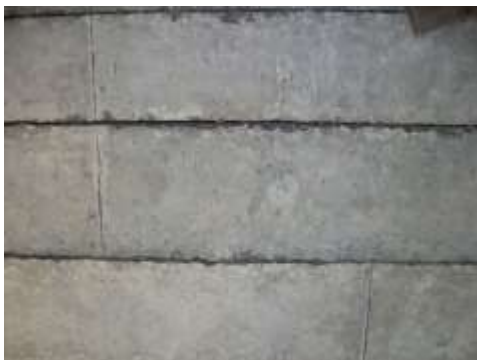
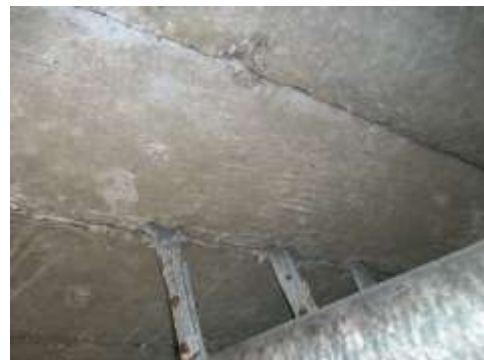
Concrete. : One of the primary functions was to carry out a close up inspection of the cycle track support concrete beams. This area has never been as accessible before now,

All Cycle track support beam slabs remain in very good condition both East & West. There are no signs of any longitudinal or transverse cracking or concrete spalling on any of the soffits of the beams. No evidence of any reinforcement movement, beam deflection or beam distortion at time of inspection.

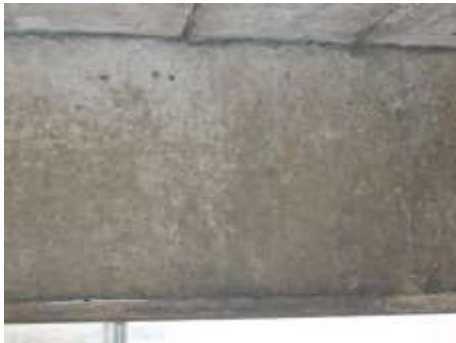
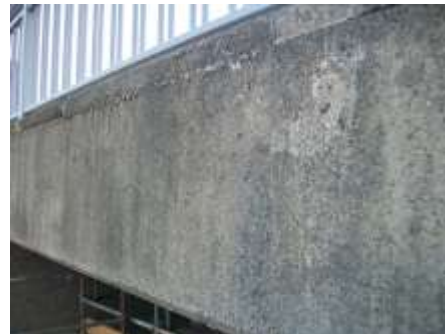
Concrete outer bridge support beam . : The cycle track outer support beam . Externally this concrete is in very good condition, there are no visible signs of any longitudinal or transverse cracking , reinforcement exposure or concrete spalling on any of the soffits or external faces of the beams. No evidence of any reinforcement movement, beam deflection or beam distortion at time of inspection.

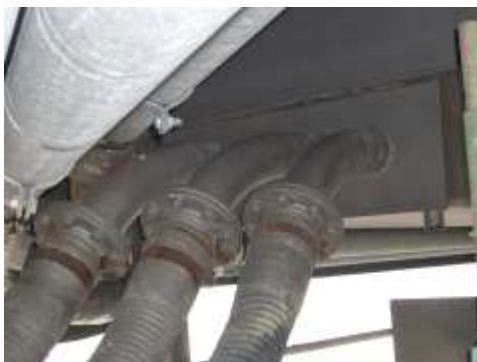
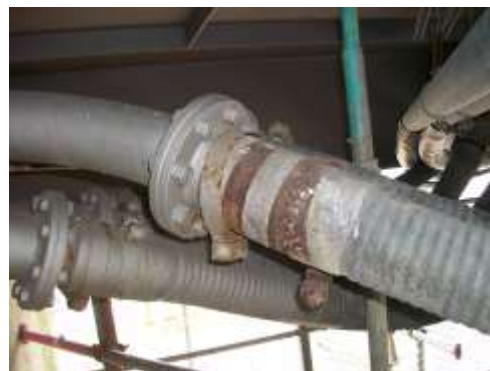
Flexi duct support brackets , ducts & fixings. :

Side- tower to Side-span flexi – ducts. : All flexi- ducts both East and West side remain in a satisfactory condition. Slight paint breakdown and corrosion evident around some flange mating faces bolts and nuts. There are some clamp arrangement fittings which are missing but this does not affect their function all ducts remain fitted and secure . The condition of these clamps have been highlighted in Past side-span inspection reports . All flexi- ducts remain in a satisfactory condition , with no deterioration evident. all support hangers remain intact and in a satisfactory condition.

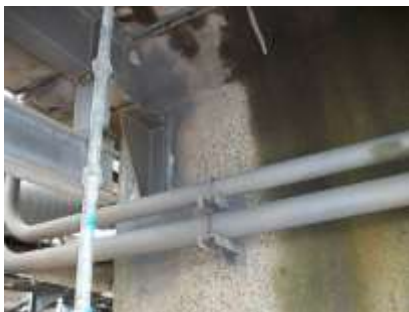
Pipe-work , support brackets & fixings.: All ring-main pipe-work on the viaduct to side tower well and inner balustrade , both East and West sides their connection flanges, support brackets, u- hangers & fixings remain in a satisfactory condition. All ring-main crossover pipe-work from side tower north face to side span inner balustrade sides of the side tower remains in a satisfactory condition.

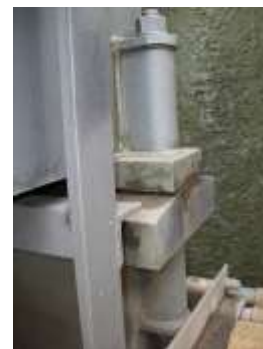
Side-span concrete corbel support blocks and top chord support columns.: All connection bolts and nuts have slight corrosion evident but remain in good condition, all remain secure and intact. All protection sleeves and welds remain in good condition. All attached side tower to top chord support columns both East and west remain in a satisfactory condition, although there is a small area of corrosion located on the north face , top west corrosion is evident.

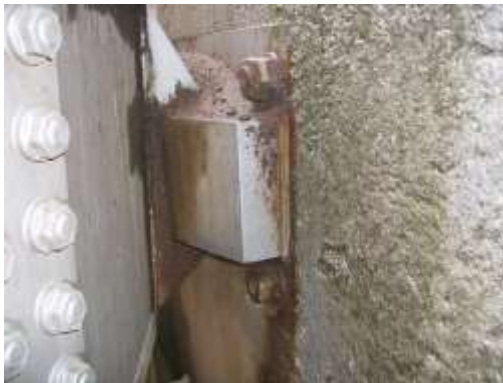
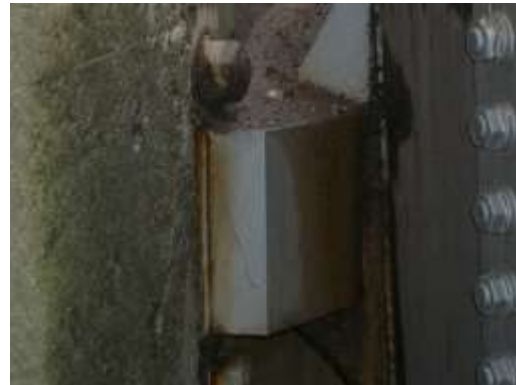
Top lateral connection to side tower , side – span side. Remains in a satisfactory condition, Slight staining evident on face and nuts. No movement .
Discolouration/staining slight corrosion , this is due to location, Constant exposure to water and road detritus being distributed on to it from both carriageway fast lanes.
Concrete surrounding plate in a satisfactory condition.

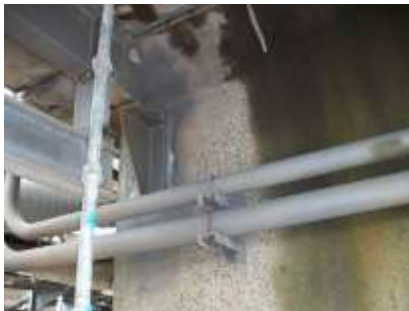
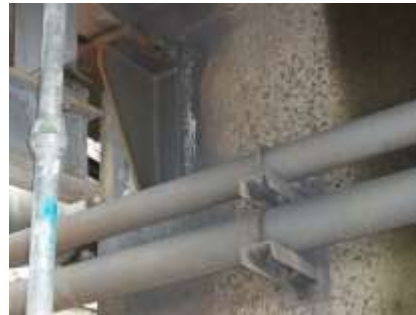
Viaduct runway beams to side tower support brackets. (south face) . : Viaduct runway beam support brackets located on the south face all remain in a satisfactory condition, slight staining / discolouration evident at mating faces of runway beam to support bracket. Location fixings satisfactory . No movement at tower face evident.

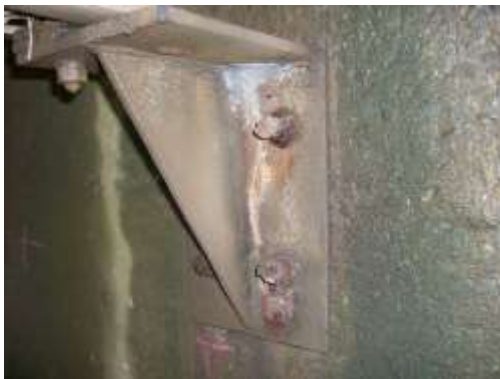
D & A line walkway support brackets (North face) side span side. Support brackets remain in a satisfactory condition on “ A ” line East & West and “ D ” line walkway connections to side tower. Plate location anchor bolts & nuts now showing signs of medium to heavy corrosion, No plate movement evident with all concrete in a satisfactory condition

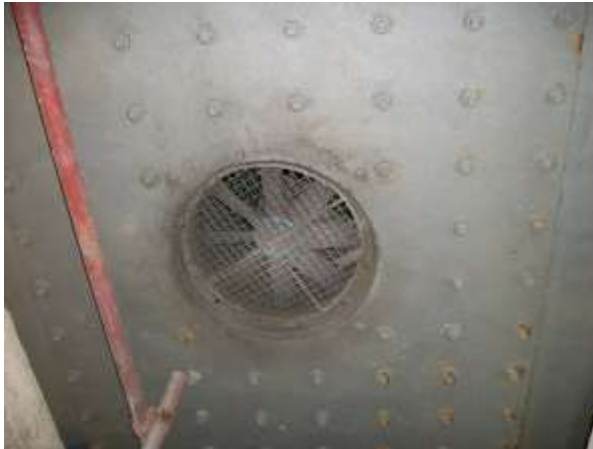
Viaduct box girder air extraction fan and splice plates. Both extractor fan units and splice plates located on the soffit of the box girder both East & West side remain in a satisfactory condition. All splice bolts & nuts remain intact and secure.
