INSPECTION DEPARTMENT
South side tower ( top ) inspection of all elements accessible.
DATE. 05/04/11.

As requested a visual / principal was conducted of all accessible elements on the South side tower top both East and West , following are photographic and written information with regards to current status related to

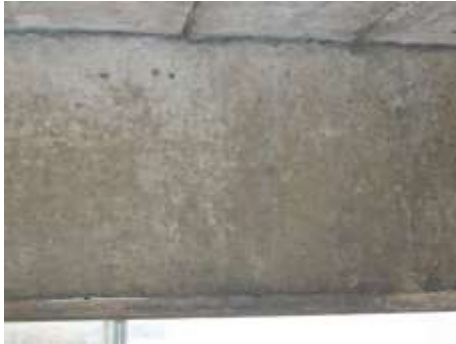
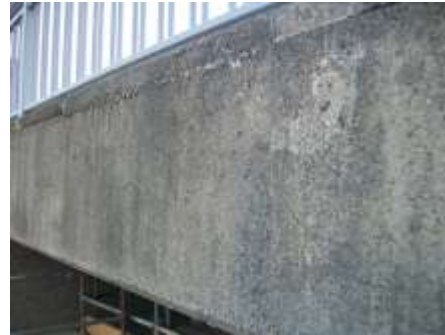
**Concrete outer bridge support beam . :** The cycle track outer support beam . Externally this concrete is in very good condition, there are no visible signs of any longitudinal or transverse cracking , reinforcement exposure or concrete spalling on any of the soffits or external faces of the beams. No evidence of any reinforcement movement, beam deflection or beam distortion at time of inspection.

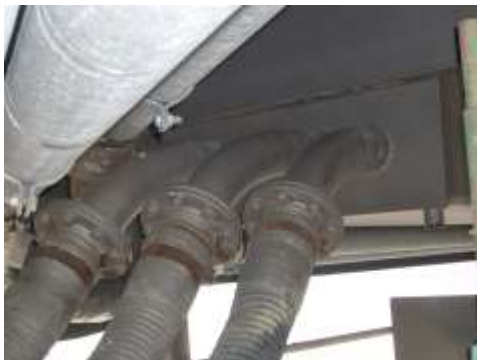
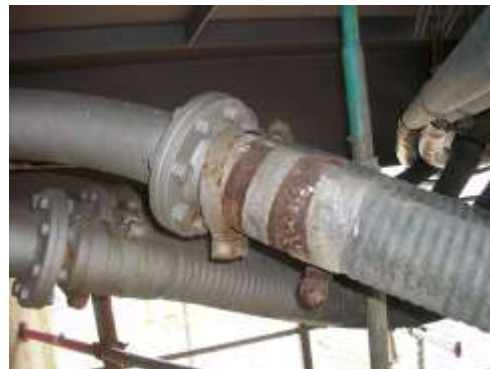
**Flexi duct support brackets , ducts & fixings. :**

Side- tower to Side-span flexi – ducts. : All flexi- ducts both East and West side remain in a satisfactory condition. Slight paint breakdown and corrosion evident around some flange mating faces bolts and nuts. There are some clamp arrangement fittings which are missing but this does not affect their function all ducts remain fitted and secure . The condition of these clamps have been highlighted in Past side-span inspection reports . All flexi- ducts remain in a satisfactory condition , with no deterioration evident. all support hangers remain intact and in a satisfactory condition.

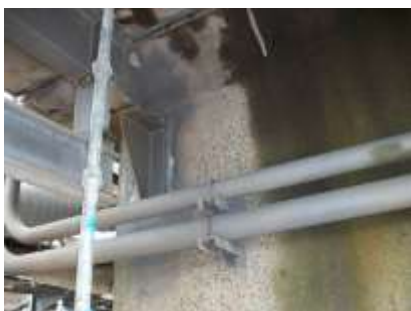
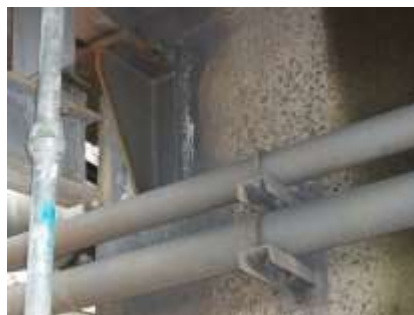
**Viaduct runway beams to side tower support brackets. ( south face )** . : Viaduct runway beam support brackets located on the south face all remain in a satisfactory condition, slight staining / discolouration evident at mating faces of runway beam to support bracket. Location fixings satisfactory . No movement at tower face evident.

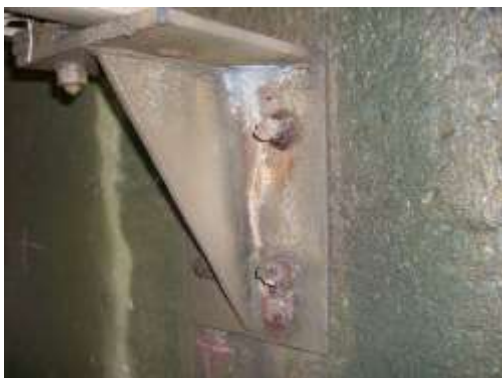
**D & A line walkway support brackets ( North face ) side span side.** Support brackets remain in a satisfactory condition on “ A ” line East & West and “ D ” line walkway connections to side tower. Plate location anchor bolts & nuts now showing signs of medium to heavy corrosion, No plate movement evident with all concrete in a satisfactory condition
