| INSPECTION DEPARTMENT |
| South west box girder. |
| DATE. 28/09/12. |

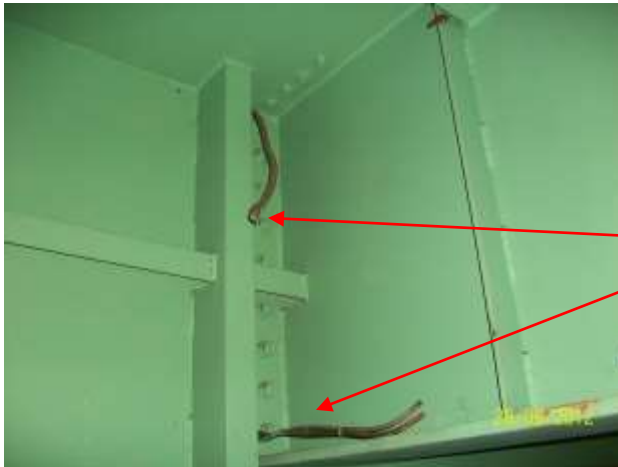
Located Between Outrigger Beams 104/105 in section box No 26, There Are What Appear To Be Redundant Cables Coming Through The East Face Of The Box Girder.

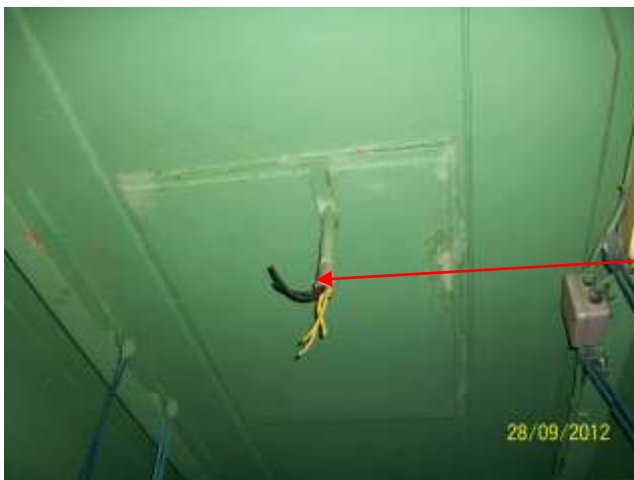
Electric Cable Coming Through A Conduit Located On The Ceiling Of The Box Girder located section box 32.

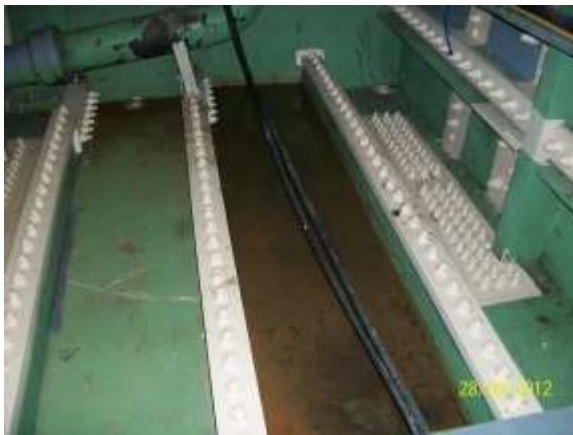
Located At Outrigger Beam 151 On The North Side Of S5 There Is Water Lying In The Second Floor Section. Evidence Of Dampness Around The Seal In The Socket Of The Carriageway Rainwater Downpipe Running Through The Box Girder.

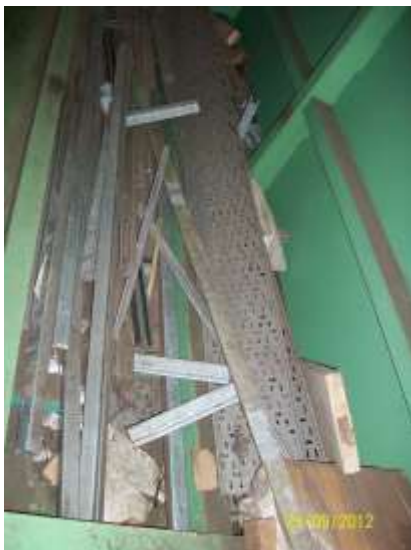
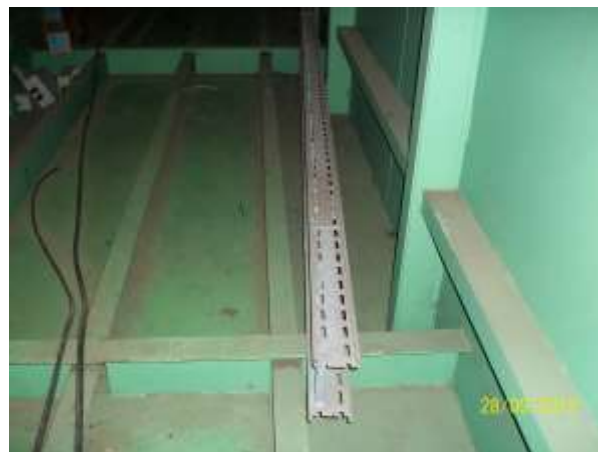
Photographs showing cable tray, unistrut, lighting boxes located in section boxes, for use in electrical program of works or removal.
?

Following completion of electrical programme of works, box girders will be cleaned and all surplus materials and debris removed by general operatives.
