# The STEEL PROTECTION CONSULTANCY Ltd.

Subject **FORTH ROAD BRIDGE ACCESS WALKWAYS, PAINT QUERY**

| PROJECT | <b>Forth Road Bridge, Access Walkways Project</b> | CONTRACTOR | <b>Raynesway</b> |
| LOCATION | <b>Forth Road Bridge, S. Queensferry, Edinburgh</b> | SPC PROJECT NO. | <b>1716 B</b> |

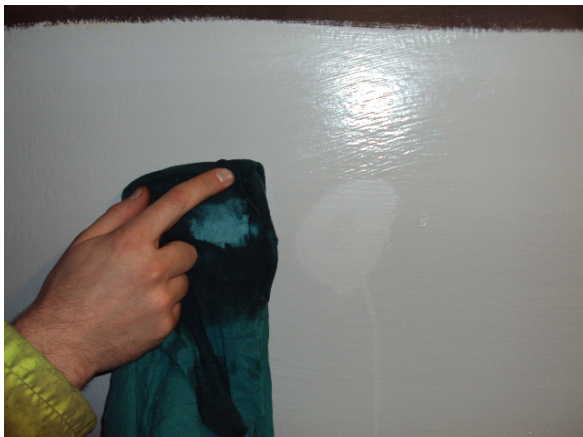
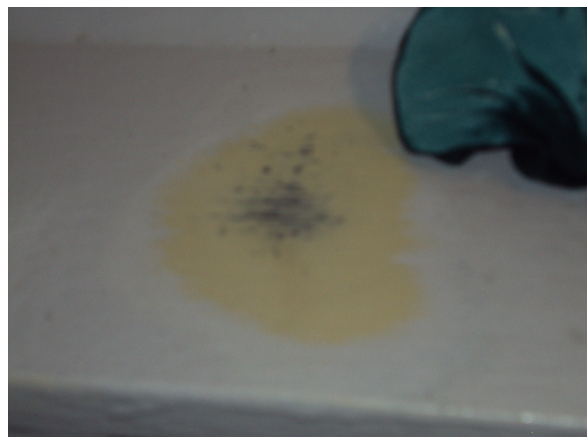
- Inspected the general area of the reported discolouration (N. Tower, Main Span, W. Carriageway, Demag Grillage Beams beneath Main Expansion Joint) and was advised that all the affected surfaces had been freshly overcoated during either 25<sup>th</sup> or 26<sup>th</sup> Sept with 3<sup>rd</sup> coat Item 116 Grey (over Item 115 Aluminium and Item 116 Green Beige).
- This material was checked by thumbnail pressure and was found to be only partially cured with some areas (of both 25<sup>th</sup> and 26<sup>th</sup> Sept material) still being wet.
- Solvent wipe (International GTA 220 Thinners) was performed at approx. 6 locations with all showing incomplete cure and transfer of colour. At the majority of locations a 1-minute wipe removed coating back through the second coat to expose the Aluminium primer beneath.

It was reported by site personnel and apparently borne out by photos at site that the areas of discolouration coincided with locations where water had run down from overhead. If this is the case, this would represent a localised remediable defect. Mr. Nicholson reported that the affected areas were lightly surface abraded to remove affected material, before overcoating.

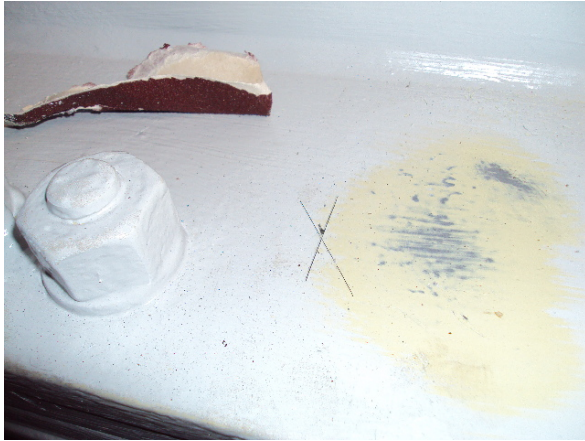
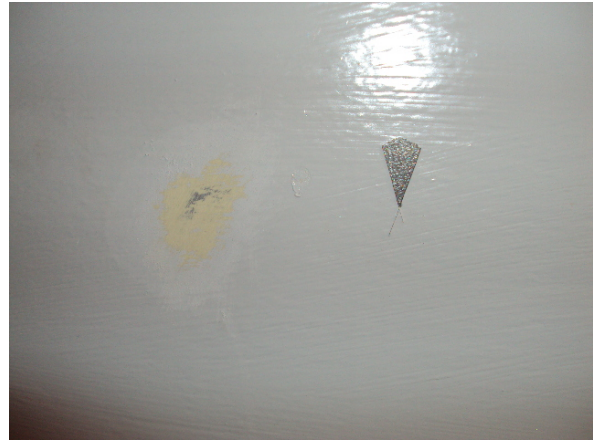
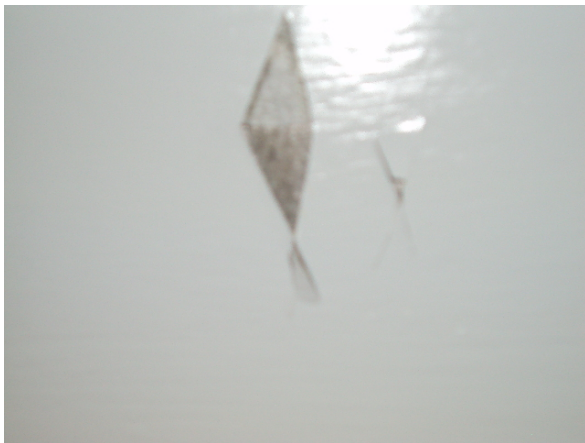
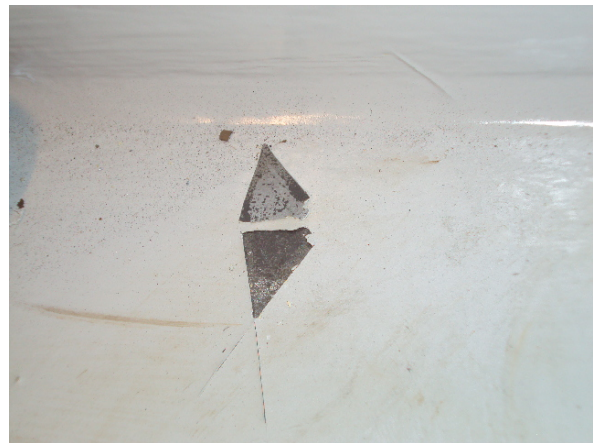
- Light surface abrasion was attempted at a couple of locations but was not proceeded with because of the softness and chewiness of the coating.
- Cross-cut adhesion tests were performed which, although some areas of sound adhesion were found, in many cases gave a complete adhesive failure at the Steel / Aluminium Primer interface. At some areas of disbondment, partial areas of discolouration were present either on the steel surface or the underside of the paint flakes, it was not possible to determine if these had been overlying dust or residues of previous coating.

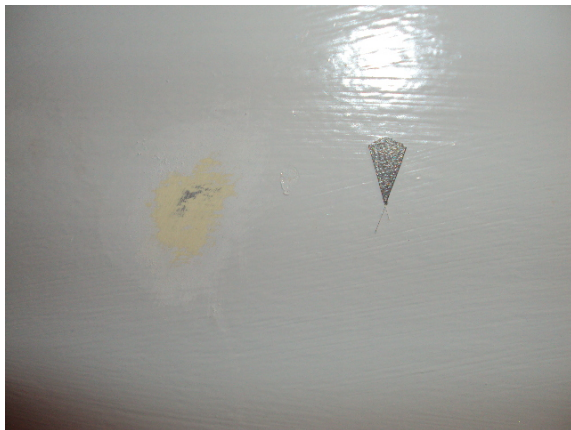
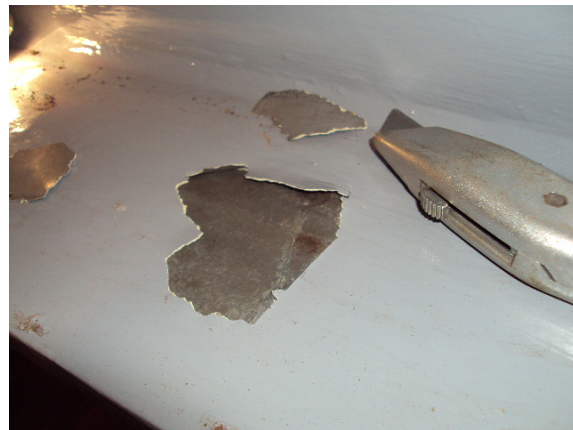
- In L 1 & 2 (as noted at ● 2 above), some areas were of sound adhesion, but a large proportion of tests showed complete adhesive failure at the Steel / Aluminium Primer interface, some of these with areas of discolouration beneath.
- For L 1 & 2, in the tests on topsides of bottom flanges (horizontal surfaces), there was only one test which gave a satisfactory result.
- In L 1 & 2 areas of complete detachment, the steel substrate surface was noted to vary from smooth to deeply deformed – due to this variation, it was concluded that surface profile was unlikely to be the primary cause of poor adhesion.

- On some of the failed test areas, it was possible to peel coating back by hand (Note : the r.h. photo above and the following 2 photos show the same area at different stages of probing).

- That the noted lack of adhesion of the coating gives serious concern for the expected life of the coating system
- That further examination is required to determine the cause and extent of the problem (including all coatings applied on the project to date), and remedial action required
- That the contractor and paint supplier should be requested to perform an examination and present their results.

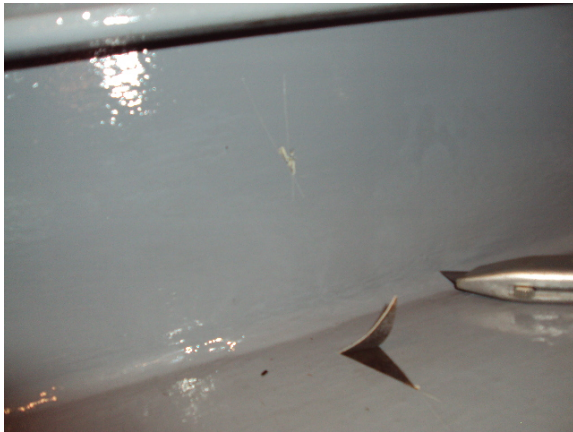
- At detached areas, there was no noticeable smell of e.g. curing agent or solvent.
- L 1 & 2 web (vertical) surfaces gave satisfactory results in approx 25% of cases.

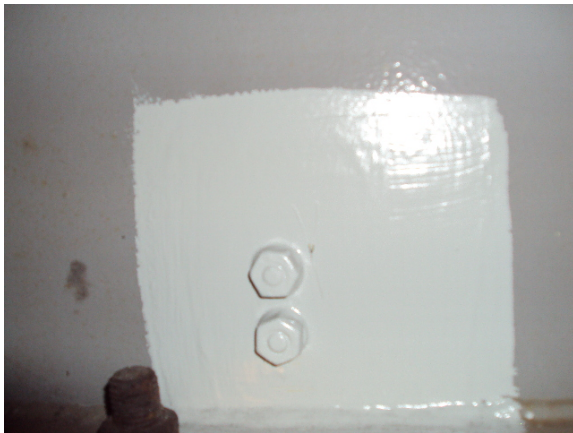
- In L 3 & 4, coating had been performed only as patch coating around nuts on web faces, hence all tests were performed on vertical surfaces. All tests gave satisfactory results.
