Main cable inspection defective nut locations. DATE. 01/03/12.

Following a main cable inspection of the suspended structure, which was carried out from 28th February to March  $1^{\text{st}}$  2012, a total of 16 defective bolt nuts with cracks at 15 bolt locations were recorded. This is the first main cable inspection to be carried out since  $9^{\text{th}}$  &  $10^{\text{th}}$  December 2009.

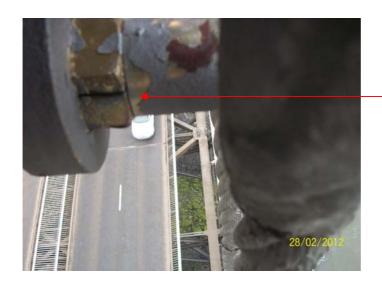
PP. 24. Bolt "D" Dead side nut, crack recorded. On top & bottom faces of nut.

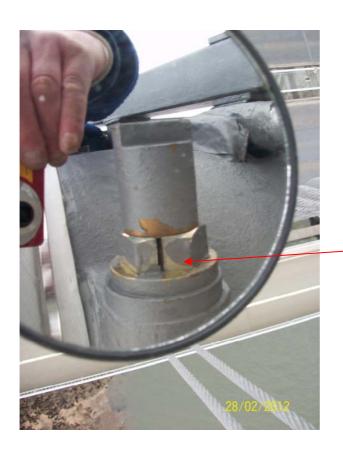
PP. 22. Bolt "F" dead side, nut crack recorded, bottom face of nut.

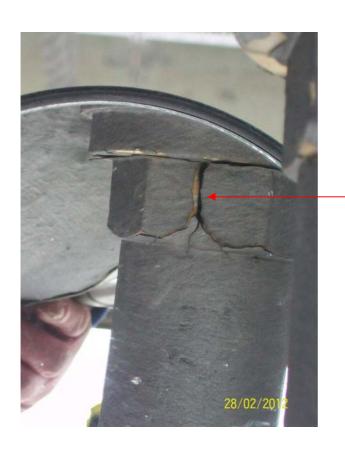
PP. 78. Bolt "D" dead side, nut crack recorded, bottom face of nut.

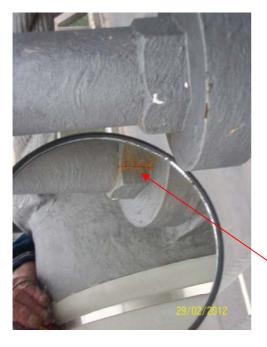
PP. 78. Bolt "B" live side, two nut cracks recorded, bottom face & south face of nut.

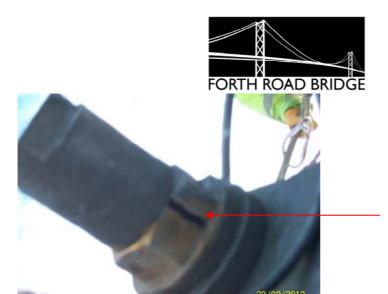
PP. 52. Bolt "A" dead side, nut crack recorded, bottom face & south face of nut.

N.B. This is the widest crack recorded on all defective nuts found, this measures 4-5 mm (fixed steel rule used) to measure.

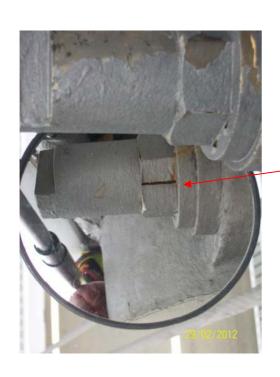
PP. 80. Bolt "B" dead side, nut crack recorded, bottom face & side face of nut.

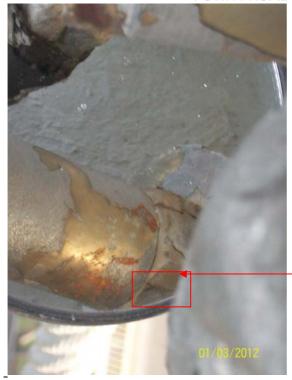
PP. 24. Bolt "D" Live side, nut crack recorded, bottom face.
