INSPECTION DEPARTMENT
Suspender casting / assembly PP. 58 N/E.
DATE. 14/04/10.

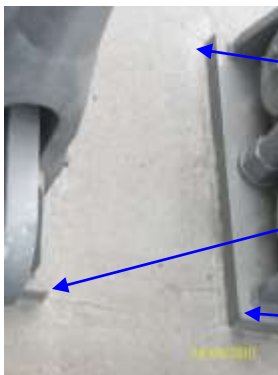
View showing paint cracks leading from all four inner corners of the suspender casting at PP. 58N/E.

Whilst carrying out the 6 monthly inspection of the structures suspenders top chord castings/ assemblies it was found that the top chord anti- skid paint surface at PP 58 n/e was showing signs of cracking around the base at all four corners . Paint around defective paint areas was removed. Loss of adhesion appears to be the cause, paint samples taken , material very brittle. No evidence of any steel defects. All welds , fixings on the casting / assembly were satisfactory. No evidence of any movement. (Please refer to photographs.). Repairs to be made to damaged anti-skid paint surface around these areas .

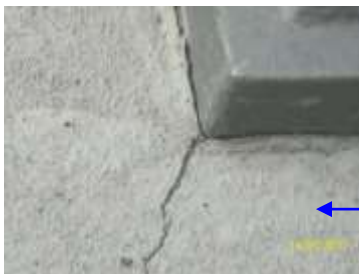
Paint crack leading from the S/E inner corner of the suspender casting to top chord at PP. 58 N/E.

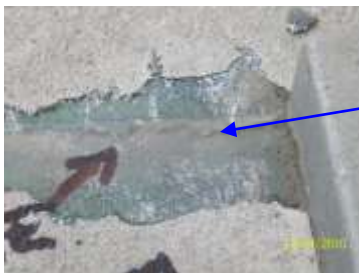
Ridge of metal on the top chord leading from the N/E inner toe of the casting plate. (paint removed) no sign of any defects.
