**INSPECTION DEPARTMENT****Trough defects. North East & West main-span.****DATE. 06/06/12.****North West**

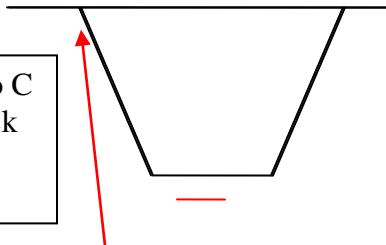
Between. Pp. P.P.95-96 N.W. Trough No.2 (B To C)(Only Visible From Bottom Chord) & Weld Crack Approx 75 Mm Long At Trough End.

ALL OF THE ABOVE DEFECTIVE TROUGH WELD LOCATIONS REQUIRE ACCESS PLATFORMS FROM “B” TO “C” LINE, WITH THE EXCEPTION OF PP. 99 TO PP 100. WHERE “ B “ TO “D” ACCESS IS REQUIRED.
