INSPECTION DEPARTMENT

South viaduct external inspection. (unused platform steelwork DATE. 09/09/09

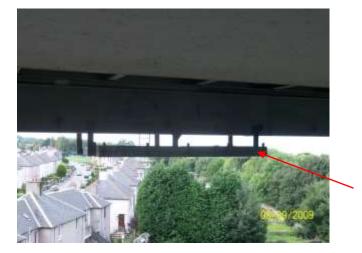
Unused box girder access/egress platform steelwork located between box girder sections 44/45 (west) between crossbeams 180/182.

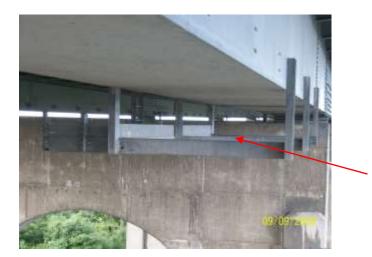
Unused box girder access/egress platform steelwork located between box girder sections 44/45 (west) between crossbeams 180/182.
