During the course of the weekly Demag topside inspection, it was found that there are cracks to west side of SE2 tongue plate.

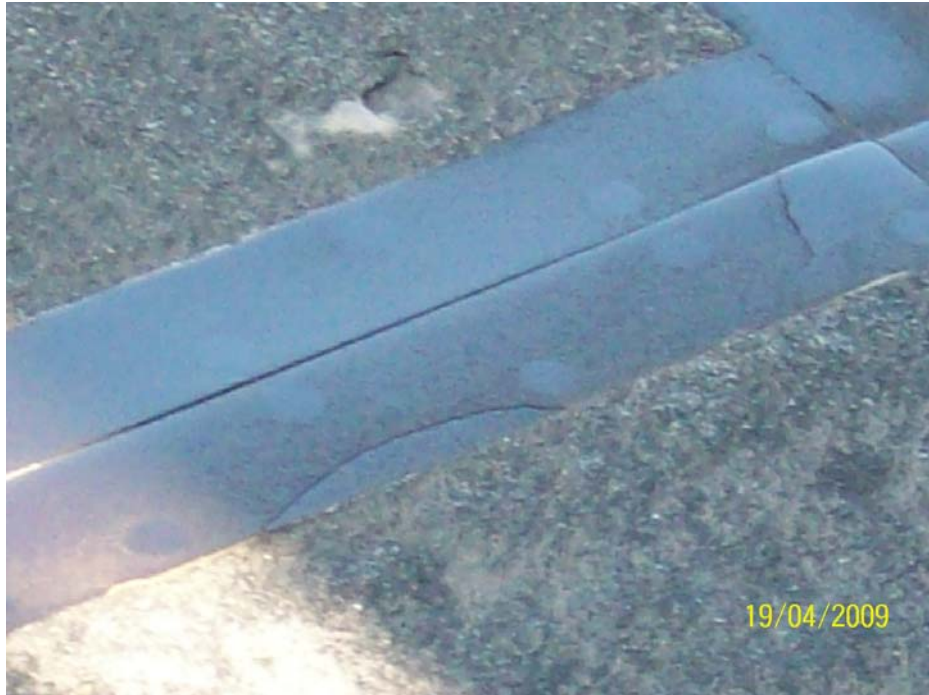
What is not shown in the above picture is how much the plate deflects upwards.
