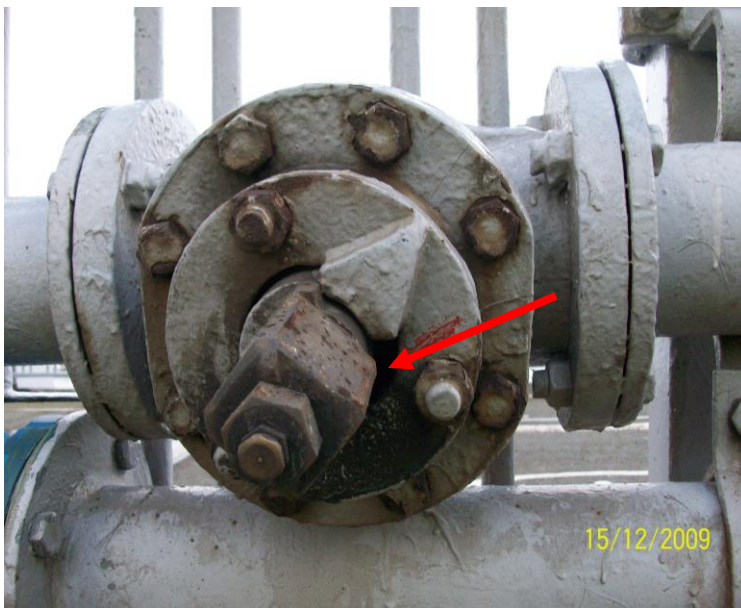
**P.P.46 S.W.**

AUDCO VALVE PASSING  
AT VALVE STEM

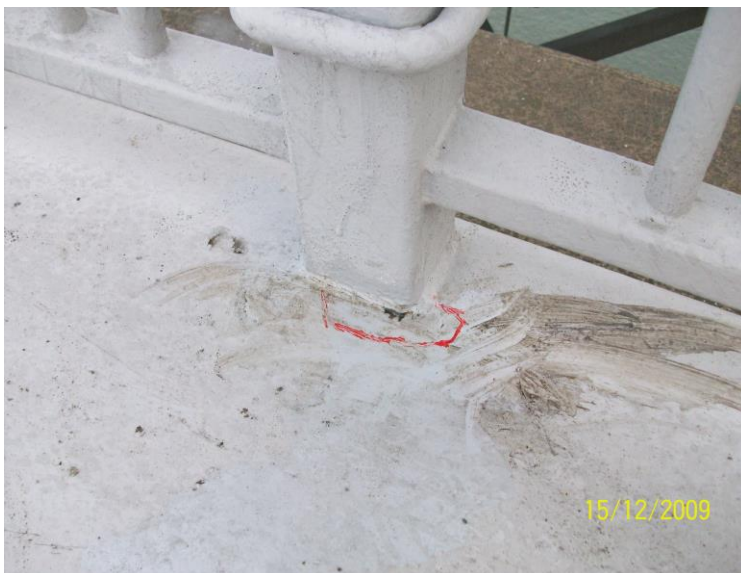
**P.P.52 S.W.**

BASE WELD CRACKED AT  
POST SOUTH OF P.P.

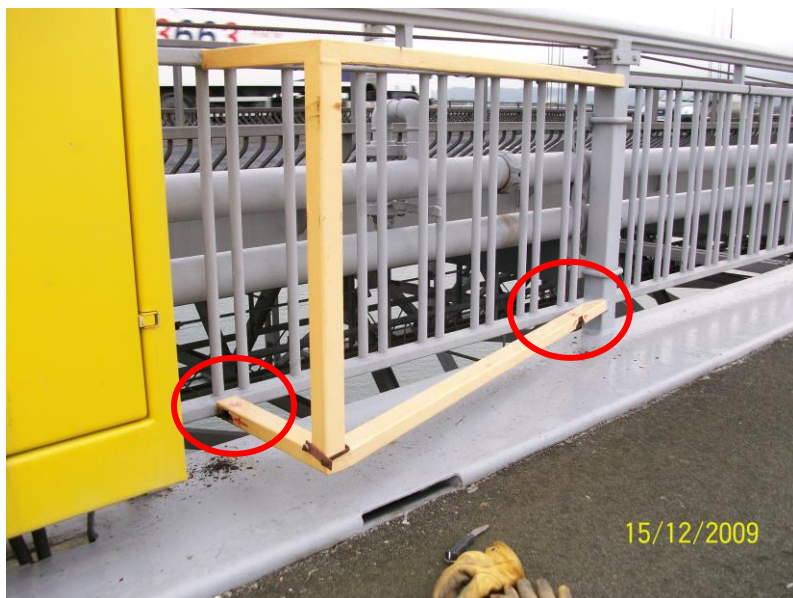
**P.P.72 S.W.**

V.M.S. PROTECTION  
BARRIER IS HOLED IN  
TWO LOCATIONS

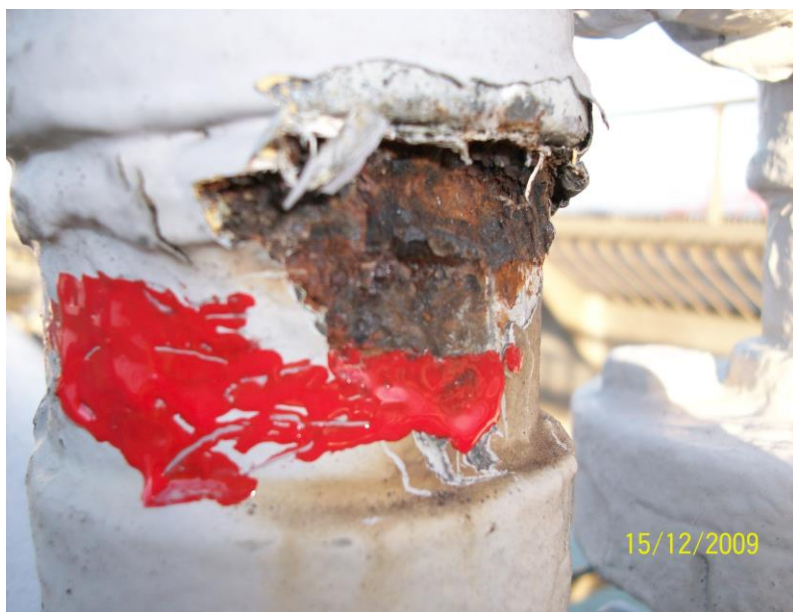
**P.P.91 N.W.**

2" AIR LINE TAKE OFF NIPPLE,  
IS HEAVILY CORRODED.

**RECOMMEND  
REPLACEMENT BEFORE  
PRESSURE LEAK**

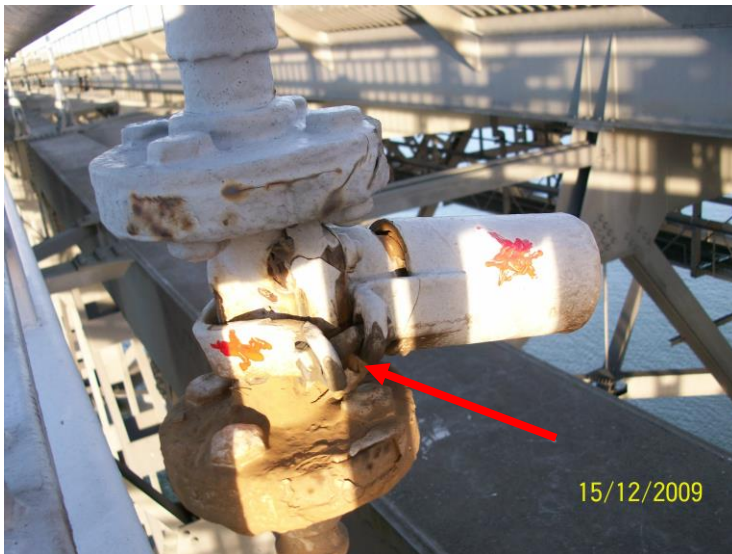
**P.P.90 N.W.**

1" WATER VALVE HAS A  
LOOSE ANTI-TAMPER SLEEVE

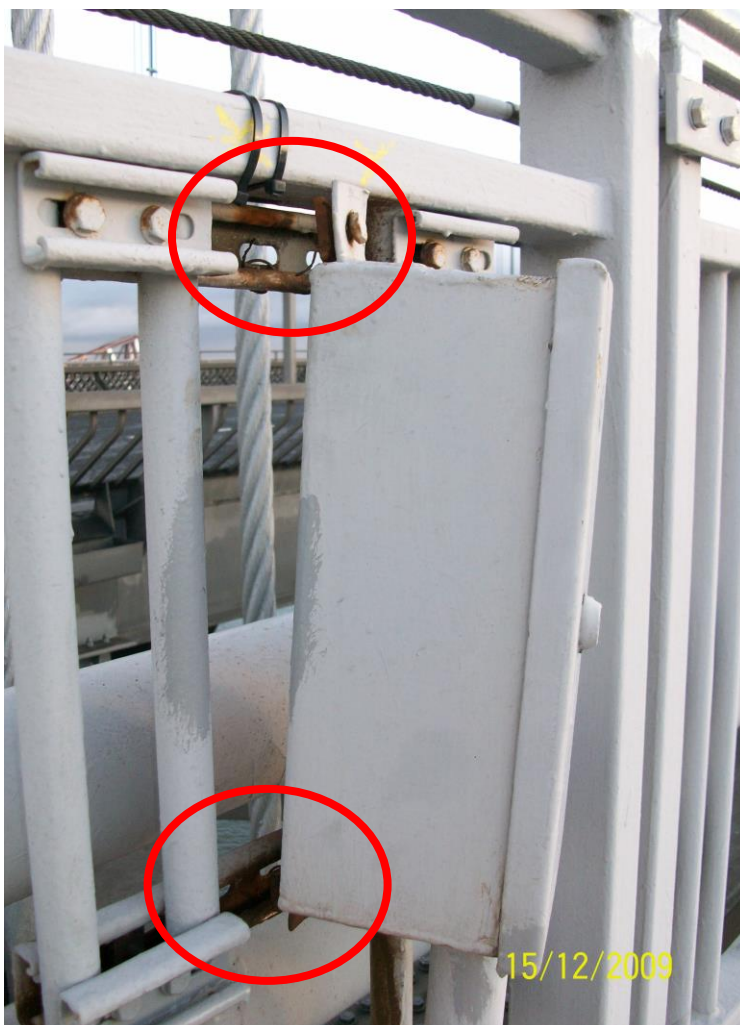
**P.P.74 N.W.**

ELEC. BOX 46 – PREVIOUSLY  
REPORTED LOOSE, NOW HAS  
BOTH FIXINGS BROKEN.

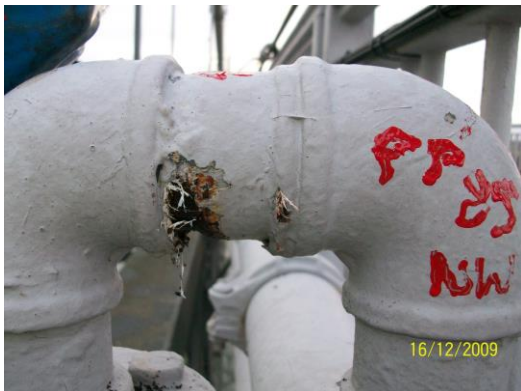
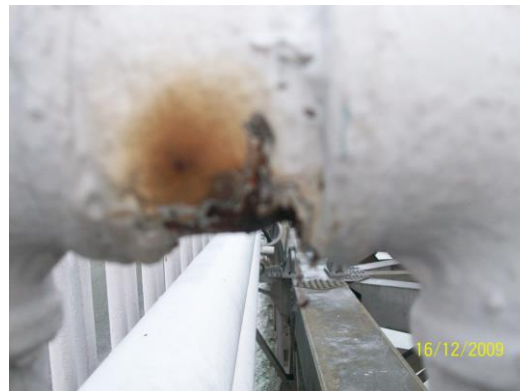
**P.P.85 N.W.**

2" AIR TAKE OFF : NIPPLE BETWEEN 90° ELBOWS HAS CORROSION AFFECTING WALL THICKNESS. REQUIRES REPLACING.
