# **Forth Road Bridge**

## Replacement of Nosing Joints from North and South Side Towers

August 2014

| Document title | Options Report for Replacement of nosing joints at north and south side towers |

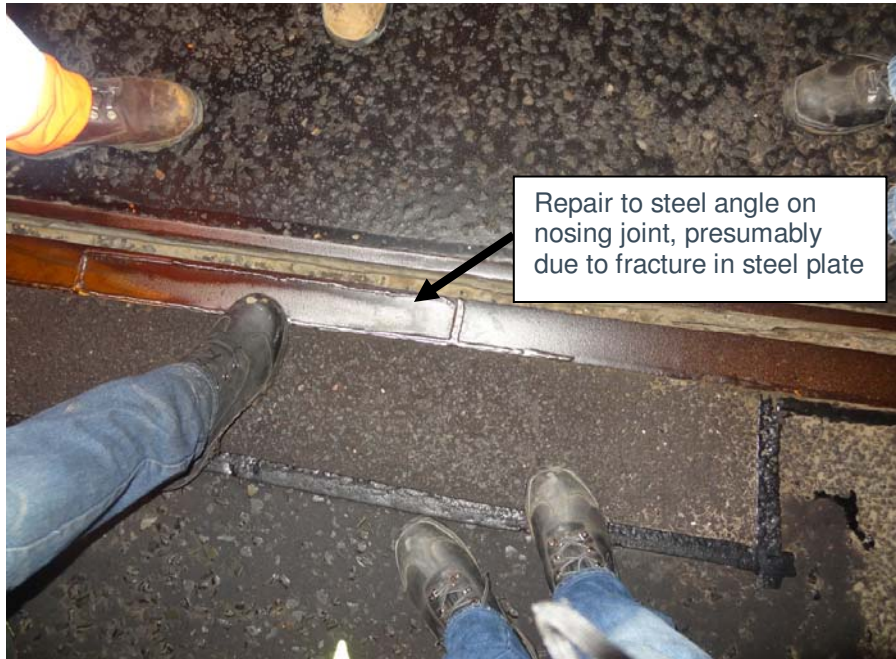
**Figure 3-3 Local Repair to Steel Edging on North Side Tower**

There is limited information on the early maintenance work carried out on the nosing joints. However, FRB has confirmed that local repairs were carried out on the nosing joints in the past. Evidence of local repair to steel edging plate/angle at the side towers is seen in the photograph below.

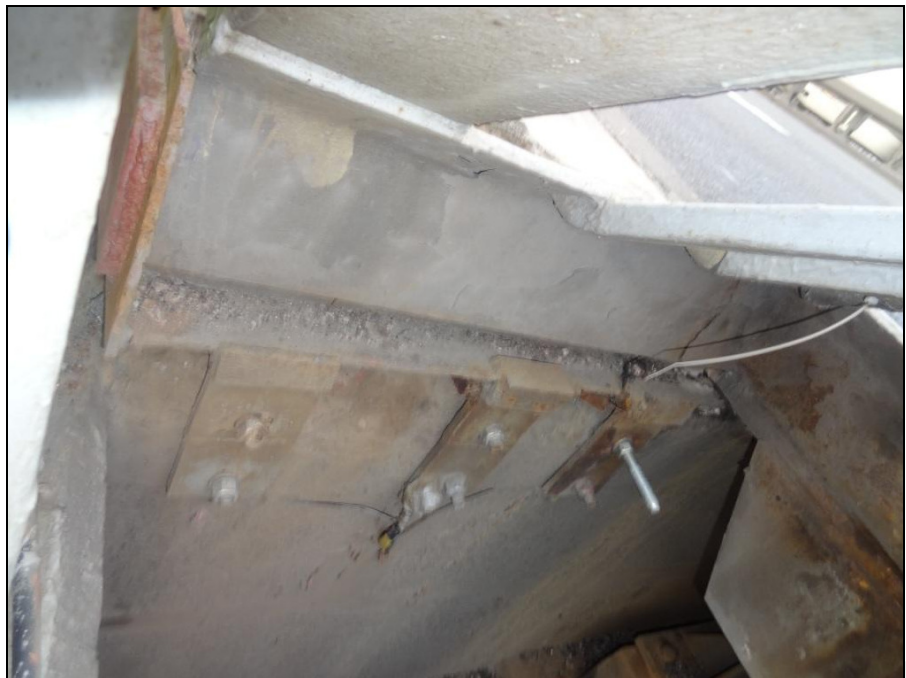
**Figure 3-4 Additional Anchoring to the Steel Edging on the North Side Tower**

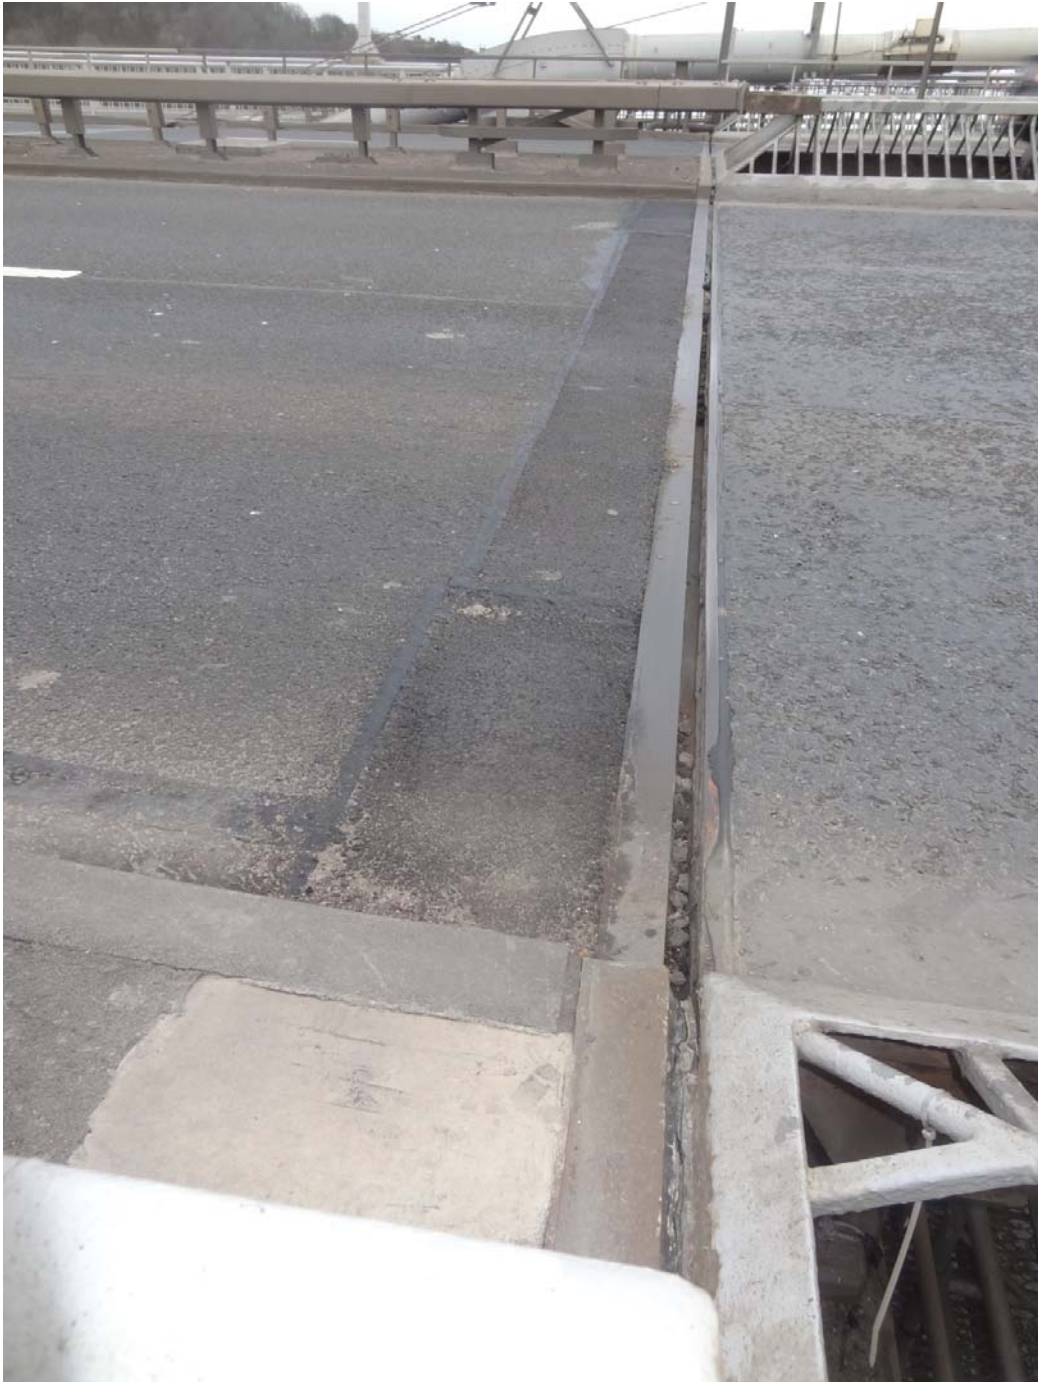
1. Fracture in the steel edging plates causing the running angle to be unsupported and becoming distorted under loading.
2. Loosening of anchorage to steel edgings towards the side tower.

The fracture in the steel plates is believed to be due to gradual wear and reduction in plate thickness from normal traffic loading, whilst the separation of nosing plates from backing concrete is likely to be due to inadequate anchorage or loosening/ delamination of the backing concrete.

**Figure B-1** View of Nosing Joint (North Side Tower, Northbound Carriageway)

3. The existing nosing joints shall be replaced with modified nosing joints with steel edgings forming the nosings (DMRB BD 33, Type 4). The new joint will consist of three key components; two steel edgings and one compressible seal. If either of these is damaged over the period of usage, they could be individually replaced without damaging the other elements.

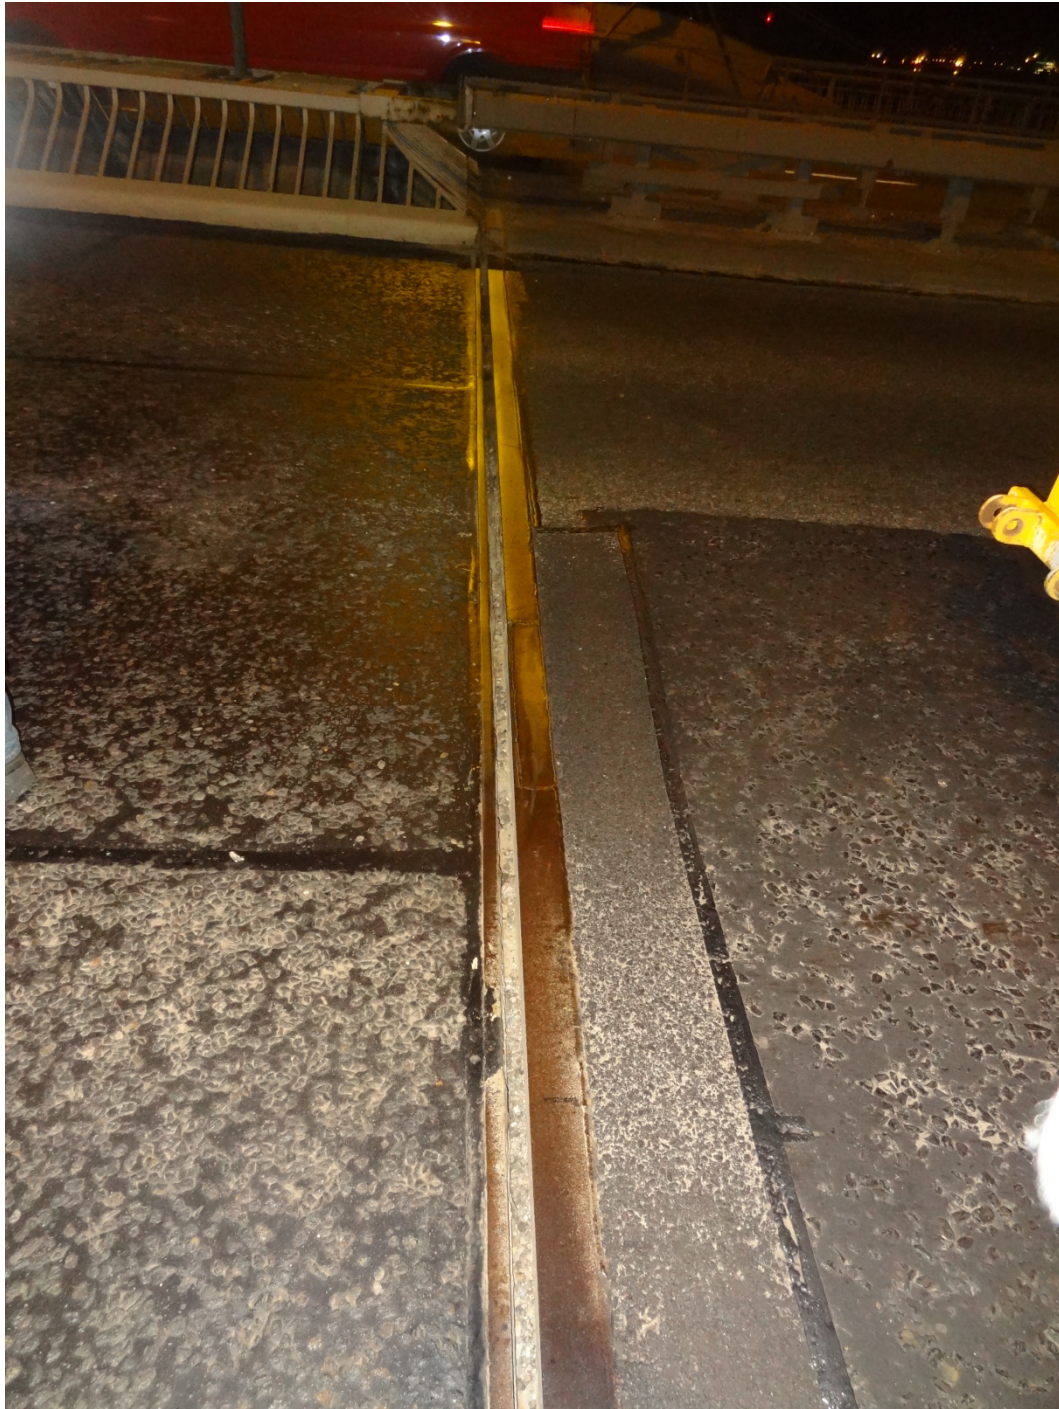
**Figure B-2 View of Nosing Joint (South Side Tower, Southbound Carriageway)**

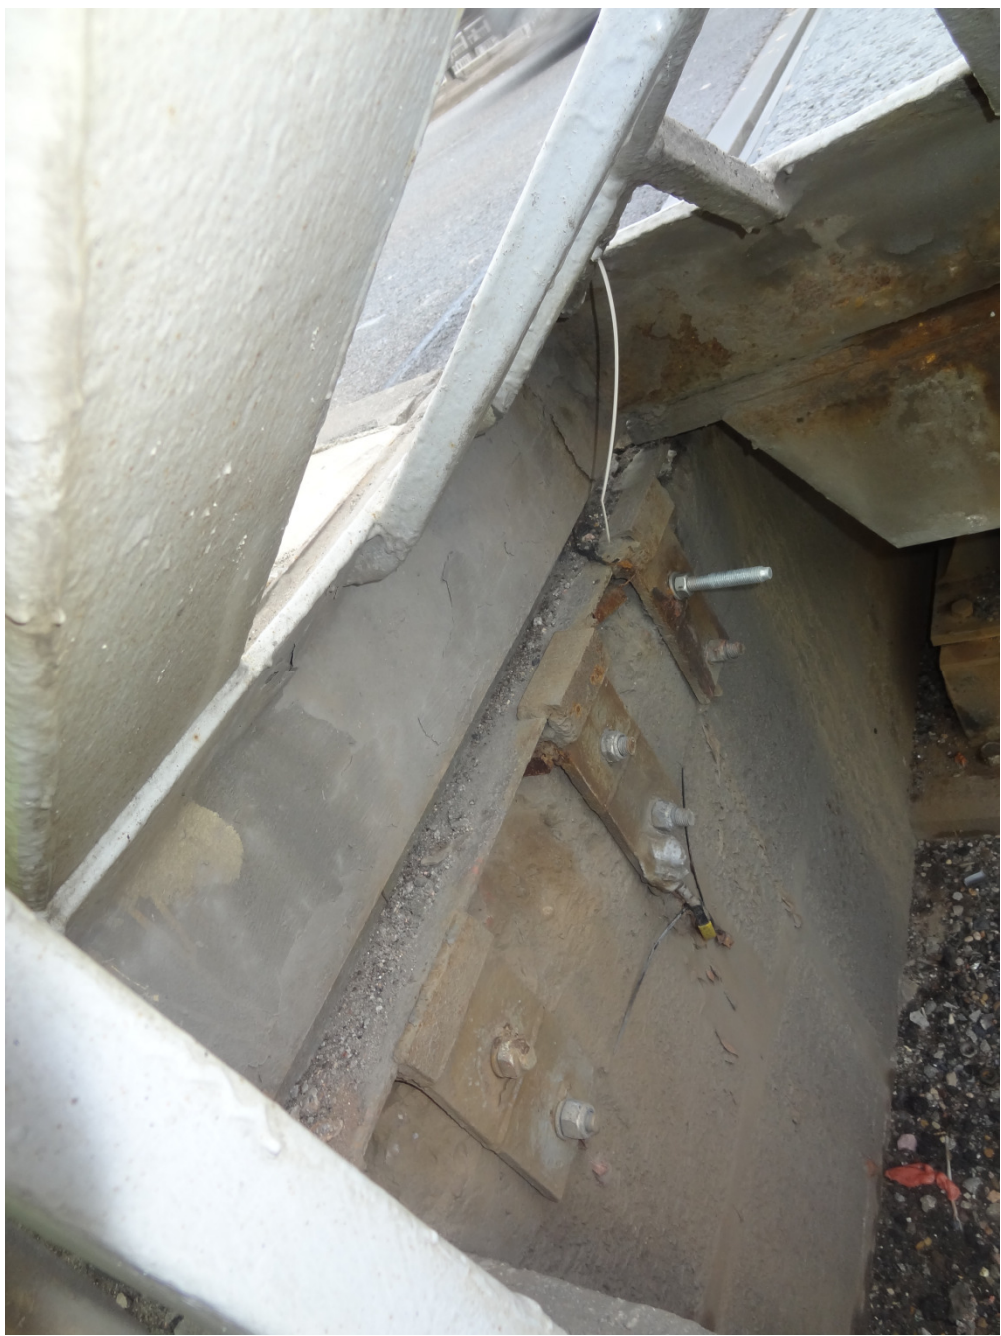
**Figure B-3     View of Nosing Joint (Local Strengthening of North Side Tower)**

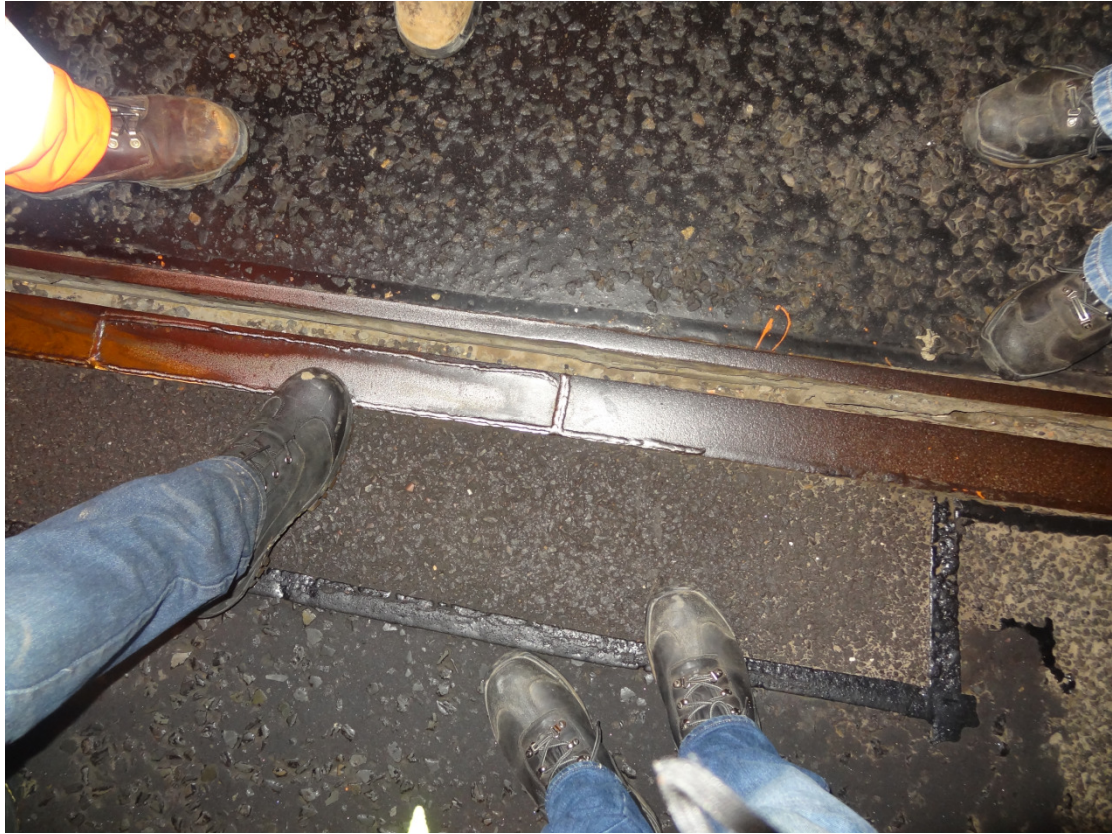
**Figure B-4**    **View of Nosing Joint (Local Repair of Steel Edging Plate)**
