# Technical Note

| Project: | <b>FRB Cable Band Bolt Replacement</b> | Job No: | <b>60267976</b> |
| Subject: | <b>The Use of Micrometers</b> | | |

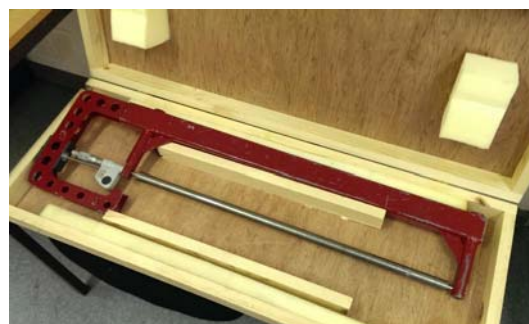
*Micrometer in its box*

- 6No. micrometers were produced in total, allowing for each gantry to have its own micrometer.
- In order to protect the micrometer assembly, micrometers were each housed in a bespoke box, strapped to the gantry when not in use.

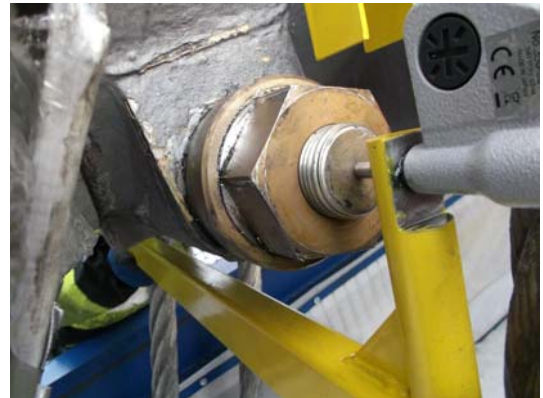
*New bolt being measured*

3. Micrometer calibration checked using corresponding standard bar.
4. Unstressed length measured from machined recesses in the end faces of the bolt and recorded in Bolt Tensioning Records.

7. New extension measured using micrometer and torque pressure recorded.
8. Additional rotation increments applied until intermediate target achieved with rotation fraction, torque pressure and extension recorded at each interval.

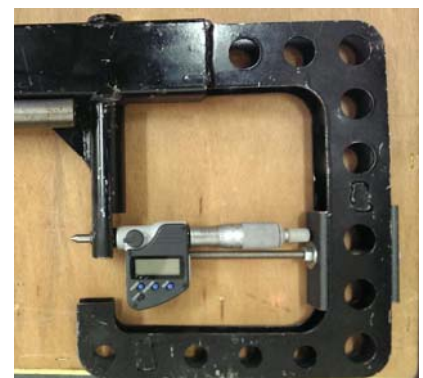
*Micrometer clamped*

Whilst the micrometers were generally reliable, on one occasion the micrometer readings were found to be spurious. It is believed that the micrometer came out of alignment. The exact cause is unknown although it was probably knocked out of position. Being only fixed at one end, the micrometer is susceptible to this and providing fixity at two ends would minimise this likelihood. The solution was to clamp the micrometer. See Technical Note SE54: Over Torquing of Cable Band Bolts for more details and the resolution.
