INSPECTION DEPARTMENT
Beeche platform feeder cradles.
DATE.

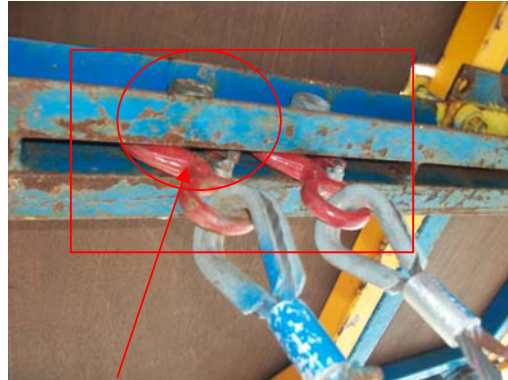
Beeche platform feeder cradle motor wires and safety wires are attached as shown above to a rectangular secured beam which is attached to the framework of the structure of the platform. Wires have fixed crimped captive hooks which are attached to GRADE. 8.8 . M 24 mm bolts which are located and fixed through the lifting beams.

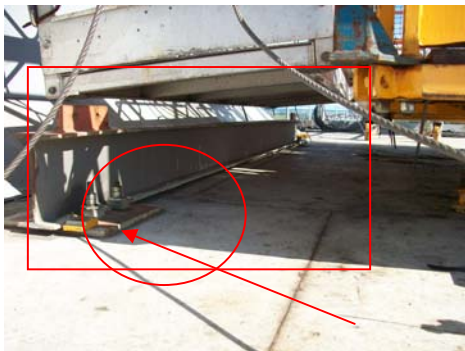
The above wires will be attached at the bottom to ensure complete stability during travel of the beeche platform to its intended work destination using wire travel bloc-stops, and associated shackle arrangements which are fixed “ H “ beam located and fixed to the dropped object canopy floor across the width of the cradle. . This beam is secured to the aforementioned by fixing bolts which travel through the full depth of the canopy floor. Prior to commencement of operational use, the feeder cradles will be subject to a visual inspection and load test which will be carried out by a competent person. All attachments and fixings will be part of an inspection regime which will be carried out by the platform charge-hand on a regular ongoing basis while the platforms are in operation. Inspections will be carried out and conform to the guidelines laid down as stated in the operational & Maintenance manual for the beeche platform. These inspections will be carried out on a Pre- use, weekly and monthly basis.
