Report on Failed Cable Band Bolt Nuts

Forth Road Bridge

Forth Estuary Transport Authority

January 2009

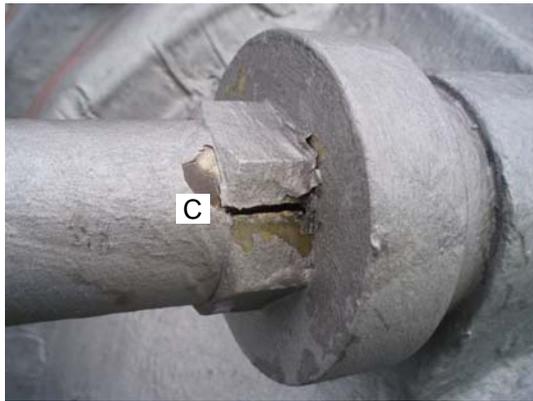
2. 24SW

Fig 2.05: Crack C

Fig 2.06: Crack A

Fig 2.07: Location of failed nut on cable band

Fig 2.08: Location of cracks around nut

There was one wide crack (C), approximately 2mm wide, plus two narrower cracks, one of which was located on a corner of the nut hexagon (A).

The failed nut was located at the live (jacking) end of the bolt.

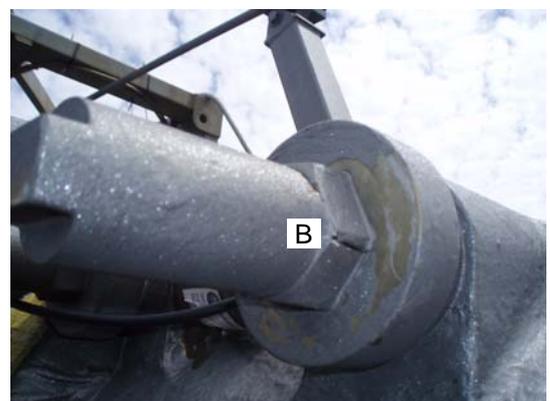
3. 42SW

Fig 2.09: Crack A

Fig 2.10: Crack B

There were two cracks approximately 1.5mm wide running the full height of the exposed portion of the nut.

The failed nut was located at the live (jacking) end of the bolt.

Fig 2.12: Location of cracks around nut

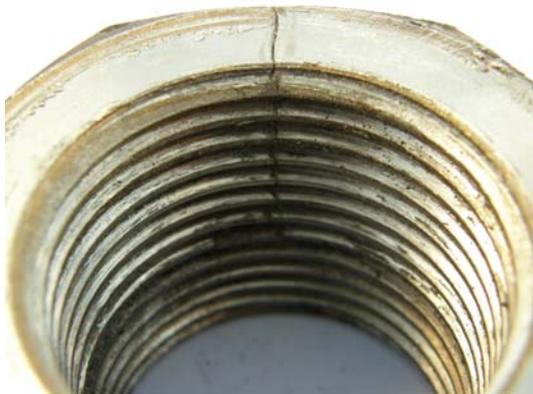
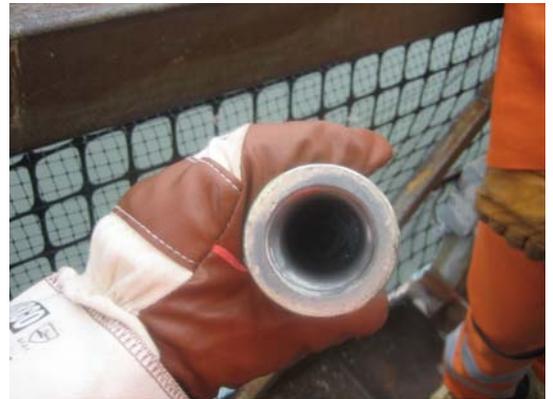
The end cap had been in close contact with the end of the nut suggesting that the end cap had been carrying a significant amount of the bolt tension.

Fig 2.17: Nut contact surface with end cap

Fig 2.18: End cap

- The end caps are substantial and a proportion of the bolt tension was transferred to them after the nut had cracked. This appears fortuitous as it prevents total failure with components potentially dropping onto the carriageway and footway below.

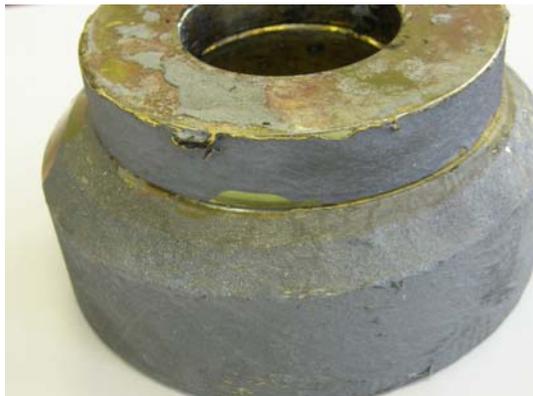
After removal and subsequent reassembly of the various parts, it was noted that the two halves of the spherical washers were not aligned concentrically with each other. In many ways this was not surprising as these heavy components would tend to slip down and rest on the bolt shaft before the bolt is tensioned.

Fig 2.19: Live end washers

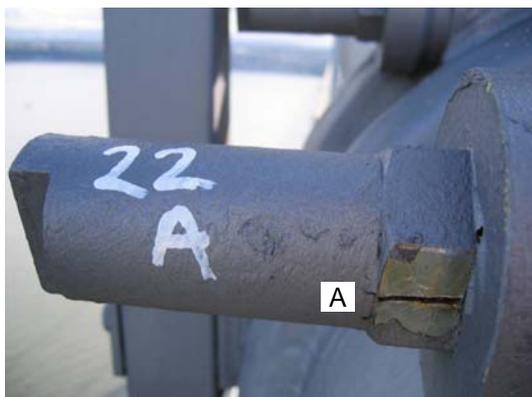
6. 22NE

Fig 2.24: Crack A

Fig 2.25: Location of nut and crack

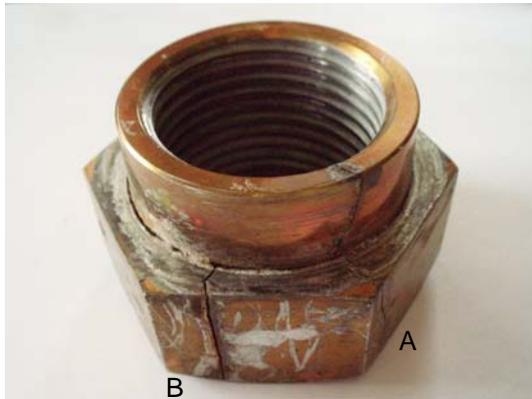
1. 54NW

Fig 2.32: Cracks A and B

Fig 2.33: Cracks A, B and C

Fig 2.34: Plan layout of cracks

On removal, in spite of the large cracks the nut remained in one piece. This was a result of cracks A and C terminating just before the top of the hexagonal section and leaving a small amount of material in place. This nut was sent for laboratory analysis, where it was readily broken apart along the crack lines shown above. After splitting, a circumferential crack at the change in section was found to extend over an angle of approximately 150 degrees.

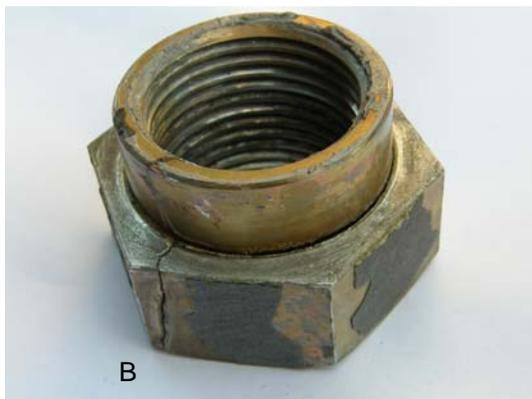
3. 42SW

Fig 2.38: Crack B

Fig 2.39: Cracks A and B

Fig 2.40: Plan layout of cracks

Two cracks were present, one full height and the other just over the height of the hexagon. The circumferential crack subtended an angle of about 135 degrees.

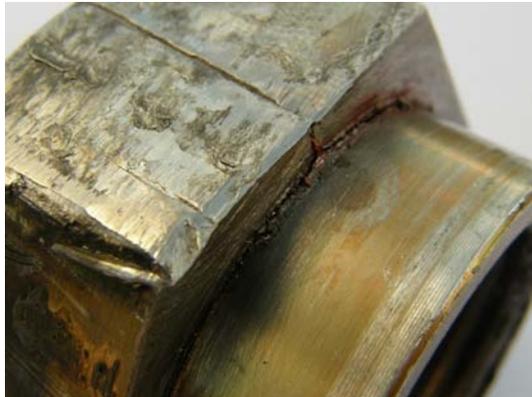
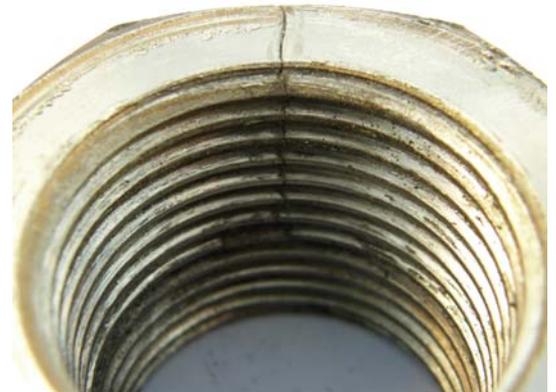
4. 20NW

Fig 2.41: Crack A

Fig 2.42: Crack A

Fig 2.43: Plan layout of cracks

This nut was found to have just one crack and therefore remained in one piece. Careful examination at the change in section externally, and internally along the threads suggested the presence of a crack length of just over half of the circumference.

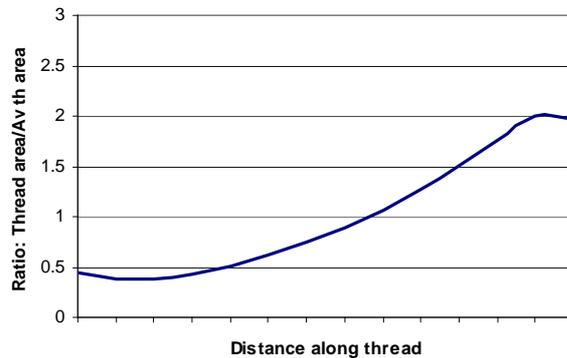
Fig 5.31: Calculated load distribution along thread helix for full normal nut

A full normal style nut was modelled first to check if a similar distribution could be produced. The result is shown in Figure 5.35, and shows a reasonable comparison.
