Maintenance managers requested information of North East box girder roller bearing . ( Photographs show the east face. ) Viaduct box girder movement measurements.

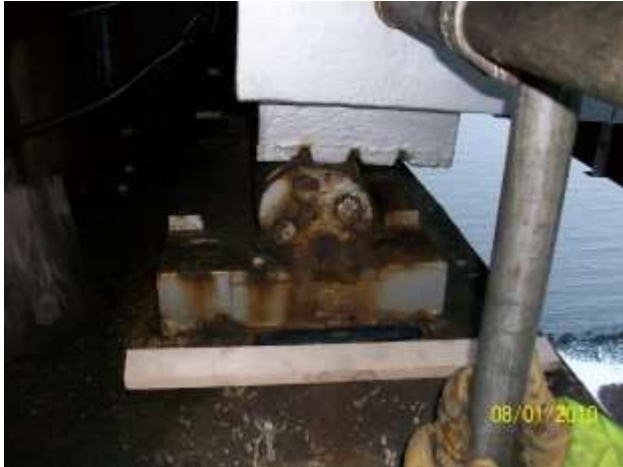
Photograph showing current status & condition of the North east viaduct box girder roller bearing & plinth from the east face.
