INSPECTION DEPARTMENT
Pier top bearings.
DATE : 16/09/09.

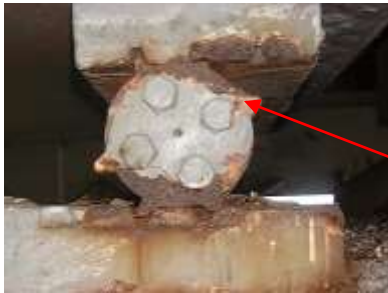
Example of. Roller bearing.  
Heavy corrosion & Paint  
breakdown.

All roller & pin bearings to be replaced under capital plan programme of works.

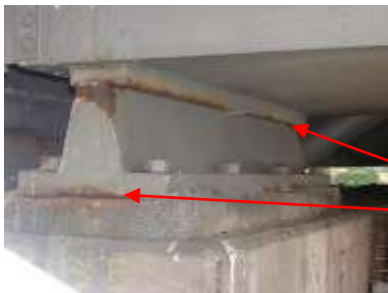
Paint breakdown &  
corrosion evident on Pin  
bearing.
