Location PP. 20 N/W North west side Span. .
Bolt change report.

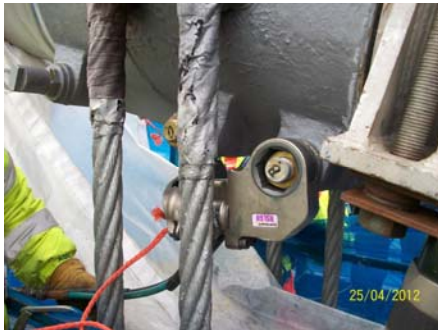
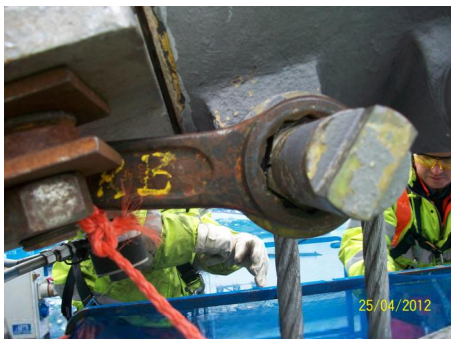
12.30 pm. Bolt began to turn, flogging spanner applied to live side to counteract this movement.

12.25 pm. . Operations to release load on dead side of defective bolt "B" began using RSL 6.

12.40 pm. Bolt released .

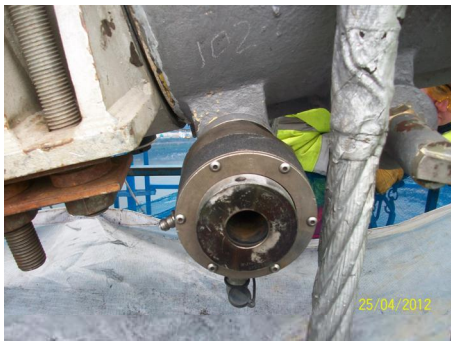
13.00 pm. PS4. tensioner applied to dead side of bolt "B".

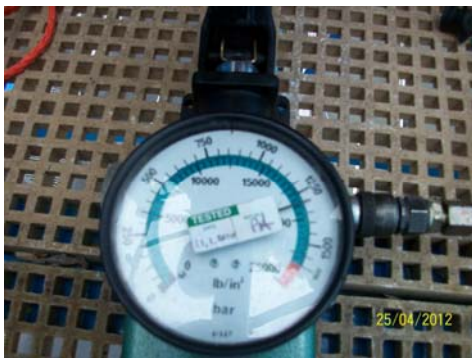
13.10 pm. Bolt "B" tightened up using hand pump to pressure as specified , pressure to be between 18,488psi and 19,578 psi.

Pressure taken up to 19,000 psi. this procedure was carried out a further two times as specified.
