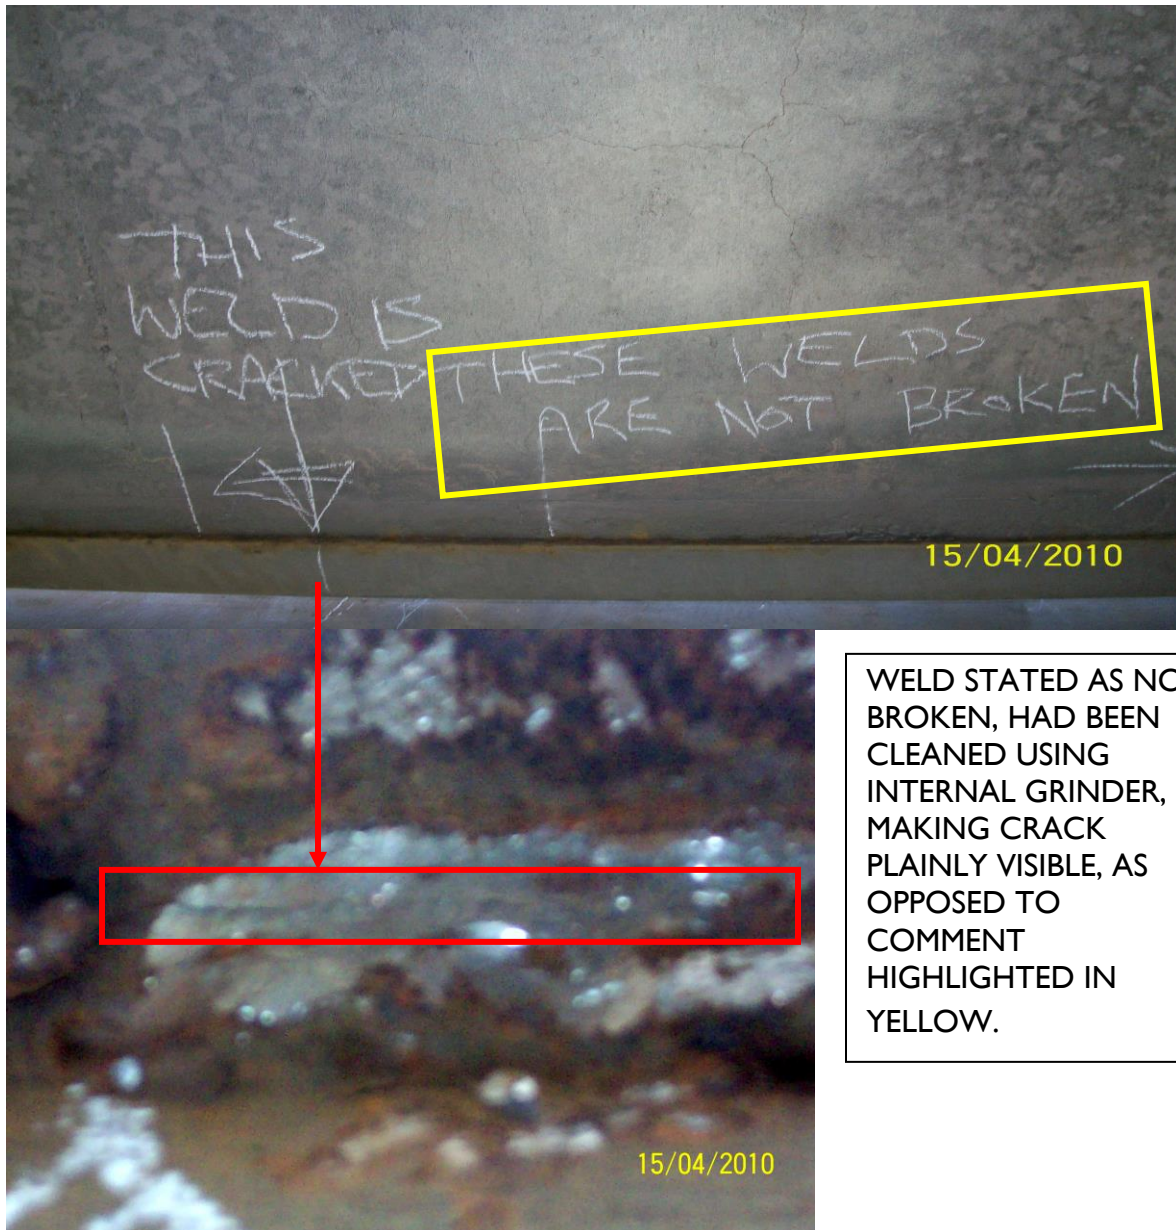
WELD STATED AS NOT BROKEN, HAD BEEN CLEANED USING INTERNAL GRINDER, MAKING CRACK PLAINLY VISIBLE, AS OPPOSED TO COMMENT HIGHLIGHTED IN YELLOW.

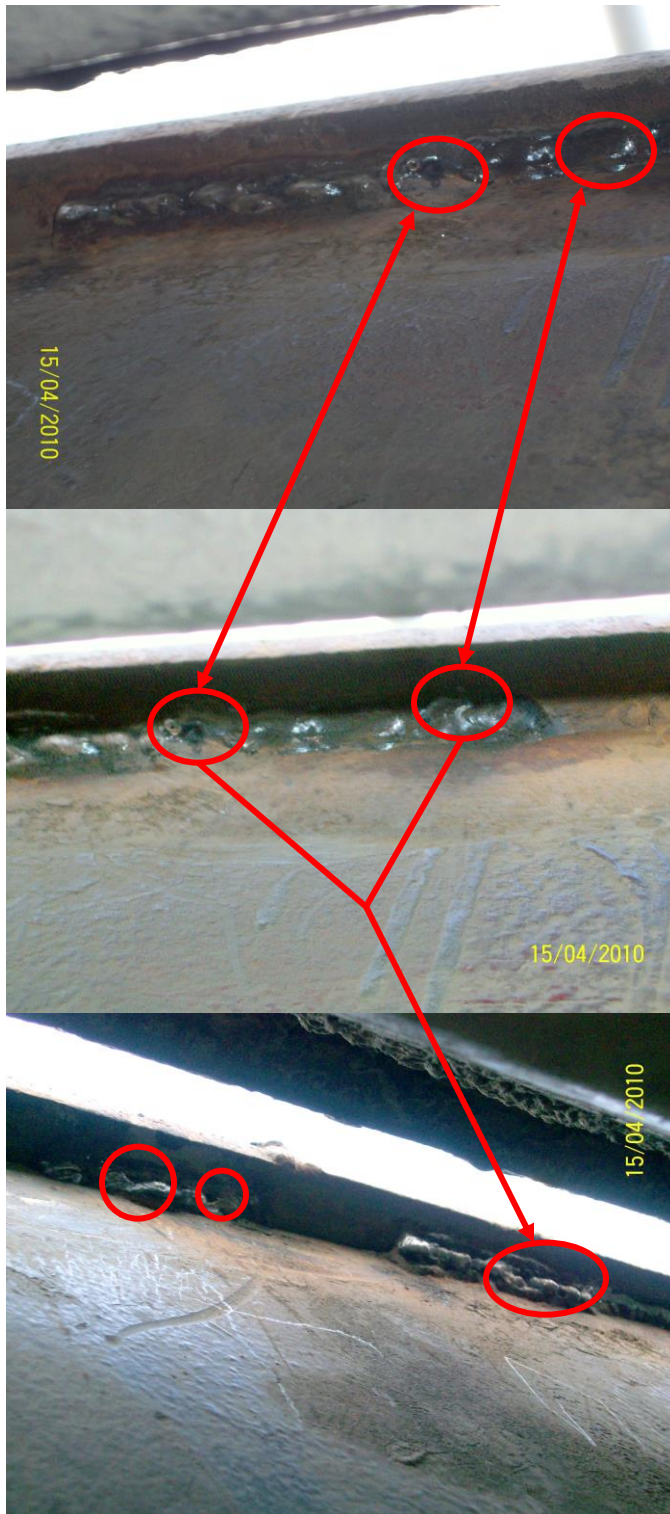
**THE TWO WELDS EITHER  
SIDE OF STRINGER NUMBER  
2 HAVE VISABLE  
INDICATIONS OF  
HOLES/SLAG INCLUSIONS**
