INSPECTION DEPARTMENT
Weld inspections. ME 3 & SE 3. .
DATE. 08/10/11.

FORTH ESTUARY TRANSPORT AUTHORITY

L.P.I. WELD INSPECTION REPORT

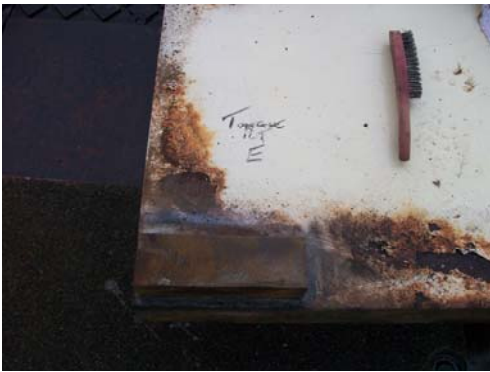
**ME3 END BEARING BLOCK ON TONGUE
PLATE (E) CLEANED.**

<u>Comments:</u> Inspection of existing welds by Visual testing and Liquid penetrant testing as specified to British standards : BS EN 13018. : 2001.. BS EN 1289. : 1998 . These tests were carried out determine if any NEW defects have appeared, other than any old defects. No new defects found. Only defects to be found were original: small indications of defects. No new defects found.		<u>Accept:</u>
		YES
		<u>Reject:</u>

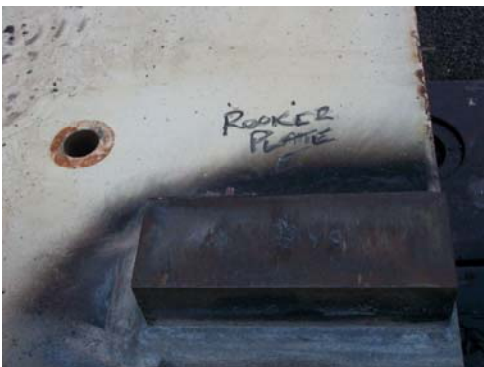
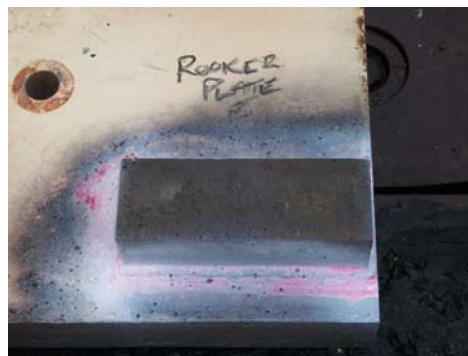
ME3 END BEARING BLOCK ON ROCKER PLATE (E) SHOWING WELDS CLEANED & TESTED.

Comments: Inspection of existing welds by Visual testing and Liquid penetrant testing as specified to British standards : BS EN 13018. : 2001.. BS EN 1289. : 1998 . These tests were carried out determine if any NEW defects have appeared, other than any old defects. No new defects found. Only defects to be found were original: small indications of defects. No new defects found.		<u>Accept:</u>
		YES
		<u>Reject:</u>

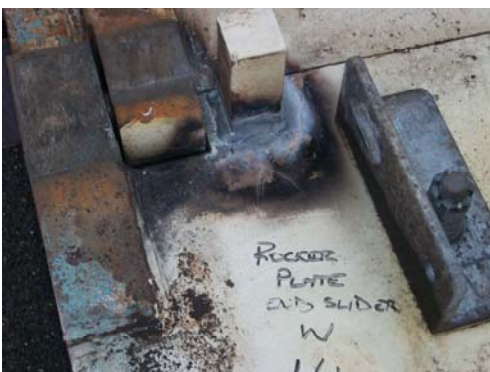
**ME3 DEMAG POS. 14 INT GUIDE BLOCK W
SHOWING WELDS TESTED & INSPECTED**

<u>Comments:</u> Inspection of existing welds by Visual testing and Liquid penetrant testing as specified to British standards : BS EN 13018. : 2001.. BS EN 1289. : 1998 . These tests were carried out determine if any NEW defects have appeared, other than any old defects. No new defects found. Only defects to be found were original: small indications of defects. No new defects found.		<u>Accept:</u>
		YES
		<u>Reject:</u>

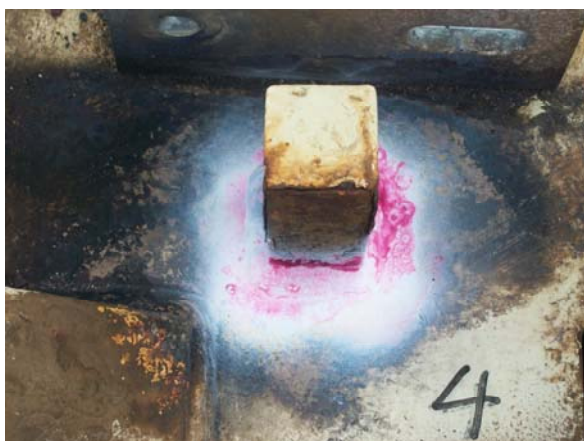
SE3. DEMAG POS. 4 INT GUIDE BLOCK TESTED & INSPECTED

Comments: Inspection of existing welds by Visual testing and Liquid penetrant testing as specified to British standards : BS EN 13018. : 2001.. BS EN 1289. : 1998 . These tests were carried out determine if any NEW defects have appeared, other than any old defects. No new defects found. Only defects to be found were original: small indications of defects.No new defects found.		Accept:
		YES
		Reject:

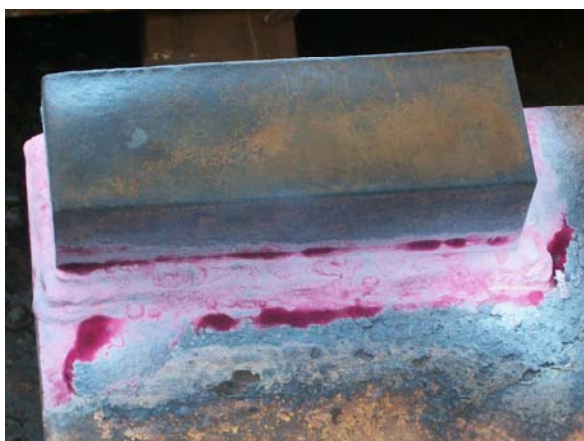
SE3. END BEARING BLOCK ON TONGUE PLATE (E) TESTED & INSPECTED

<u>Comments:</u> Inspection of existing welds by Visual testing and Liquid penetrant testing as specified to British standards : BS EN 13018. : 2001.. BS EN 1289. : 1998 . These tests were carried out determine if any NEW defects have appeared, other than any old defects. No new defects found. Only defects to be found were original: small indications of defects. No new defects found.		<u>Accept:</u> YES
		<u>Reject:</u>
