INSPECTION DEPARTMENT
Weld inspections. ME 3 & SE 3. .
DATE. 08/10/11.

Following the successful removal of the South Main Tower expansion joint plates ME3 & SE3, weld inspections were required to be carried out on randomly selected welds on both plates.

FORTH ESTUARY TRANSPORT AUTHORITY

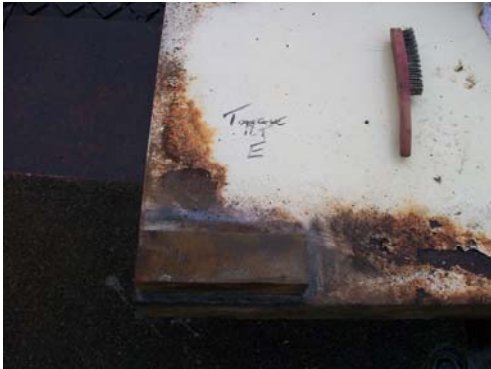
ME3 END BEARING BLOCK ON TONGUE
PLATE (E) CLEANED.

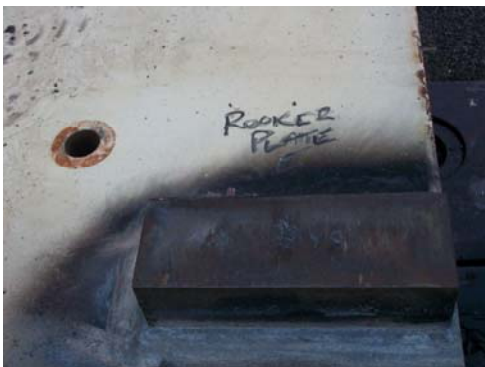
ME3 END BEARING BLOCK ON ROCKER PLATE (E) SHOWING WELDS CLEANED & TESTED.

Comments: Inspection of existing welds by Visual testing and Liquid penetrant testing as specified to British standards : BS EN 13018. : 2001.. BS EN 1289. : 1998 . These tests were carried out determine if any NEW defects have appeared, other than any old defects. No new defects found. Only defects to be found were original: small indications of defects. No new defects found.		<u>Accept:</u>
		YES
		<u>Reject:</u>

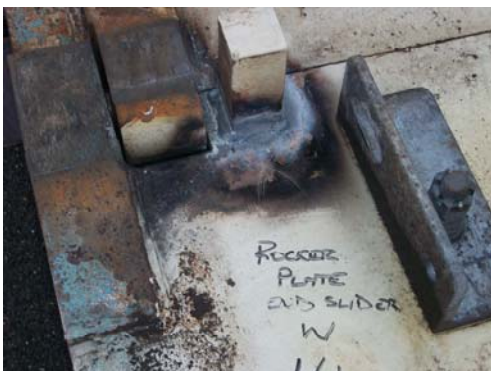
ME3 DEMAG POS. 14 INT GUIDE BLOCK W
SHOWING WELDS TESTED & INSPECTED

<u>Comments:</u> Inspection of existing welds by Visual testing and Liquid penetrant testing as specified to British standards : BS EN 13018. : 2001.. BS EN 1289. : 1998 . These tests were carried out determine if any NEW defects have appeared, other than any old defects. No new defects found. Only defects to be found were original: small indications of defects. No new defects found.		<u>Accept:</u> YES
		<u>Reject:</u>

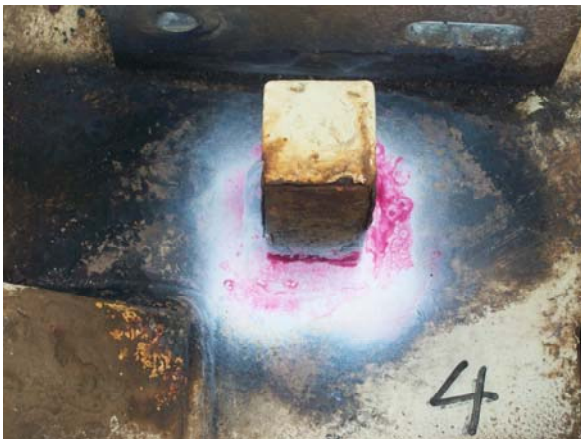
SE3. DEMAG POS. 4 INT GUIDE BLOCK TESTED & INSPECTED

Comments: Inspection of existing welds by Visual testing and Liquid penetrant testing as specified to British standards : BS EN 13018. : 2001.. BS EN 1289. : 1998 . These tests were carried out determine if any NEW defects have appeared, other than any old defects. No new defects found. Only defects to be found were original: small indications of defects.No new defects found.		Accept:
		YES
		Reject:

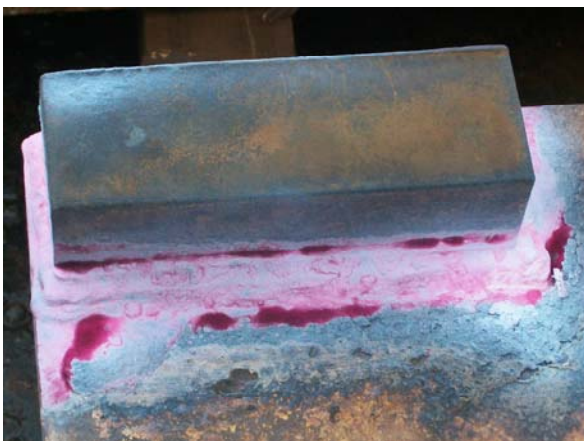
SE3. END BEARING BLOCK ON TONGUE PLATE (E) TESTED & INSPECTED

<u>Comments:</u> Inspection of existing welds by Visual testing and Liquid penetrant testing as specified to British standards : BS EN 13018. : 2001.. BS EN 1289. : 1998 . These tests were carried out determine if any NEW defects have appeared, other than any old defects. No new defects found. Only defects to be found were original: small indications of defects. No new defects found.		<u>Accept:</u> YES
		<u>Reject:</u>
