**Forth Estuary Transport Authority**

**Forth Road Bridge  
Extending the Life of the Main Expansion Joints**

## Reducing the Risk of Failure and Extending the Life of the Main Expansion Joints

**February 2009**

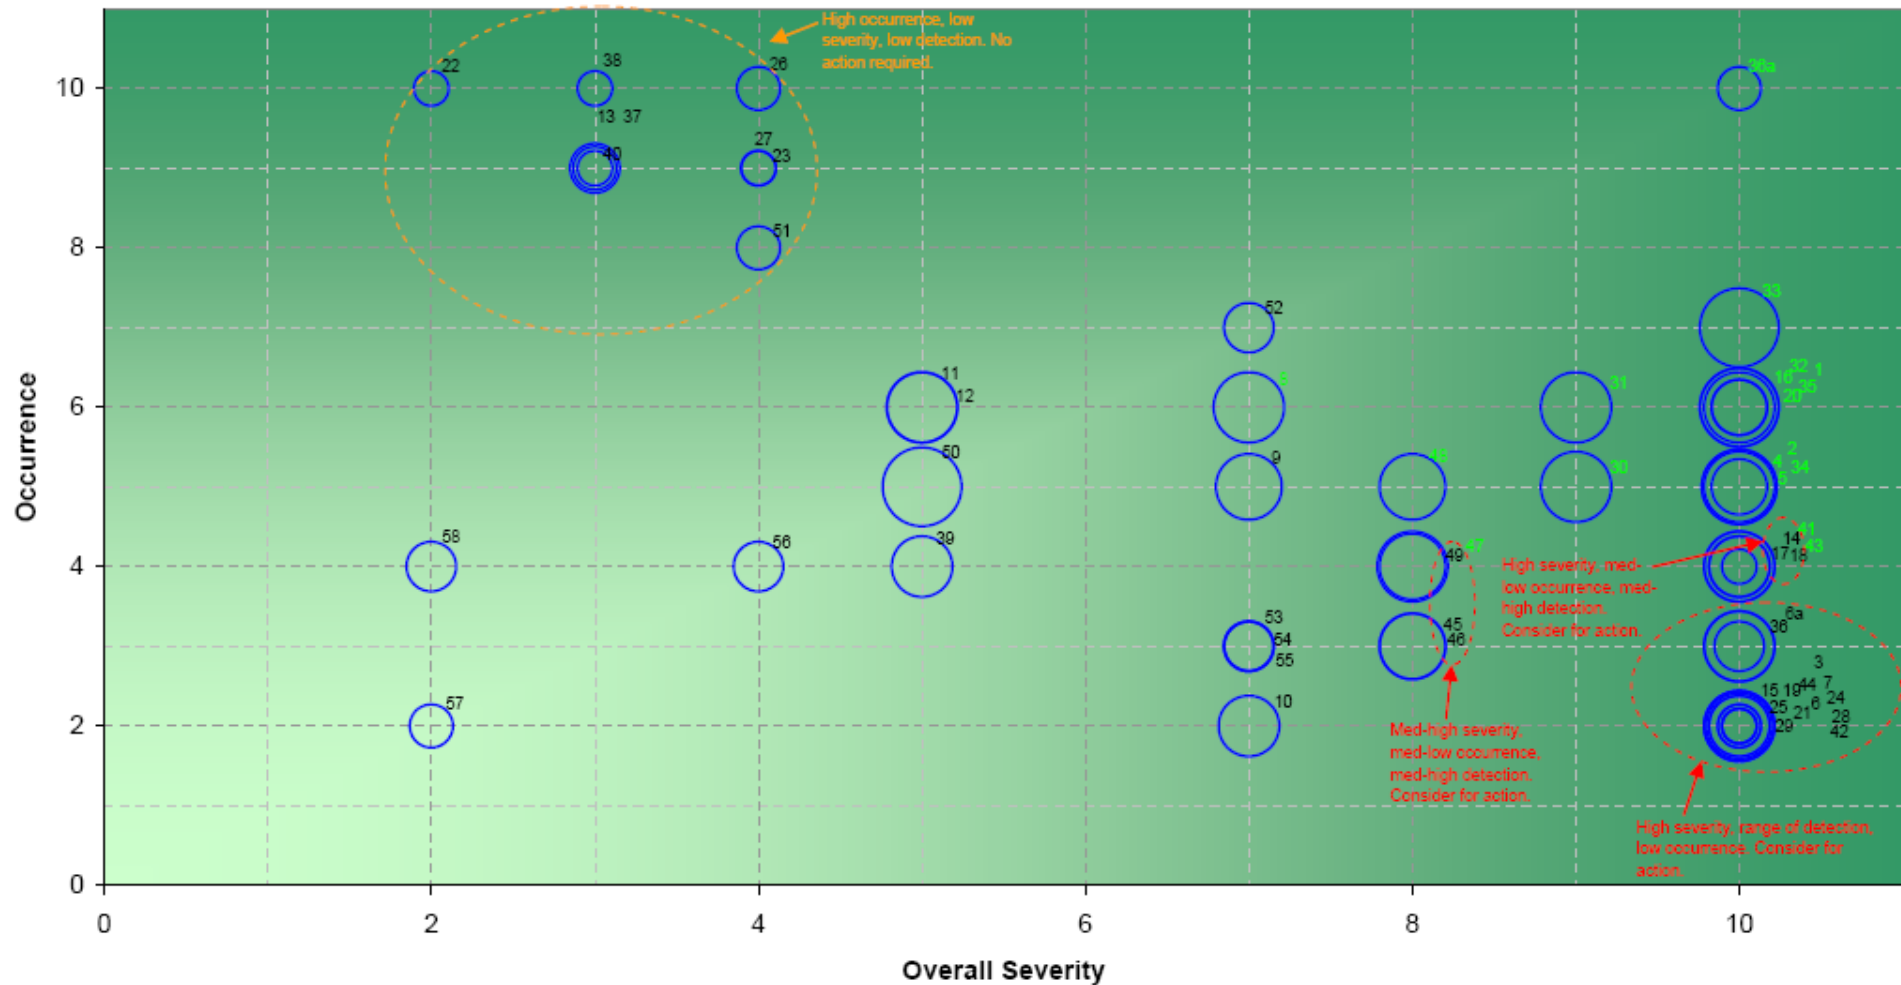
### Key (3):

Risk Tolerance is indicated by chart shading. Items which are marked towards the top right (in areas of darker shading) should be considered for action.

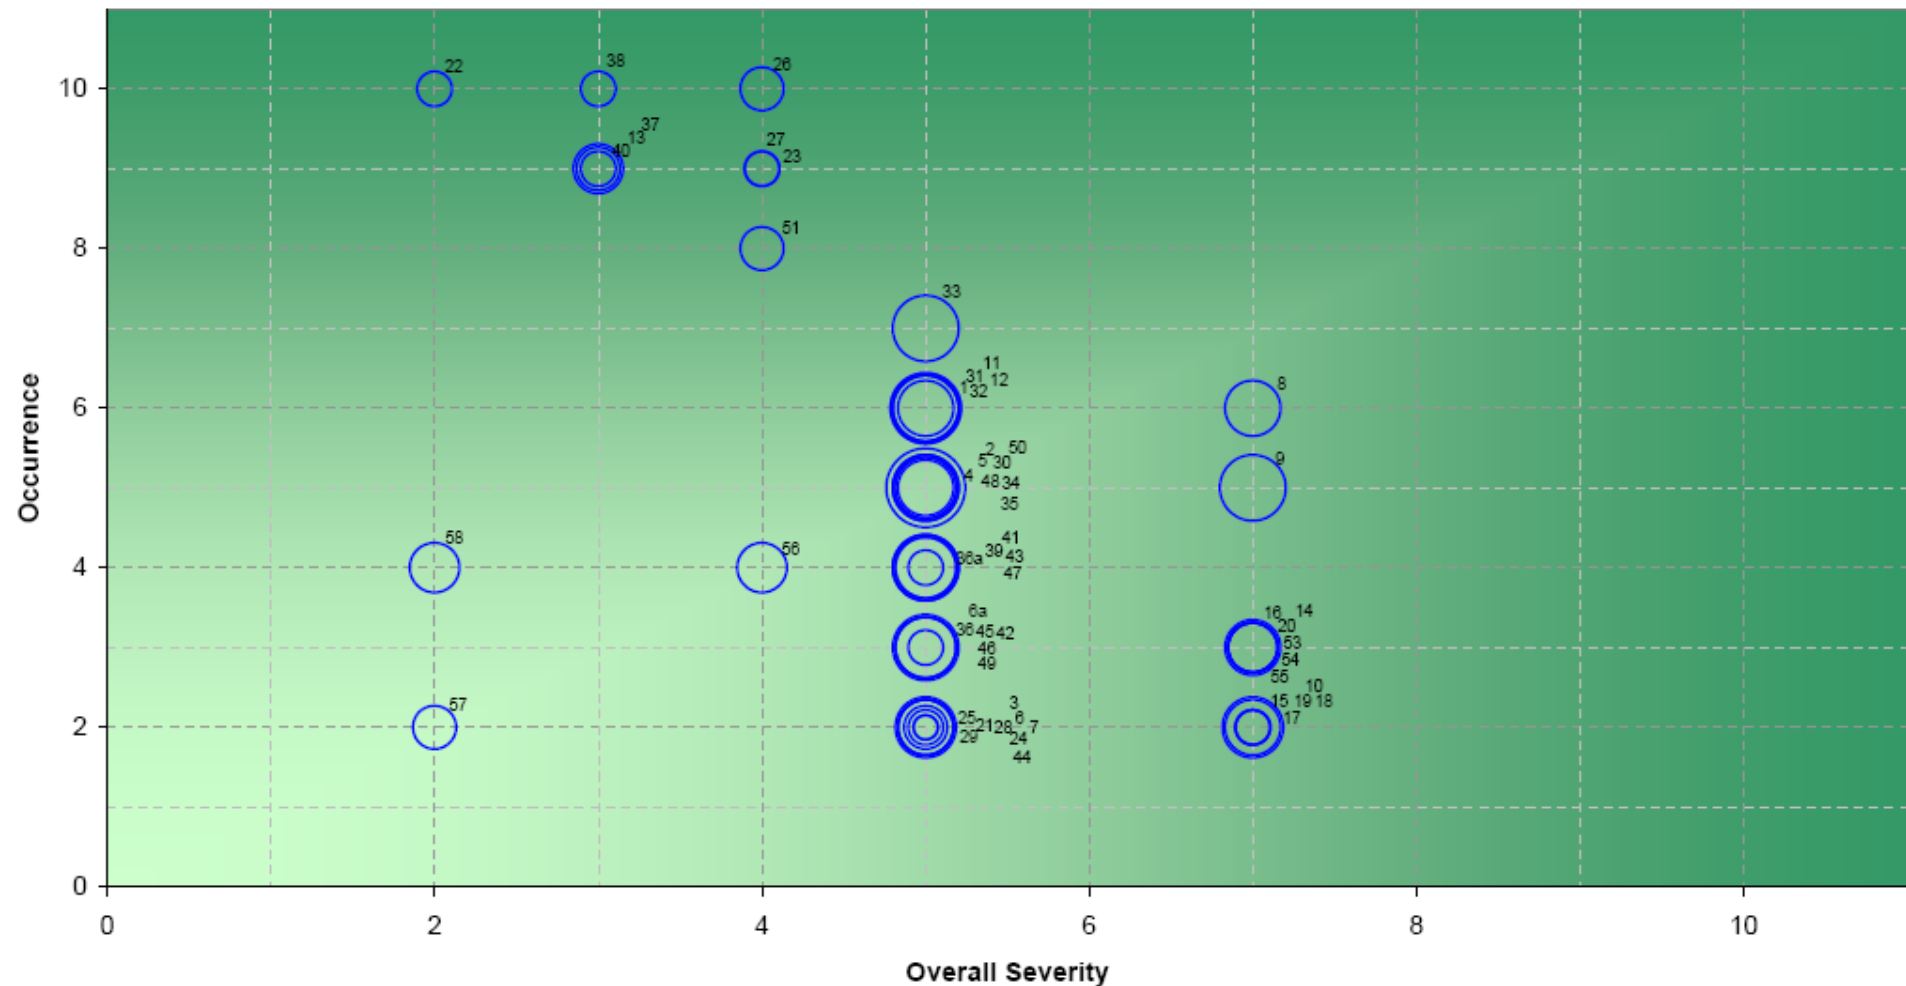
## A.4.2 Bubble Chart for Resultant FMEA Scoring

**Key (3):**

Risk Tolerance is indicated by shading. Items which are marked towards the top right (in darker shading) should be considered for action.
