**PROJECT:** Forth Bridge Bearing Replacement Feasibility

**Report Title:** Preliminary Feasibility Report

# **FORTH BRIDGE BEARING REPLACEMENT FEASIBILITY**

## **PRELIMINARY FEASIBILITY REPORT**

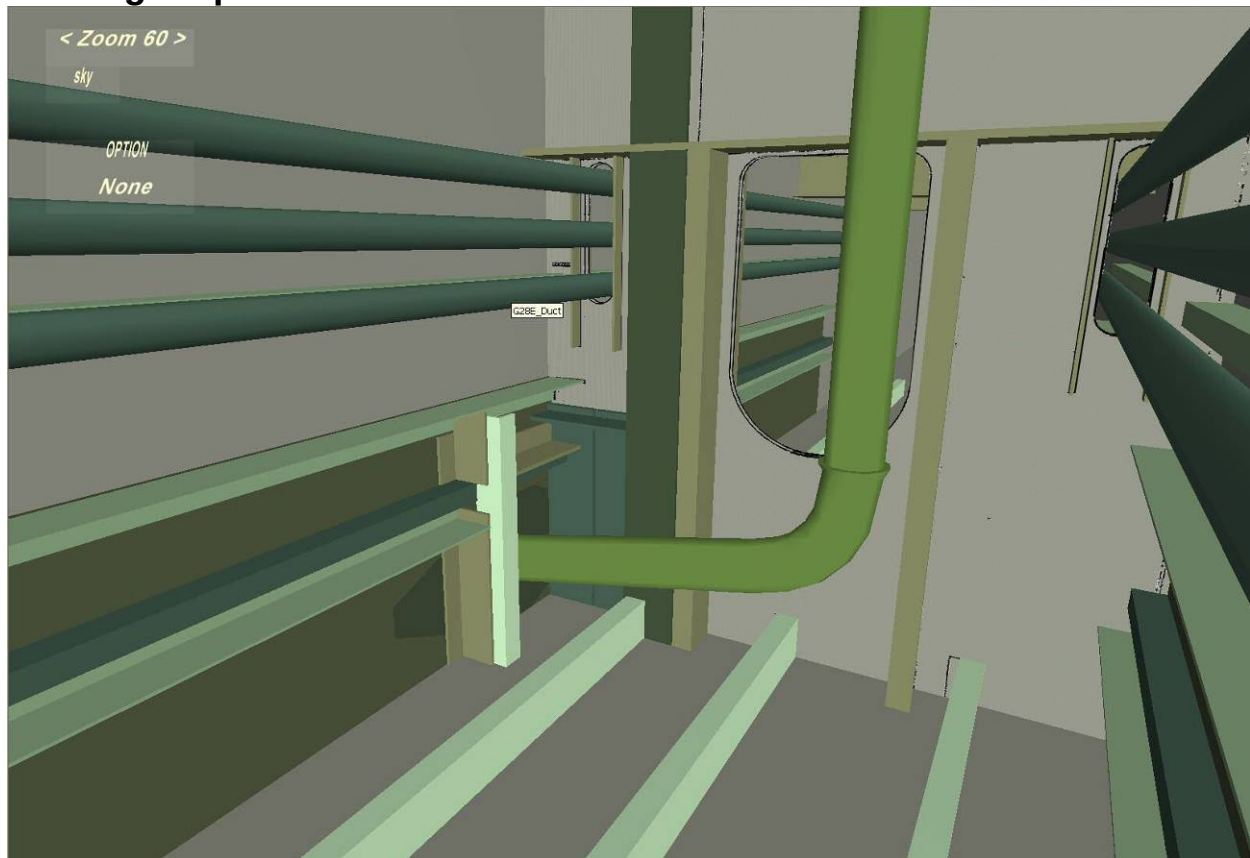
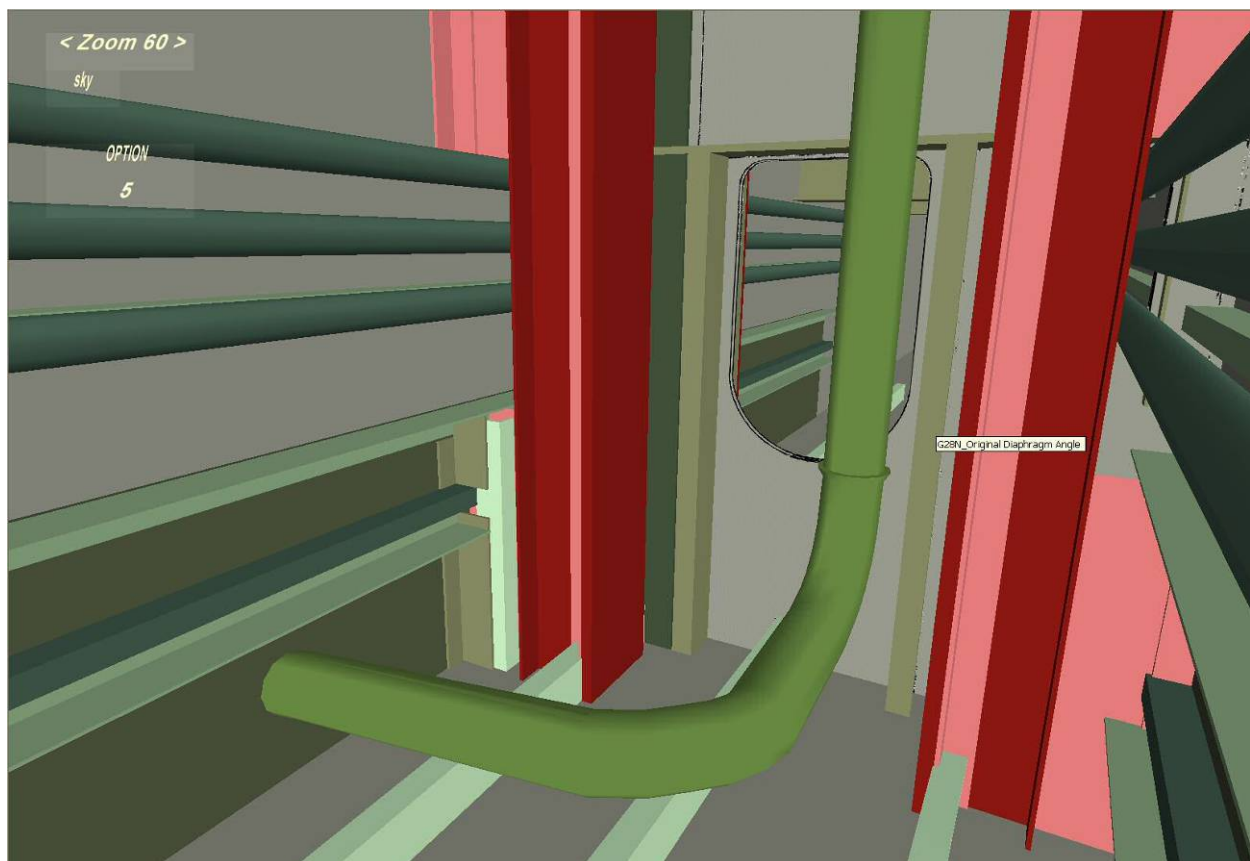
## Drainage Pipe Diversion

Several options are possible for the diversion of this pipe. The first would be to divert the drainage through the deck slab and move the main drainage pipe outside, as the current drainage pipes leak and causing water build up inside of the box. By removing the pipe from the box, this leakage will be removed. However, this option would require the removal of a section of the structural slab, and would therefore affect the local capacity of the deck at this cross section. It will also be more expensive to complete and will require that the carriageway is closed during the diversion of the drainage pipe. More of the pipe will be visible from the ground, though the pipe will mostly be located above the pier.

The second option would involve the diversion of the pipe inside of the box. The pipe would be diverted to exit the box at an alternate position. This would mean that the box would have to be strengthened using doubler plates at the pipes new exit diversion. More bends will be introduced in the pipe so additional rodding points will be required. The pipe is probably already deficient in that respect but the large diameter of the pipe and large head of water is effective in flushing any debris through. If the pipe remains in the box, provisions should be made for drainage of the water from the box in the event of a pipe leak.
