INSPECTION DEPARTMENT
Main tower inspection.
DATE. 18/12/2013.

(E2.1 Bridge)
Report No 413.
Main Towers north & south.

Date: 02.09.13 to 20.11.13

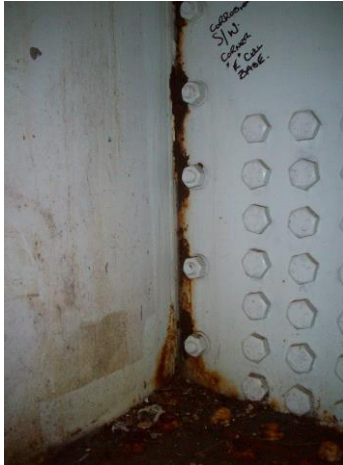
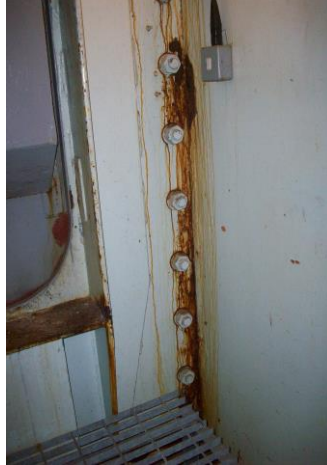
Paintwork. : . Externals as main tower introduction, however there is an area of paintwork on the south main tower external crossover at the tower top on the west side where the painted surface has broken down over an area of approximately 8 to 10 meters square. This area requires to be removed as surface corrosion is evident on floor panels where breakdown. Internals generally remain in a satisfactory condition . On the south main tower top crossover internal however there are areas where bolts have been removed/drilled and the surrounding perimeter paintwork has been removed and corrosion is evident at these locations. As recorded defects last inspection stating corrosion and water was evident in shelves located at "C" level in certain cells , this inspection no water evident at time of inspection, corrosion/ discoloration remains. Please refer to relevant Photographs & structure numbers Please refer to relevant Photographs & structure numbers .

View of defective area of paintwork on the South main tower top crossover external.
