Main tower expansion joint plate removal.

Location: Main tower North west joint No 3. slow lane.

On Saturday 17th January 2009 the inspection to the Demag expansion joint MW3, continued after its extraction and initial inspection checks on nightshift 16th/17th January.

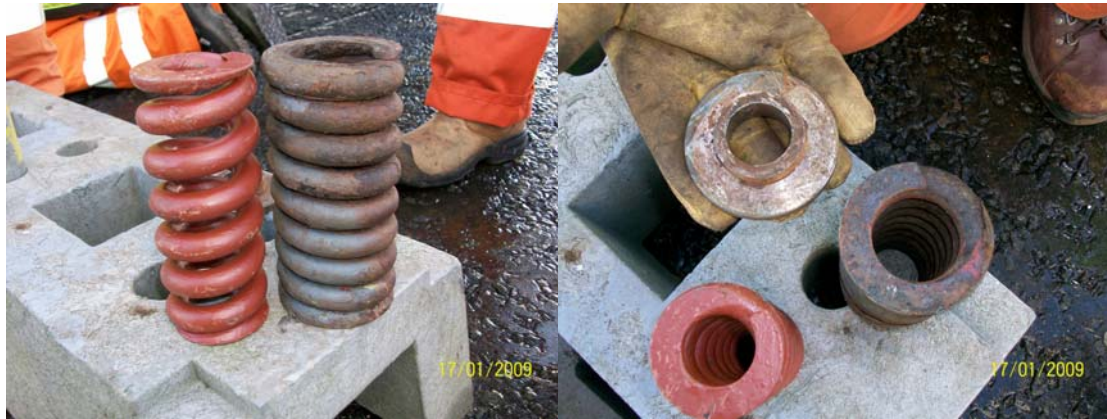
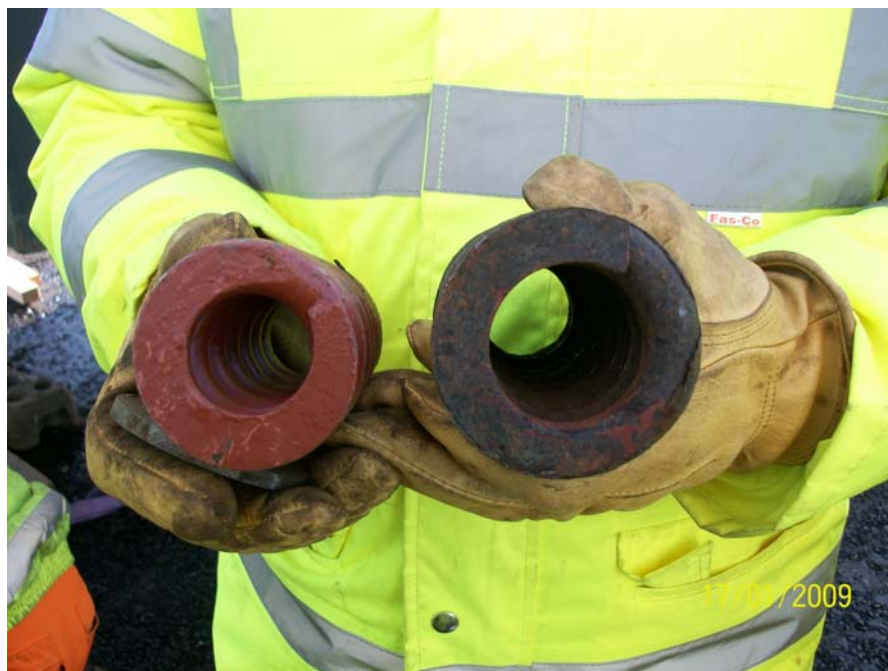
EXISTING SPRING

On reinstating the expansion joint, new springs were fitted to MW3 tongue plate and also to MW2 (east spring only) and also to MW4 (west spring only). On installation of the rocker plate it was discovered that the newly purchased rocker plate springs were the incorrect size. The original spring was re-used as it was in good enough condition.

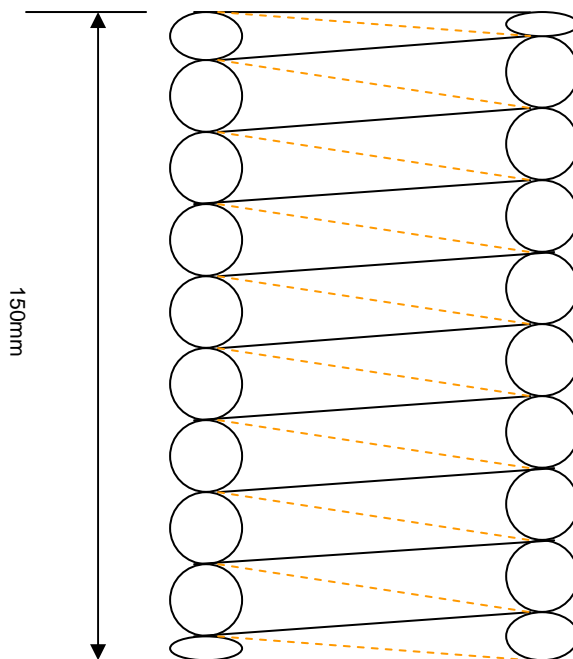
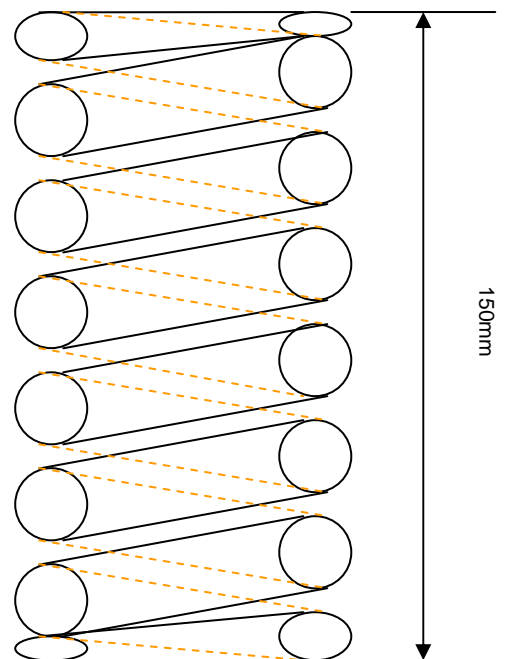
MEAN DIA. = 47mm

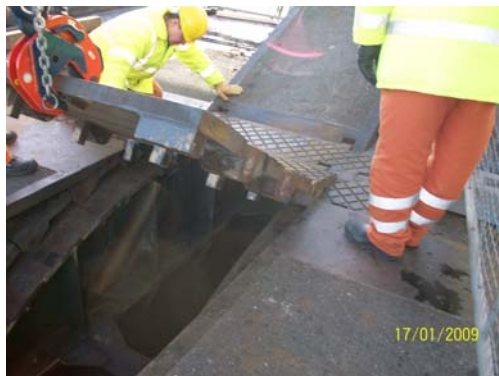
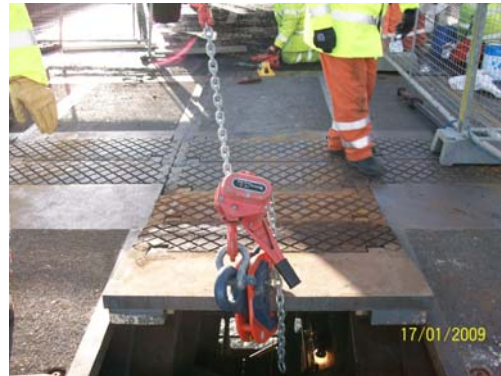
Follow up check Monday 19/01/09:

Slide plate No.5 has still not settled back into its original position, as photos show.
