INSPECTION DEPARTMENT
INSPECTION. North Anchorage Monthly Inspection
DATE. 2015.07.10

INSPECTION DEPARTMENT
SOUTH ANCHORAGE FACE WEEKLY INSPECTION
DATE. 2015.07.10

INSPECTION DEPARTMENT
South east anchor chamber. Crosshead block C6. & R2 INSPECTION.
DATE. 2015.07.10

INSPECTION DEPARTMENT
SOUTH WEST ANCHORAGE CHAMBER BLOCK R3
DATE. 2015.07.10

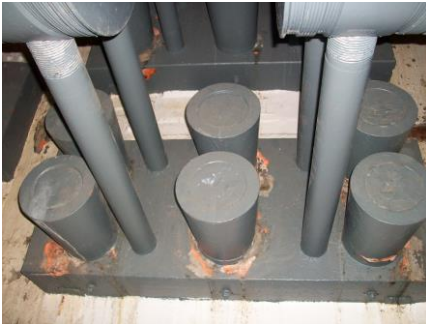
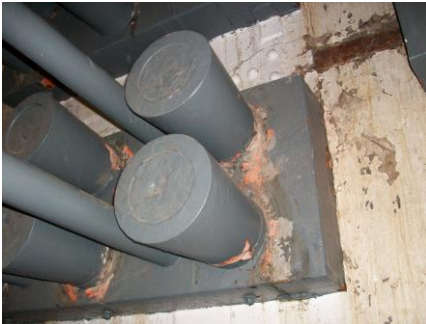
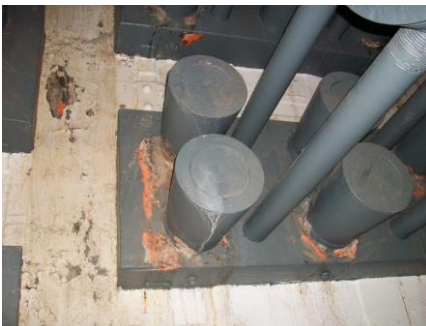
Comparison photographs recorded on Inspection date. . (15.06.15.)

No moisture evident on any zinc poured sockets or any crosshead blocks at time of inspection. No movement evident.

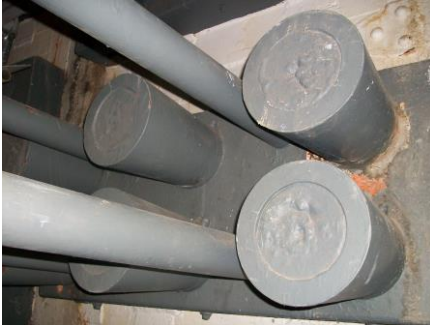
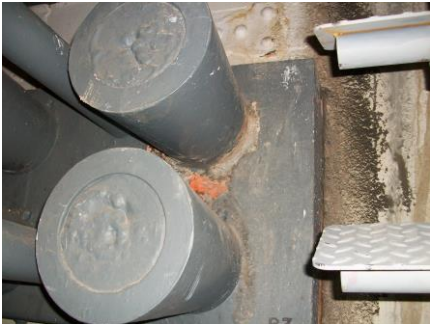
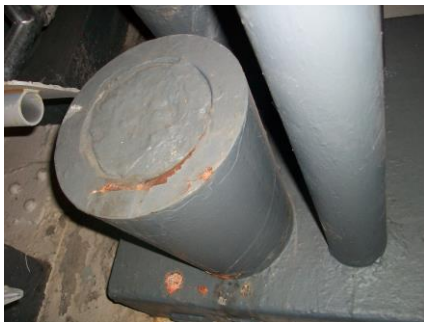
Comparison photographs recorded on Inspection date. . (15.06.15.)

No moisture evident on any zinc poured sockets or any crosshead blocks at time of inspection. No movement evident.
