INSPECTION DEPARTMENT
INSPECTION. North Anchorage Monthly Inspection
DATE. 2015.09.11

INSPECTION DEPARTMENT
SOUTH ANCHORAGE FACE WEEKLY INSPECTION
DATE. 2015.09.11

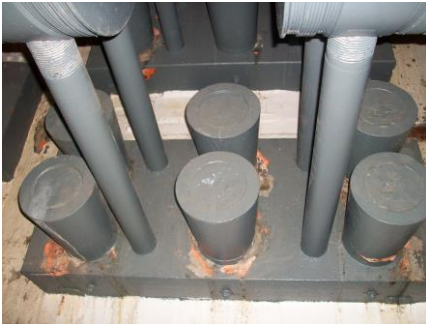
East side of crosshead block from area between poured sockets. Paint very brittle, cracking over whole Block evident. loss of adhesion. (No change from inspection date. (06.08.15)

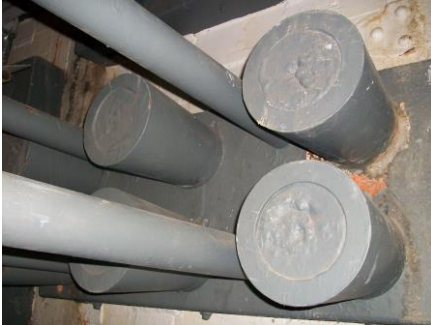
West side of crosshead block R3. paint removed from East & west side and directly below top socket .

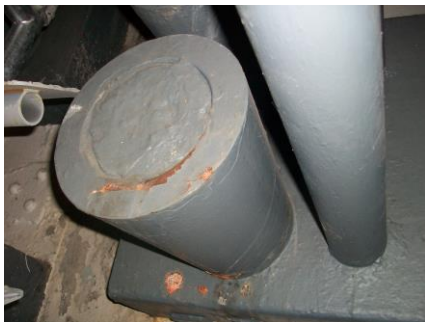
Sight area of zinc salts present on S/W corner of bottom socket. Area of paint breakdown evident.

Top socket satisfactory.
