North West Main tower. Expansion Joints
Main-span

Pre - Post Inspection Information.

North West main Tower Expansion Joint.

North West Main Tower expansion joint . Removal and re-instatement of plate Main-span west No. 3.

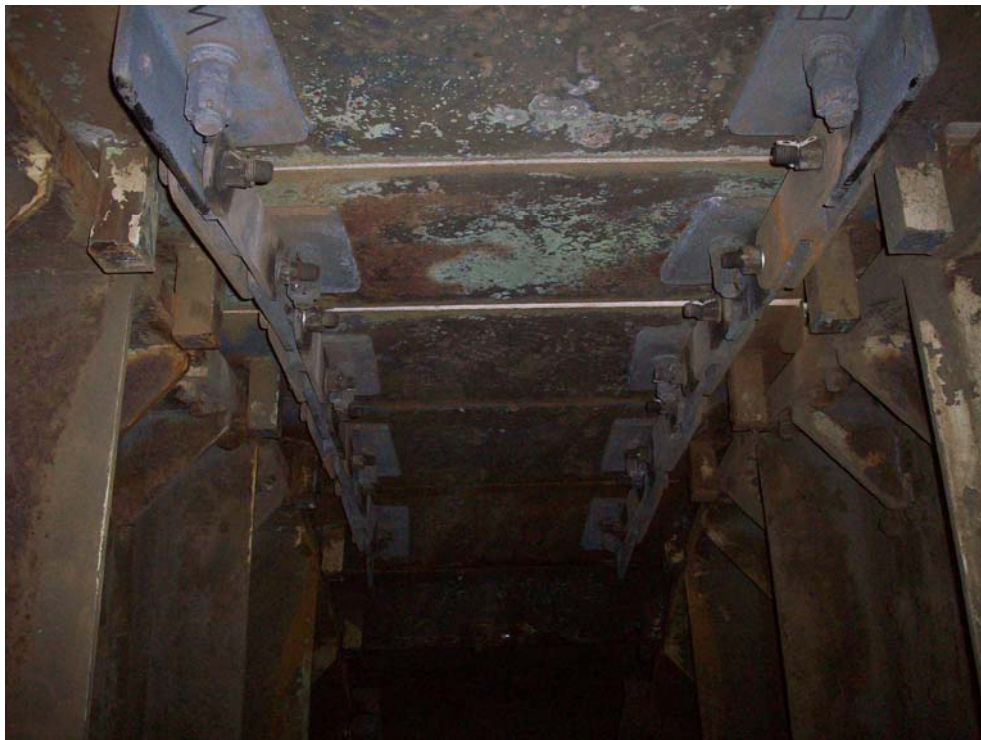
On Sunday the 12th of October 2014, a programme of works operational procedure was carried out, the objective, to inspect and report the current status of the North main tower expansion joint plate MW 3. and to carry out any requested repairs or remedial works if required before being reinstated back into position.
