A90 Forth Road Bridge Special Inspection Report

North Main Tower Expansion Joint
Removal & Reinstatement of Side-Span Plate
SW No.3
October 2015

SPECIAL INSPECTION REPORT

October 2015

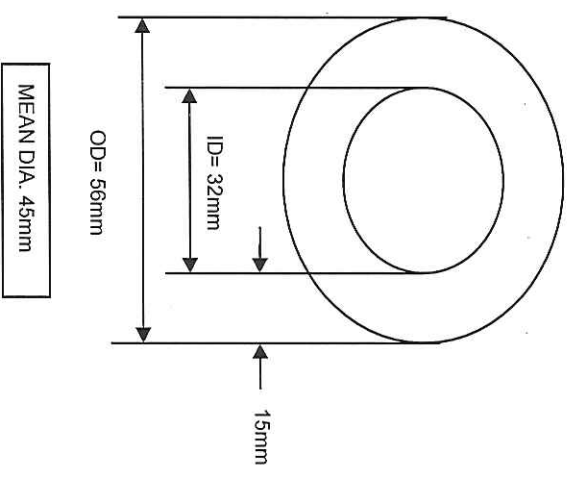
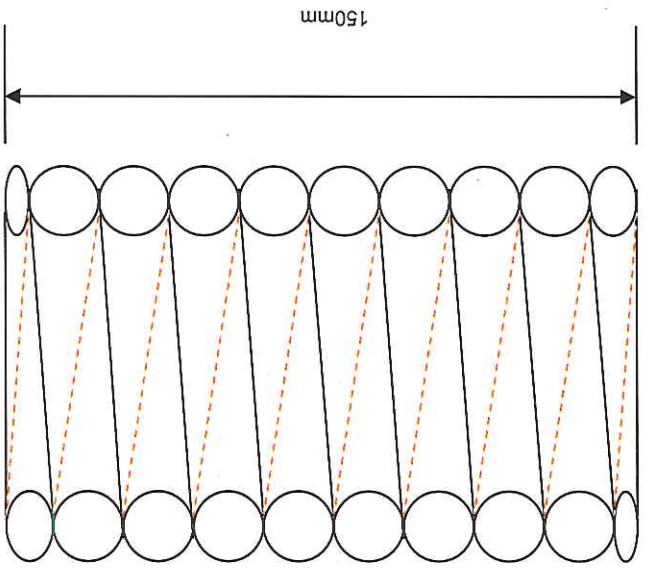
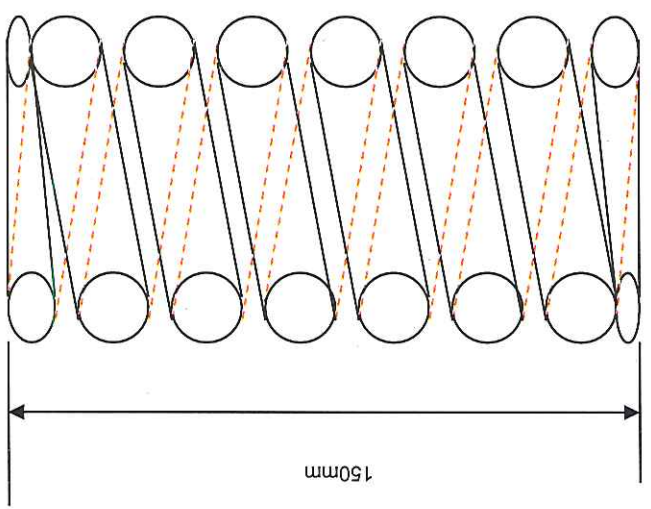
INSPECTION DEPARTMENT.
DEMAG PLATE SPRING DIMENSIONS, ROCKER PLATE, SW 3.
DATE: 2015.10.24.

NEW SPRING
Spring replaced

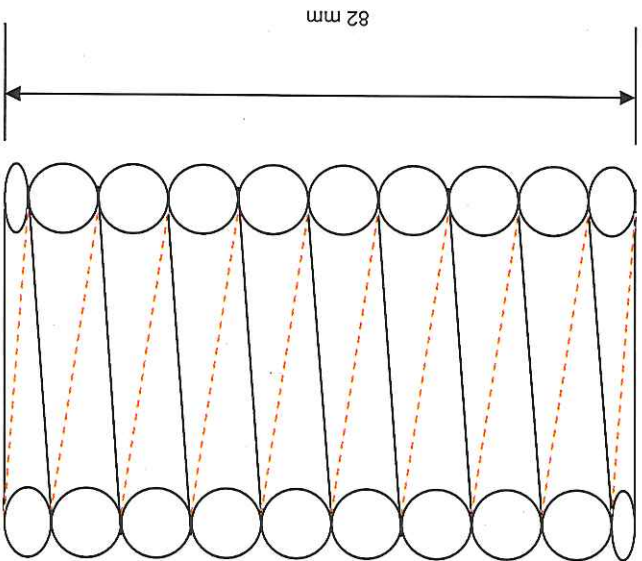
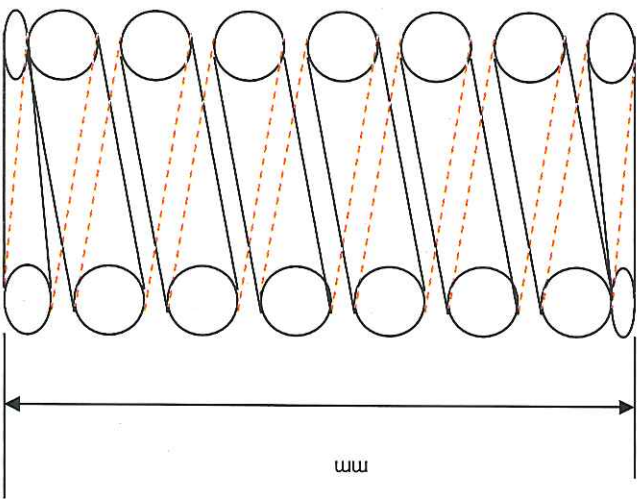
New spring (E)

New spring (W)

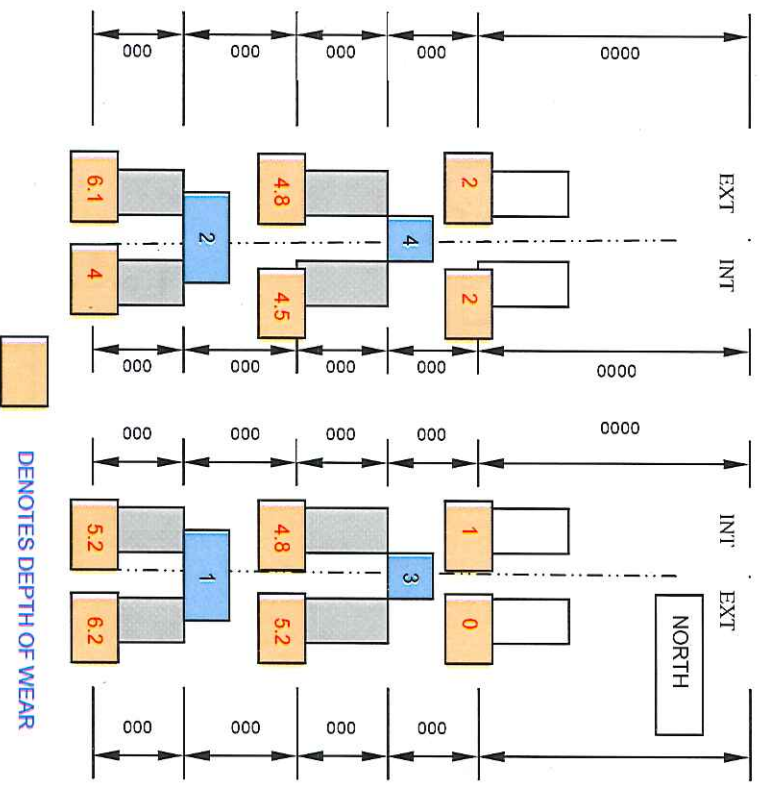
Pin No.	Internal Dia.	External Dia.
1	39mm	39mm
Top	5 mm	5 mm
Bottom	3 mm	3 mm
North	3.5 mm	0 mm
South	3.5 mm	3.5 mm
Pin No.	Internal Dia.	External Dia.
2	39mm	39mm
Top	0 mm	6 mm
Bottom	3 mm	2.5 mm
North	3 mm	0 mm
South	1.5 mm	4.5 mm
Pin No.	Internal Dia.	External Dia.
3	39mm	39mm
Top	2 mm	2.5 mm
Bottom	4 mm	2 mm
North	5 mm	0 mm
South	3 mm	1.5 mm
Pin No.	Internal Dia.	External Dia.
4	39mm	39mm
Top	0 mm	5 mm
Bottom	0 mm	0 mm
North	0 mm	0 mm
South	0 mm	3 mm

Bush bore dimensions. :- (largest across oval, horizontal axis.) - No dimensions taken

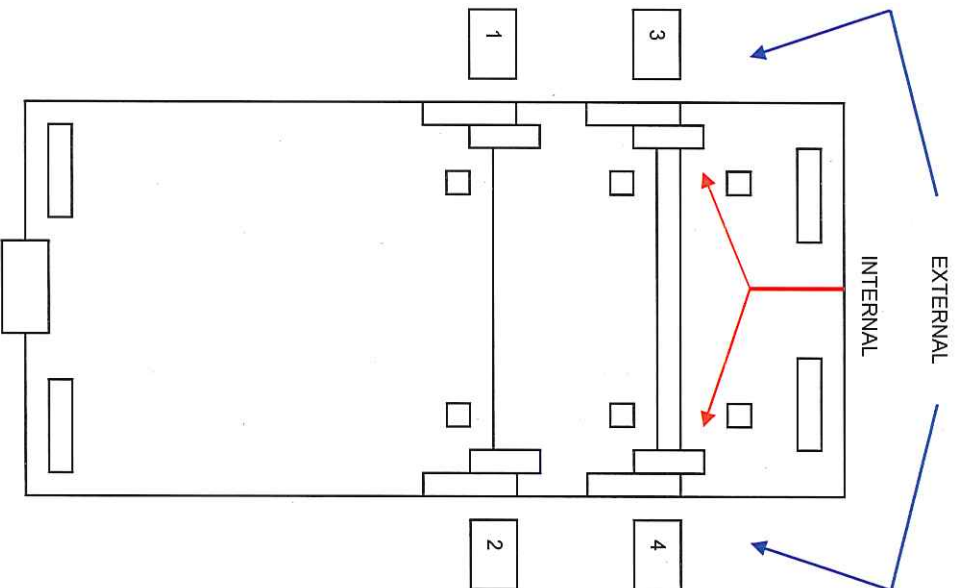
INSPECTION DEPARTMENT
DEMAG DIMENSIONAL BLANK . PINS & BUSHES. SW 3.
DATE, 2015.10.24.

PIN No.	EXTERNAL	INTERNAL
<u>1</u>	39mm	39mm
Bush thickness		
Top	5 mm	5 mm
Bottom	3 mm	3 mm
North	0 mm	3.5 mm
South	3.5 mm	3.5 mm
<u>2</u>	39mm	39mm
Bush thickness		
Top	6 mm	0 mm
Bottom	2.5 mm	3 mm
North	0 mm	3 mm
South	4.5 mm	1.5 mm
<u>3</u>	39mm	39mm
Bush thickness		
Top	2.5 mm	2 mm
Bottom	2 mm	4 mm
North	0 mm	5 mm
South	1.5 mm	3 mm
<u>4</u>	39mm	39mm
Bush thickness		
Top	5 mm	0 mm
Bottom	0 mm	0 mm
North	0 mm	0 mm
South	3 mm	0 mm
