Location PP. 54 North East Main Span. .
Bolt change report.

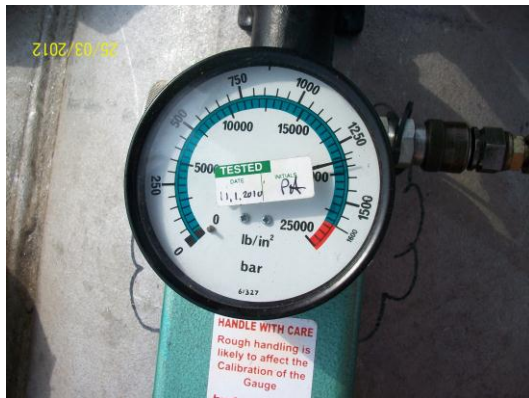
Pressure taken to 19667 psi. this operation was completed three times to ensure that required load had been reached. All readings taken were over 19000 Psi.

ESM. present and happy with load pressures applied.
