An exploratory exercise was undertaken during a nightshift road repair at panel point 00 N.W. on the side tower side.

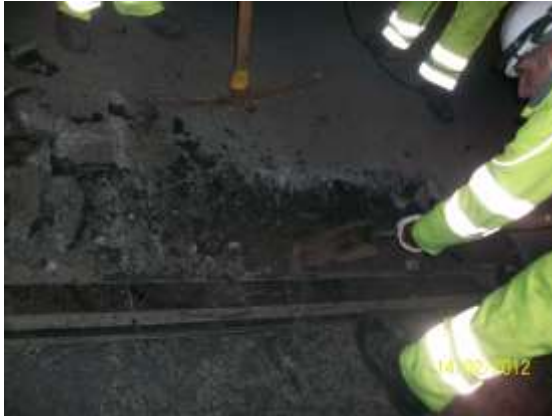
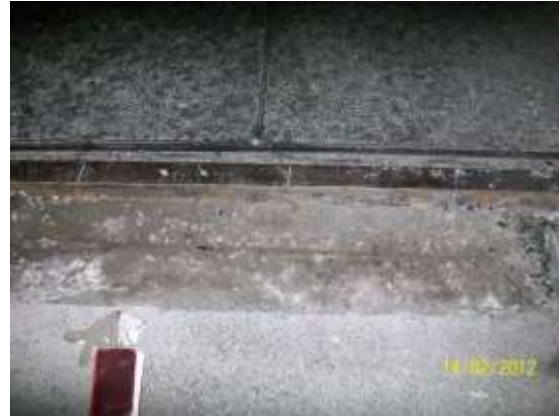
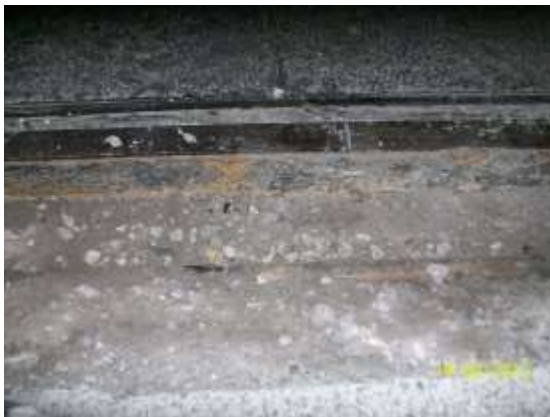
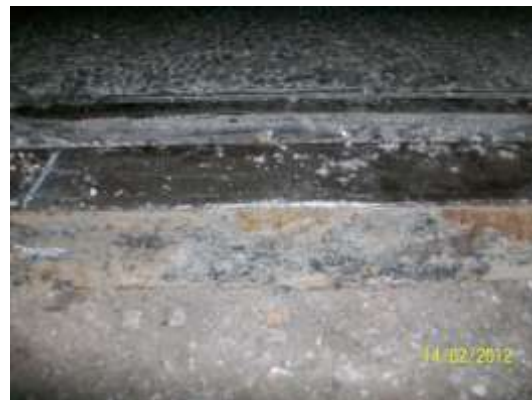
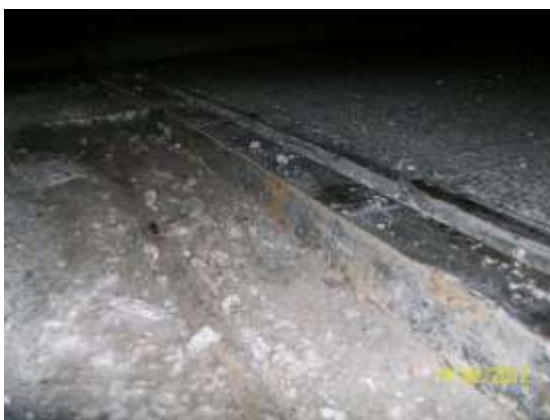
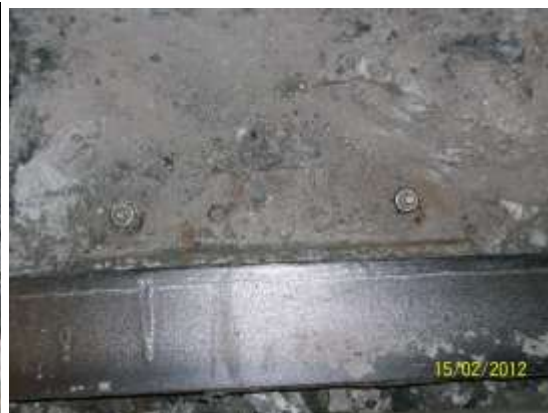
In carrying out these repairs, an investigation into discovering what the anchor detail is in situ. This double angle fabrication is suffering from a lot of movement, which indicates that the anchor detail has failed.

Three original tangs were exposed (marked with red dot) under the more serious surface depression. These tangs have a spacing of 600mm between them, suggesting there could be tangs at this spacing over the entire length, but this has not been confirmed.

During the surface removal two other sections of angle from a previous repair were discovered, one of which was fully exposed, revealing that the fixings were loose. As indicated the sketch there was 6mm – 8mm pull-down on these nuts.

Five additional tangs were added (see detail above), the three exposed original tangs were re-welded. It must be noted that the angle is suffering from corrosion/lamination which may result in future weld failure for all the tang welds old and new.

Tangs welded, area cleared of dust and debris. Rapid set concrete poured, allowed to cure for 1 hrs – 1.5hrs, overlaid with road surface filler and over banded.
