An urgent repair was undertaken on the southbound carriageway during a nightshift on the 17th of July, 2012; at Panel Point 00 N.E. at the side tower.

This temporary repair was carried out with the same detail as P.P. 00 N.W. on the 14th of February, 2012. In carrying out these repairs, it was found that the existing anchors had failed.

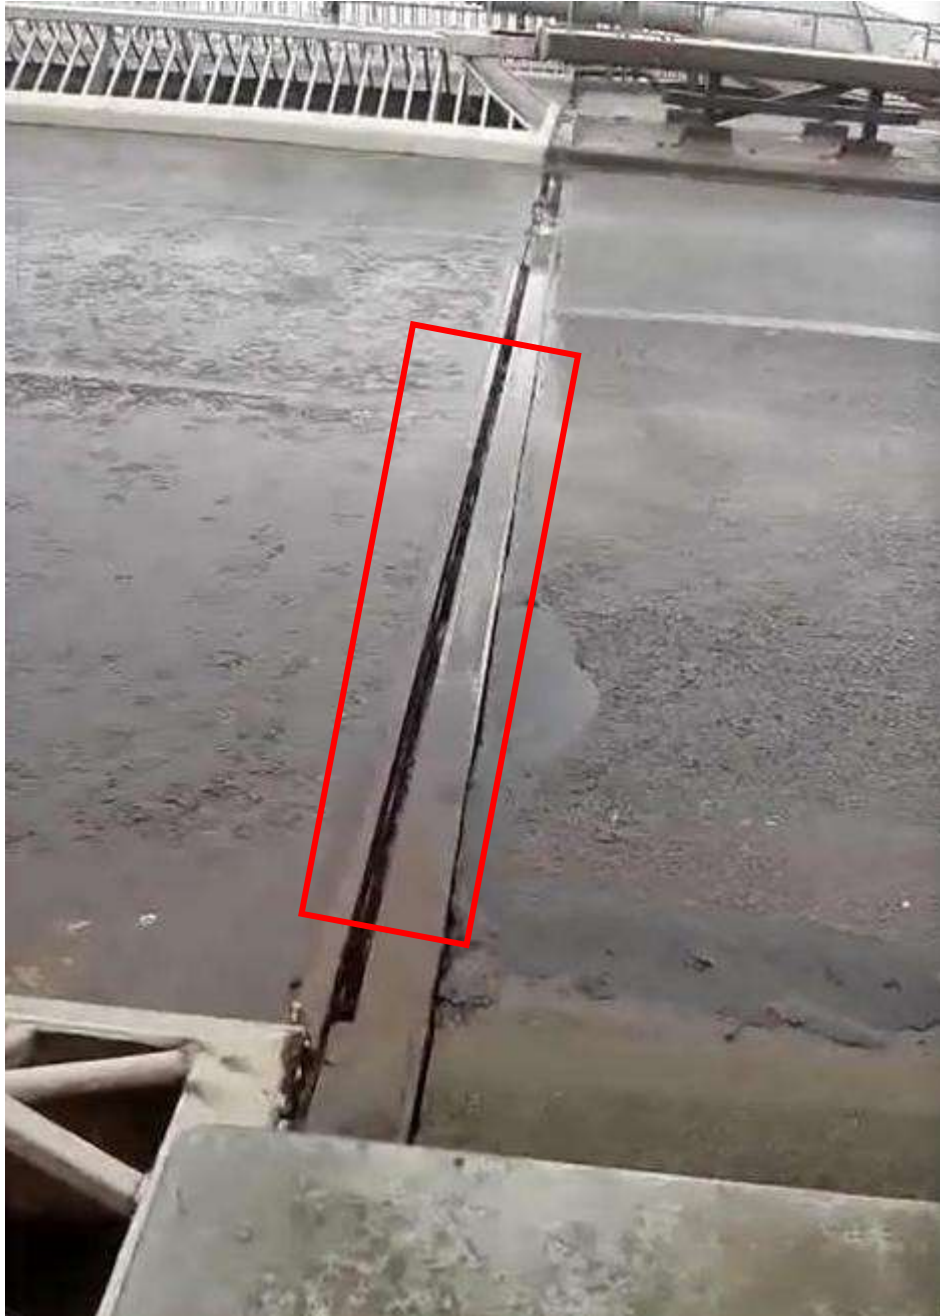
Two original tangs were exposed (marked with red dot). These tangs had split and an air gap of approximately 30mm was present. They are also showing signs of corrosion. These tangs have a spacing of 600mm between them, possibly confirming that there could be tangs at this spacing over the entire length, as with the N.W. Eight additional tangs were added (see detail above) with a spacing of approximately 150mm.

The new tangs were welded into position and the area was cleared of dust and debris. Rapid set concrete was mixed and poured in to a depth of approximately 25-35mm completely covering the new tangs. The concrete was allowed to cure for 1hr – 1.5hrs. The concrete was overlaid with a road surface filler and compacted before a hot applied sealant was used on the joints.

It should be noted that no tack coat was used on the concrete surface prior to the road surface filler being laid.
